LAWRENCE HARGRAVE DRIVE

Risk Assessment and Hazard Reduction

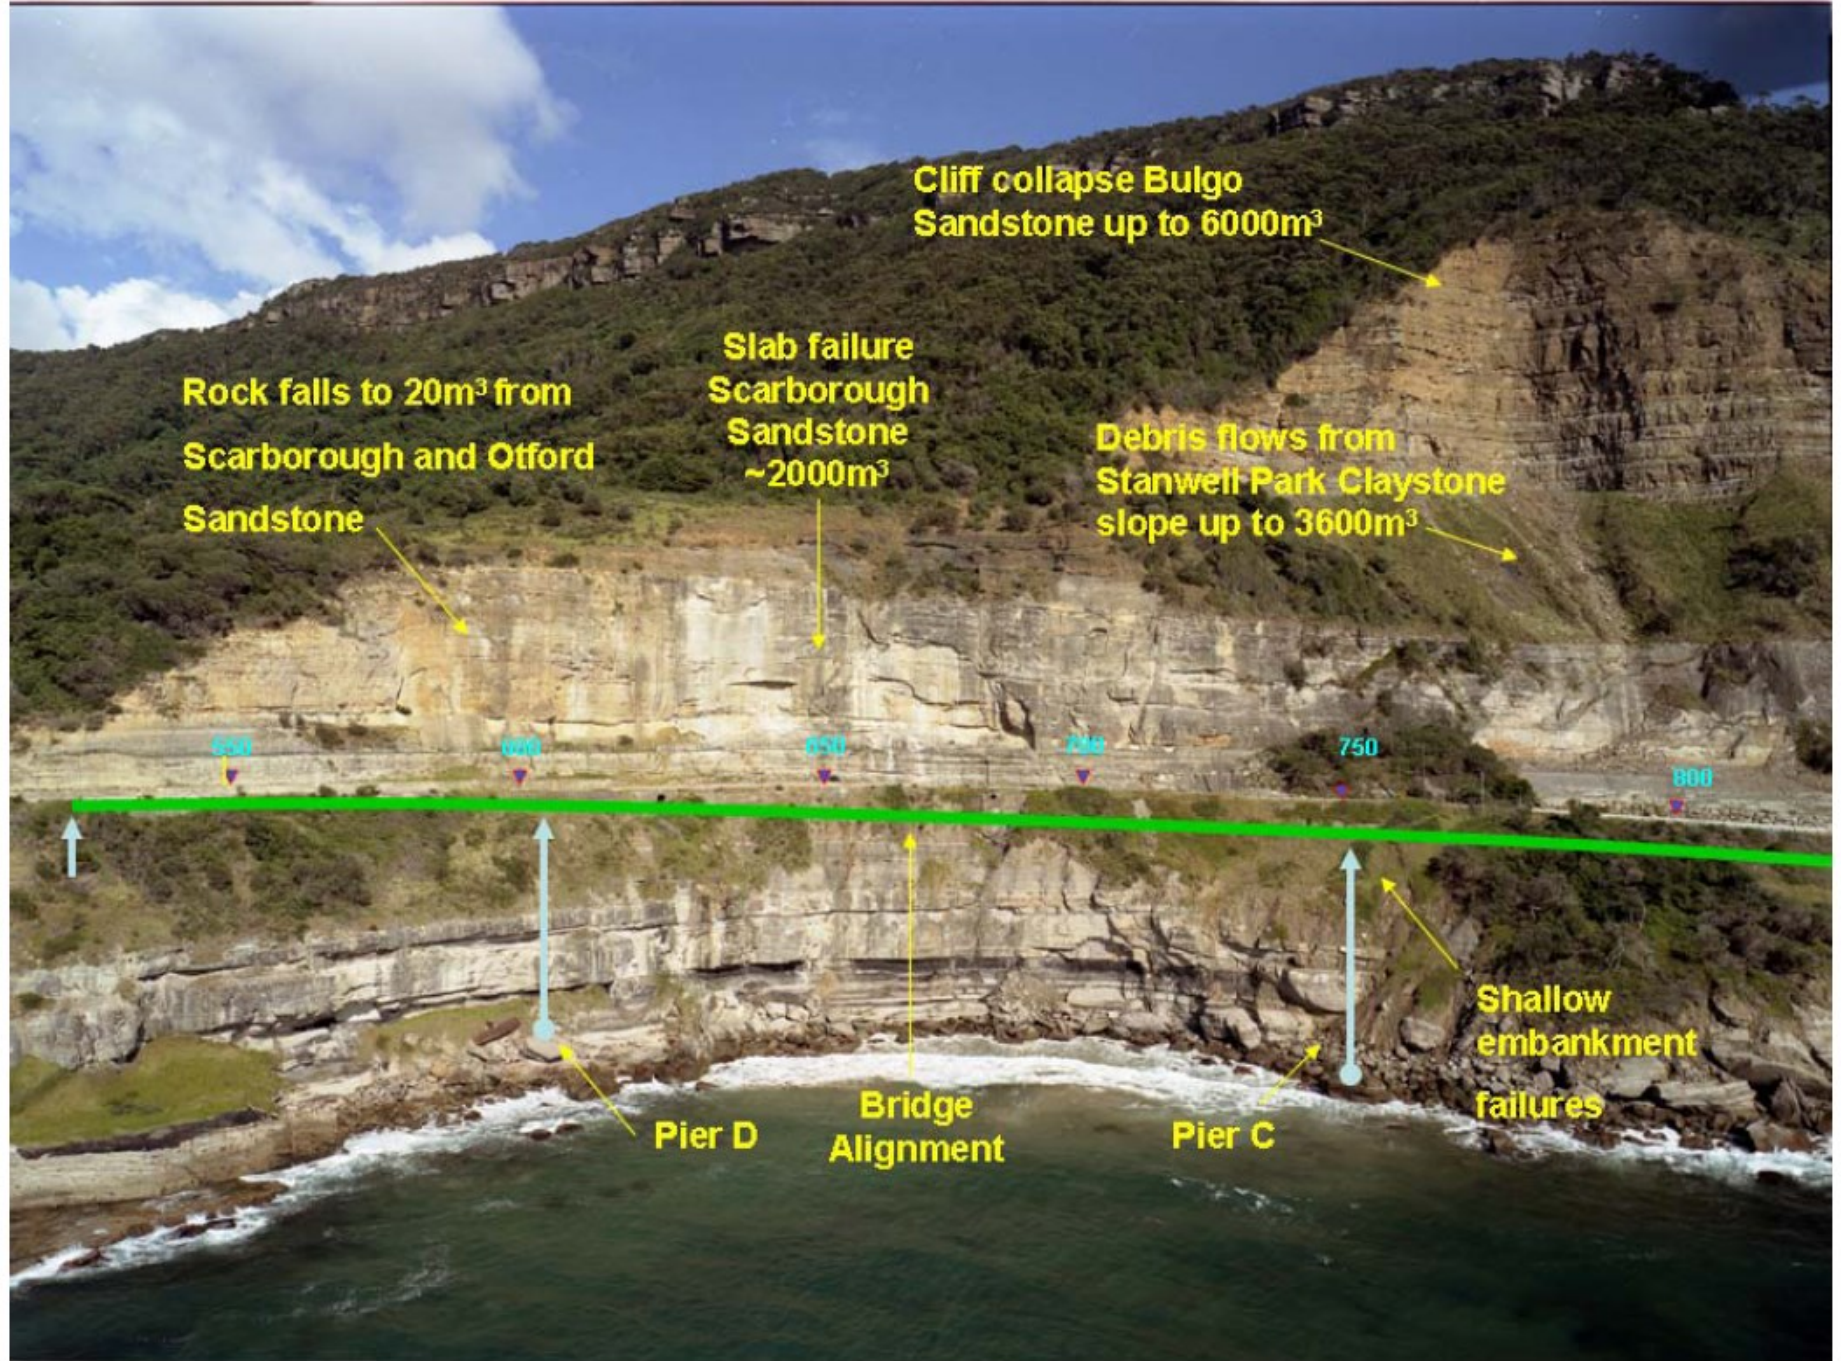
Cliff collapse Bulgo
Sandstone up to 6000m³

Rock falls to 20m³ from
Scarborough and Otford
Sandstone

Slab failure
Scarborough
Sandstone
~2000m³

Debris flows from
Stanwell Park Claystone
slope up to 3600m³

Shallow
embankment
failures
