ENGINEERING GEOLOGY & GEOTECHNICAL MODELS

Lake George – Federal Highway Slope Stability

SH3 - FEDERAL HIGHWAY. ROCKFALL INCIDENT ON 20 JUNE 2005.

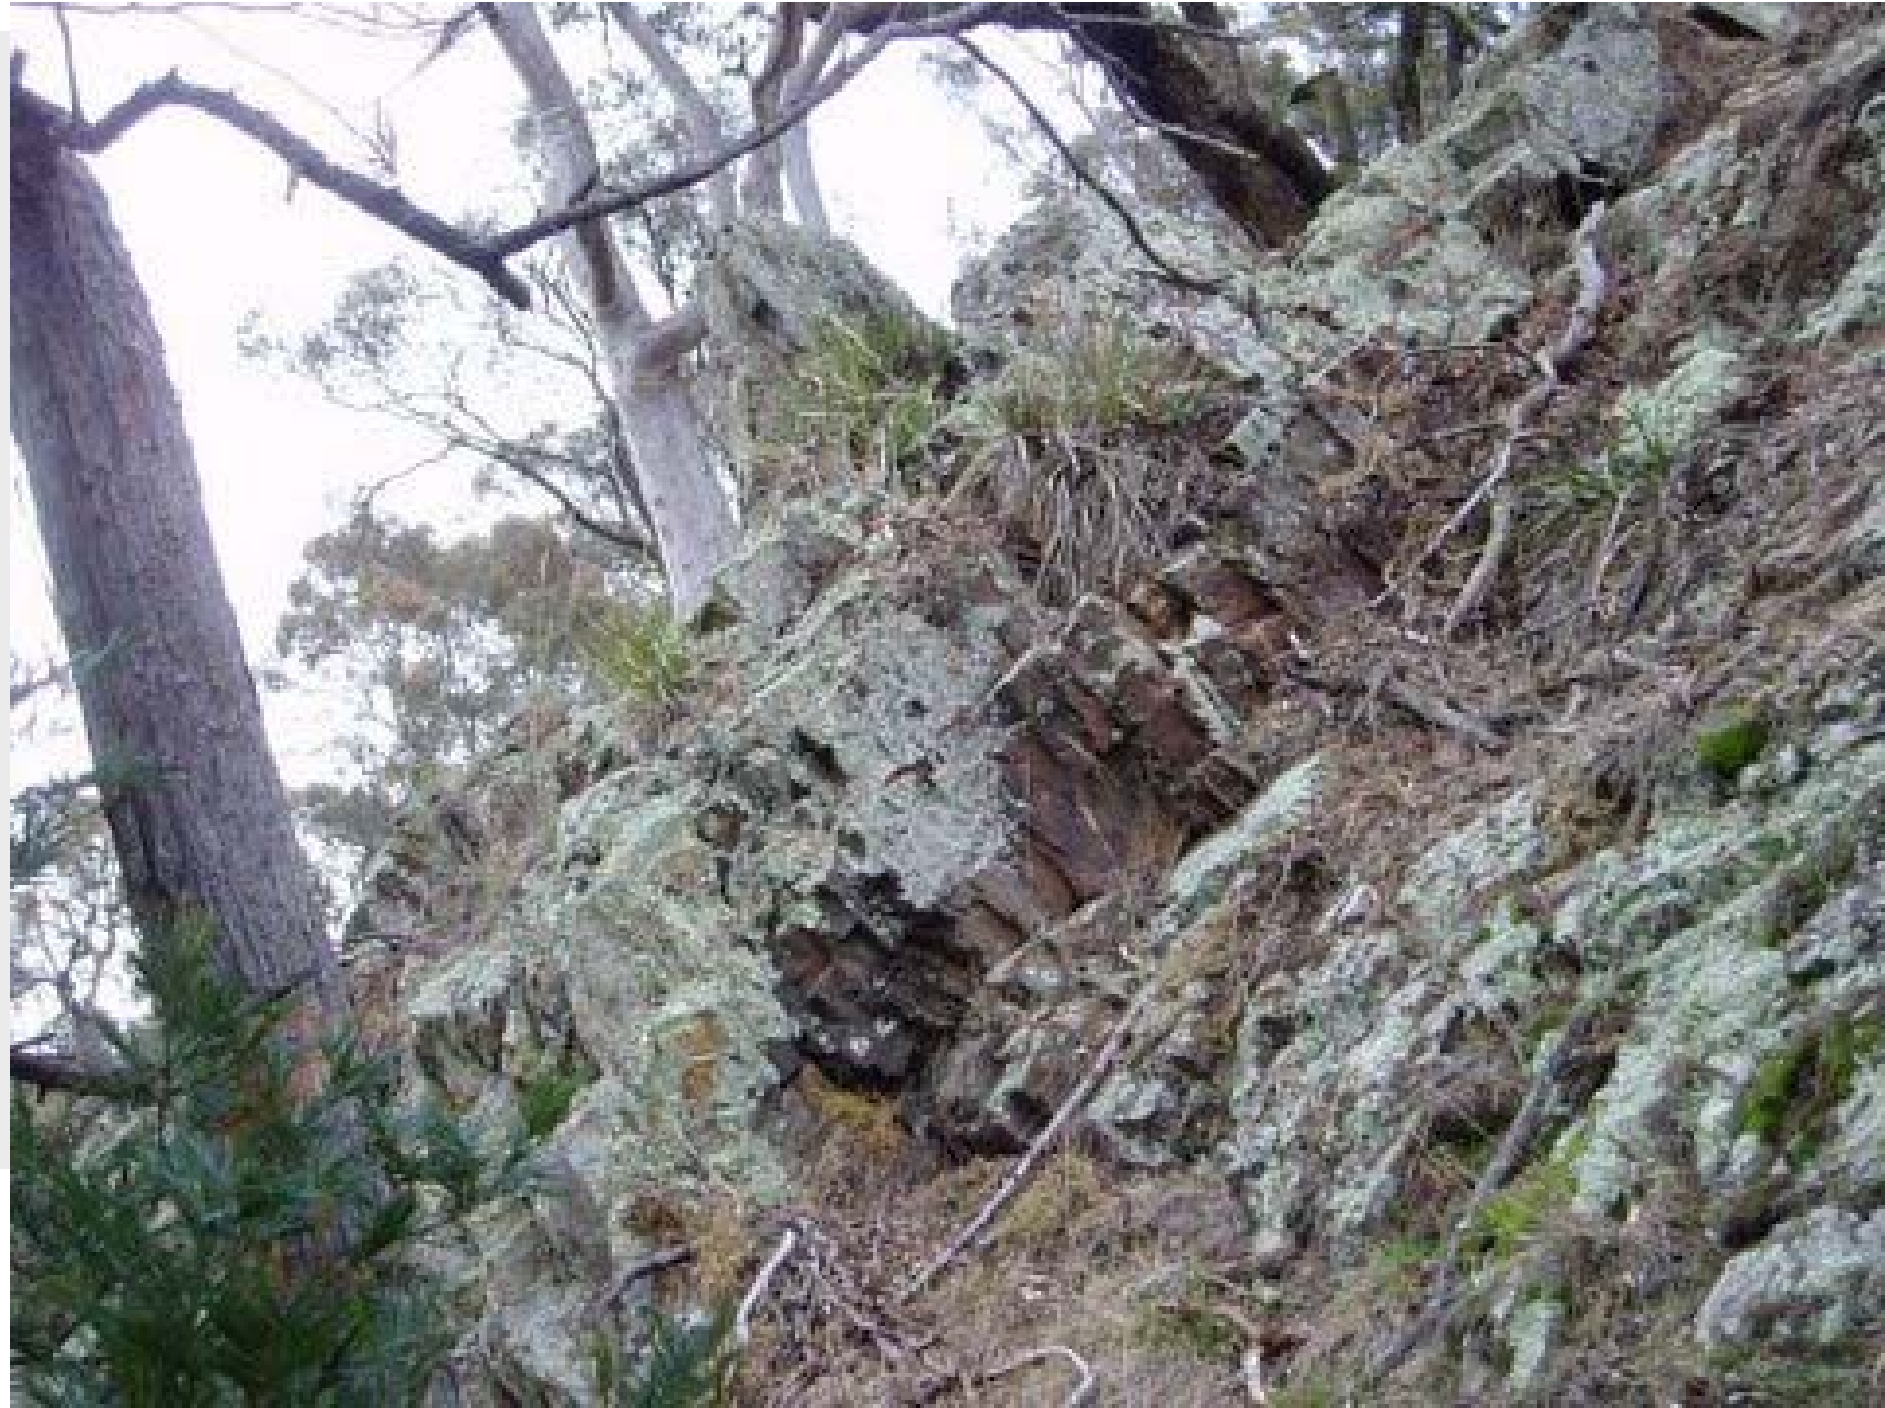
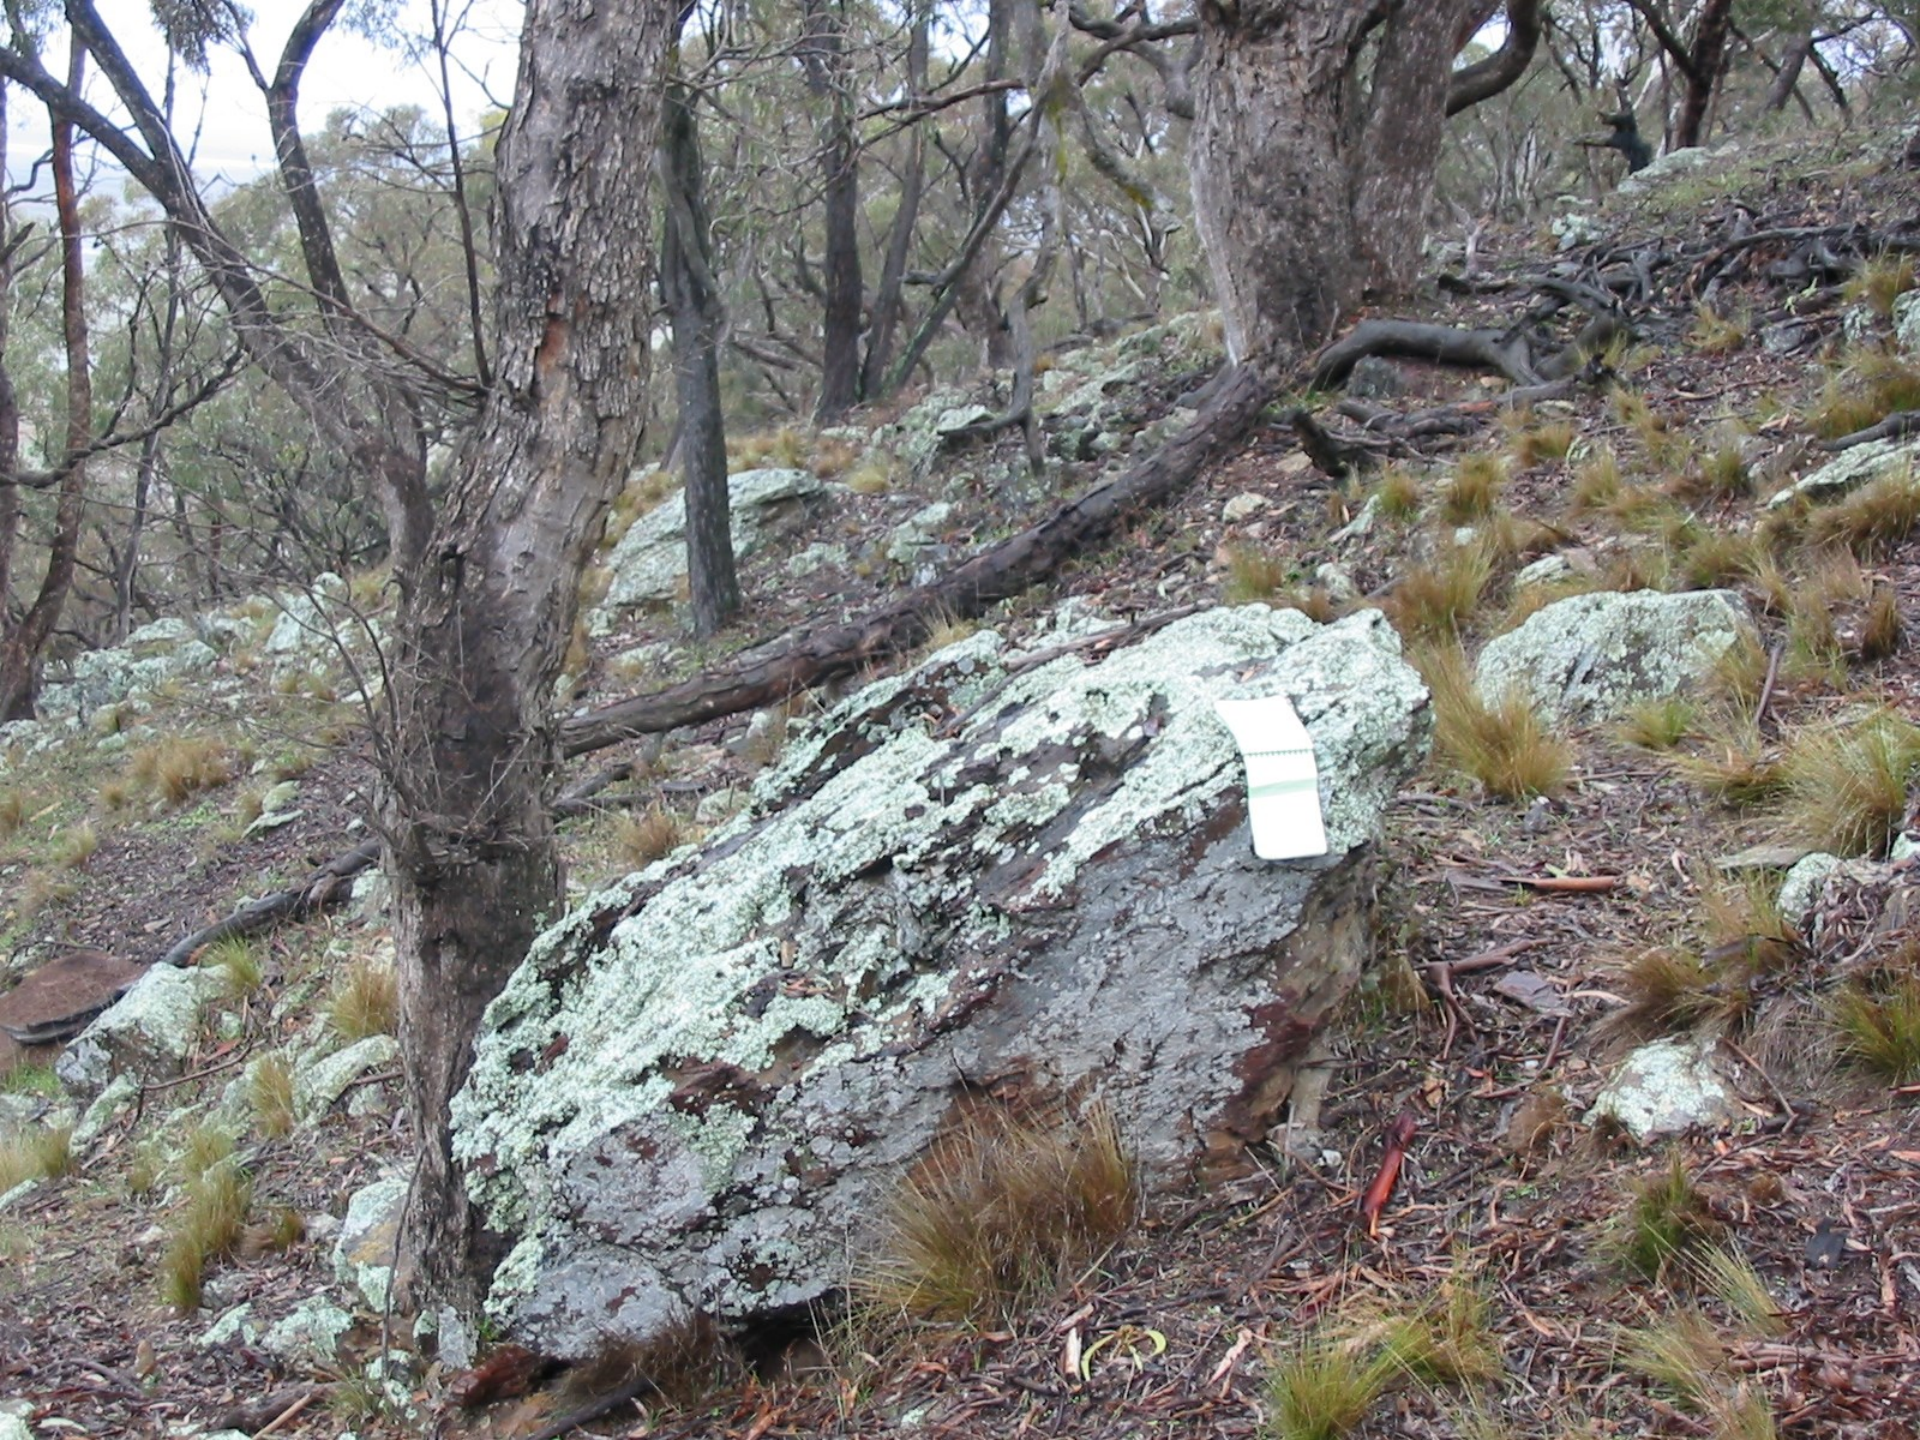
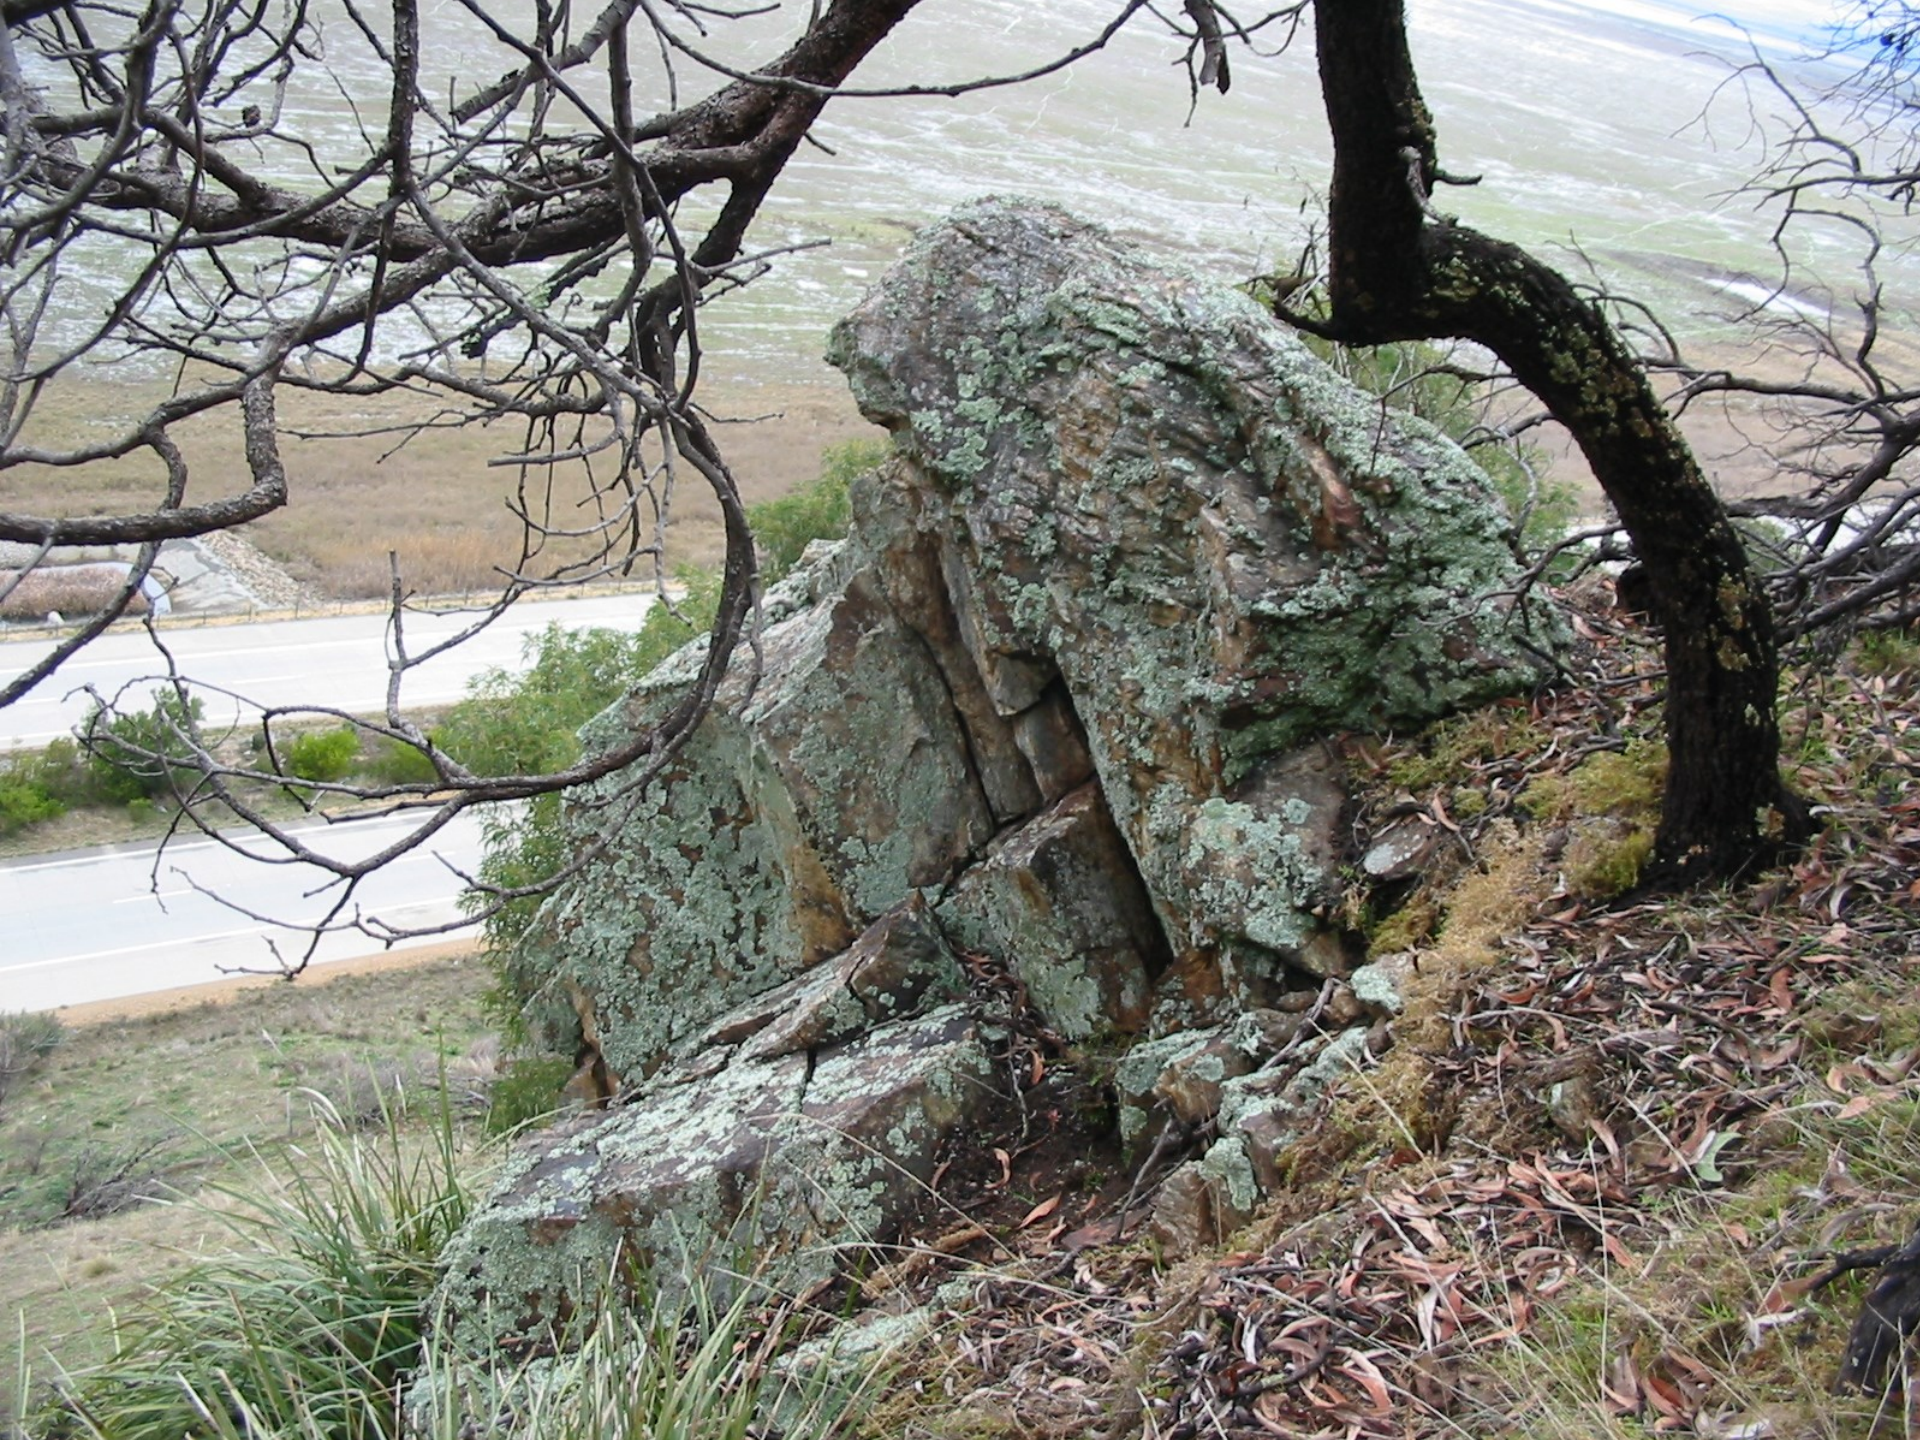
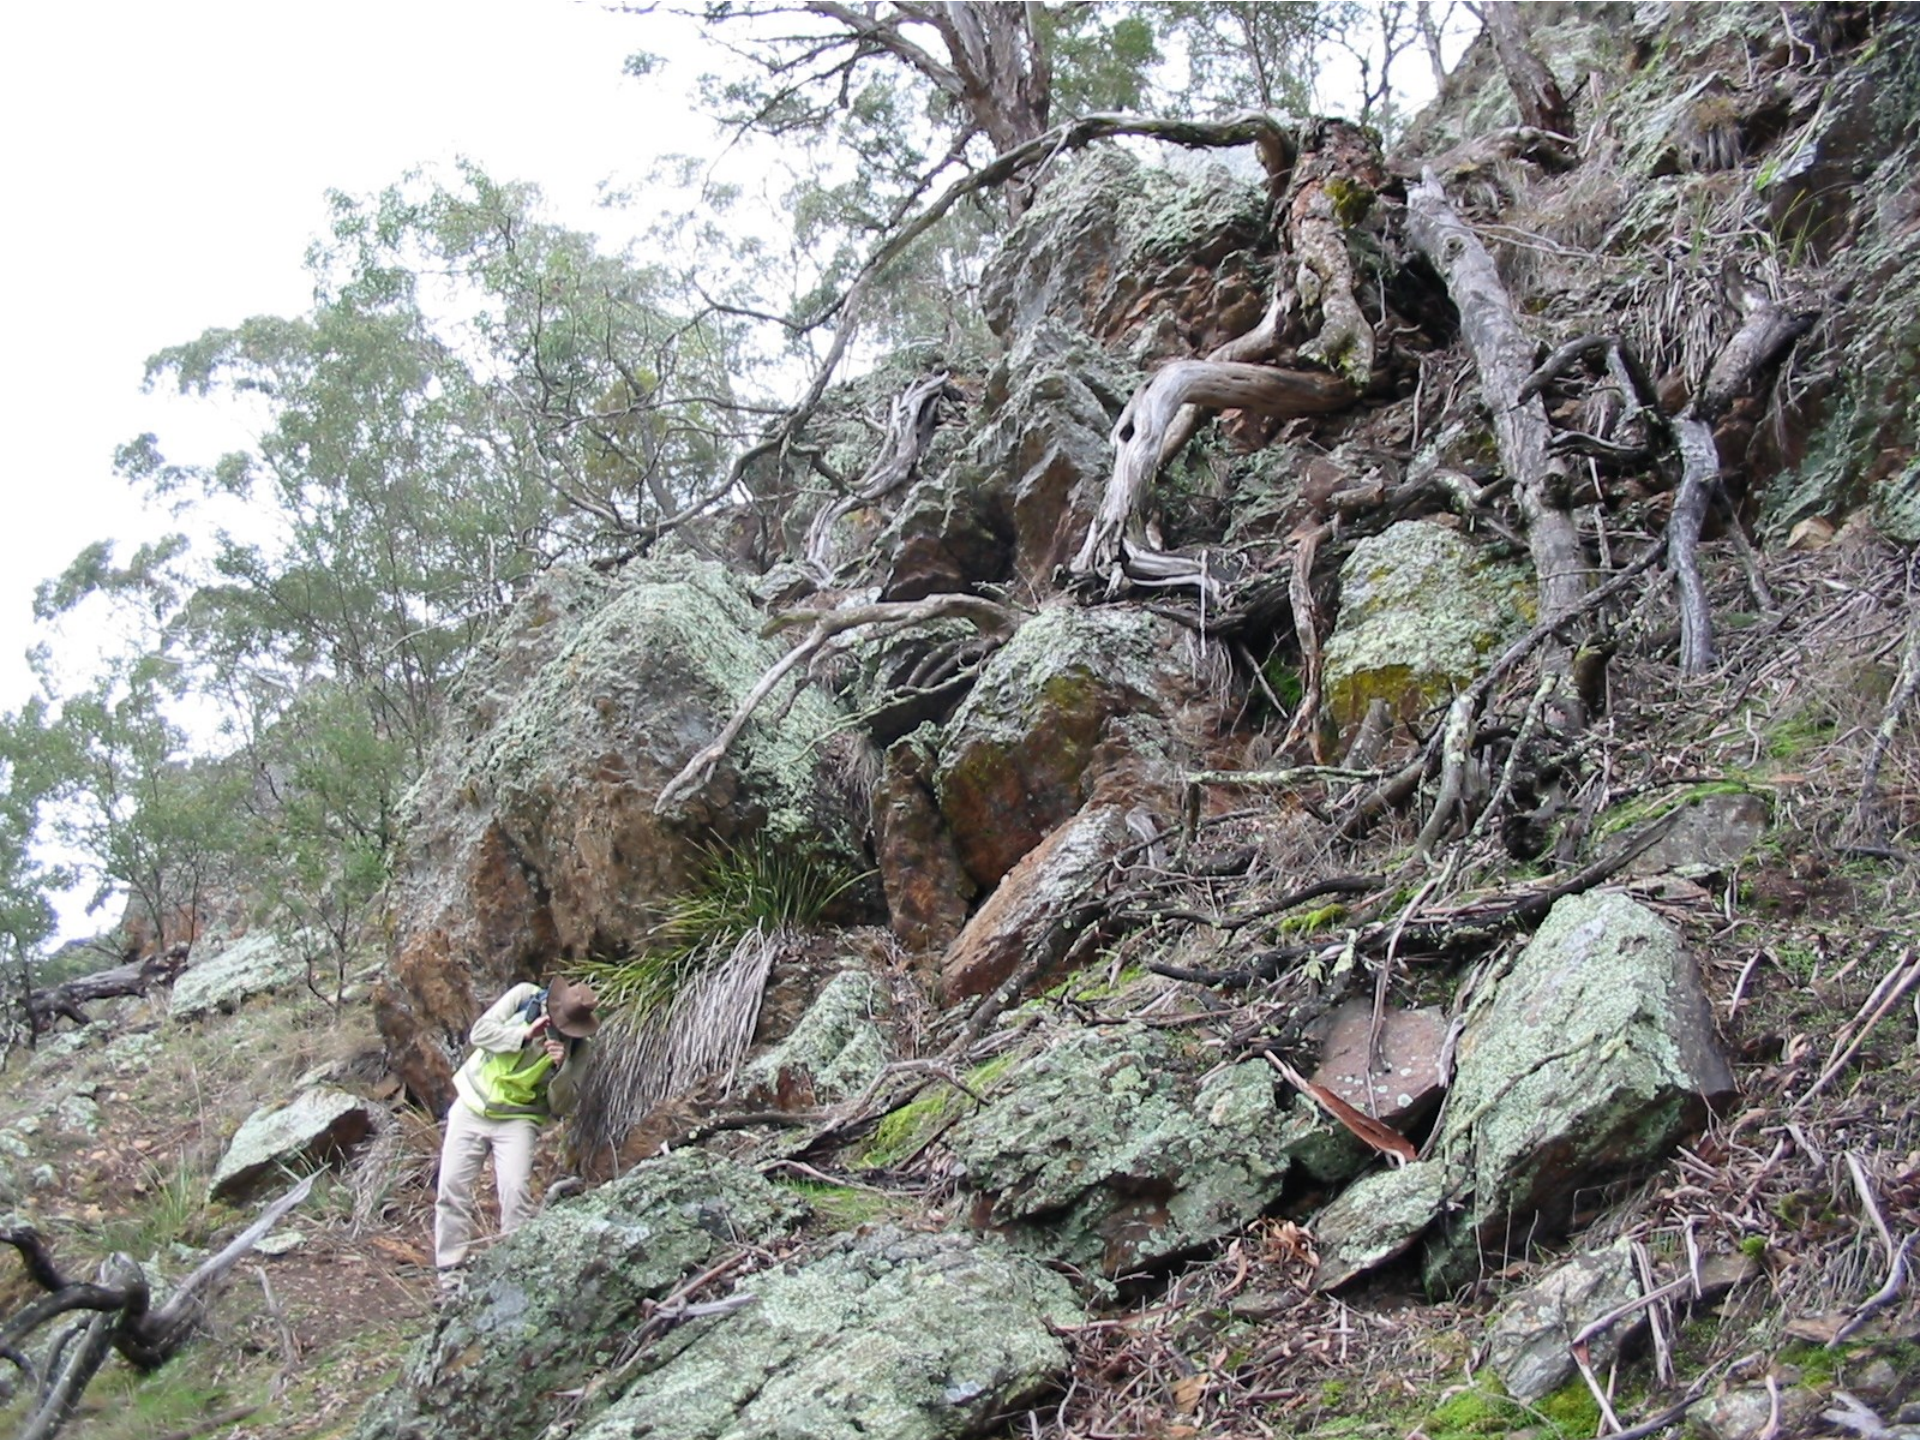
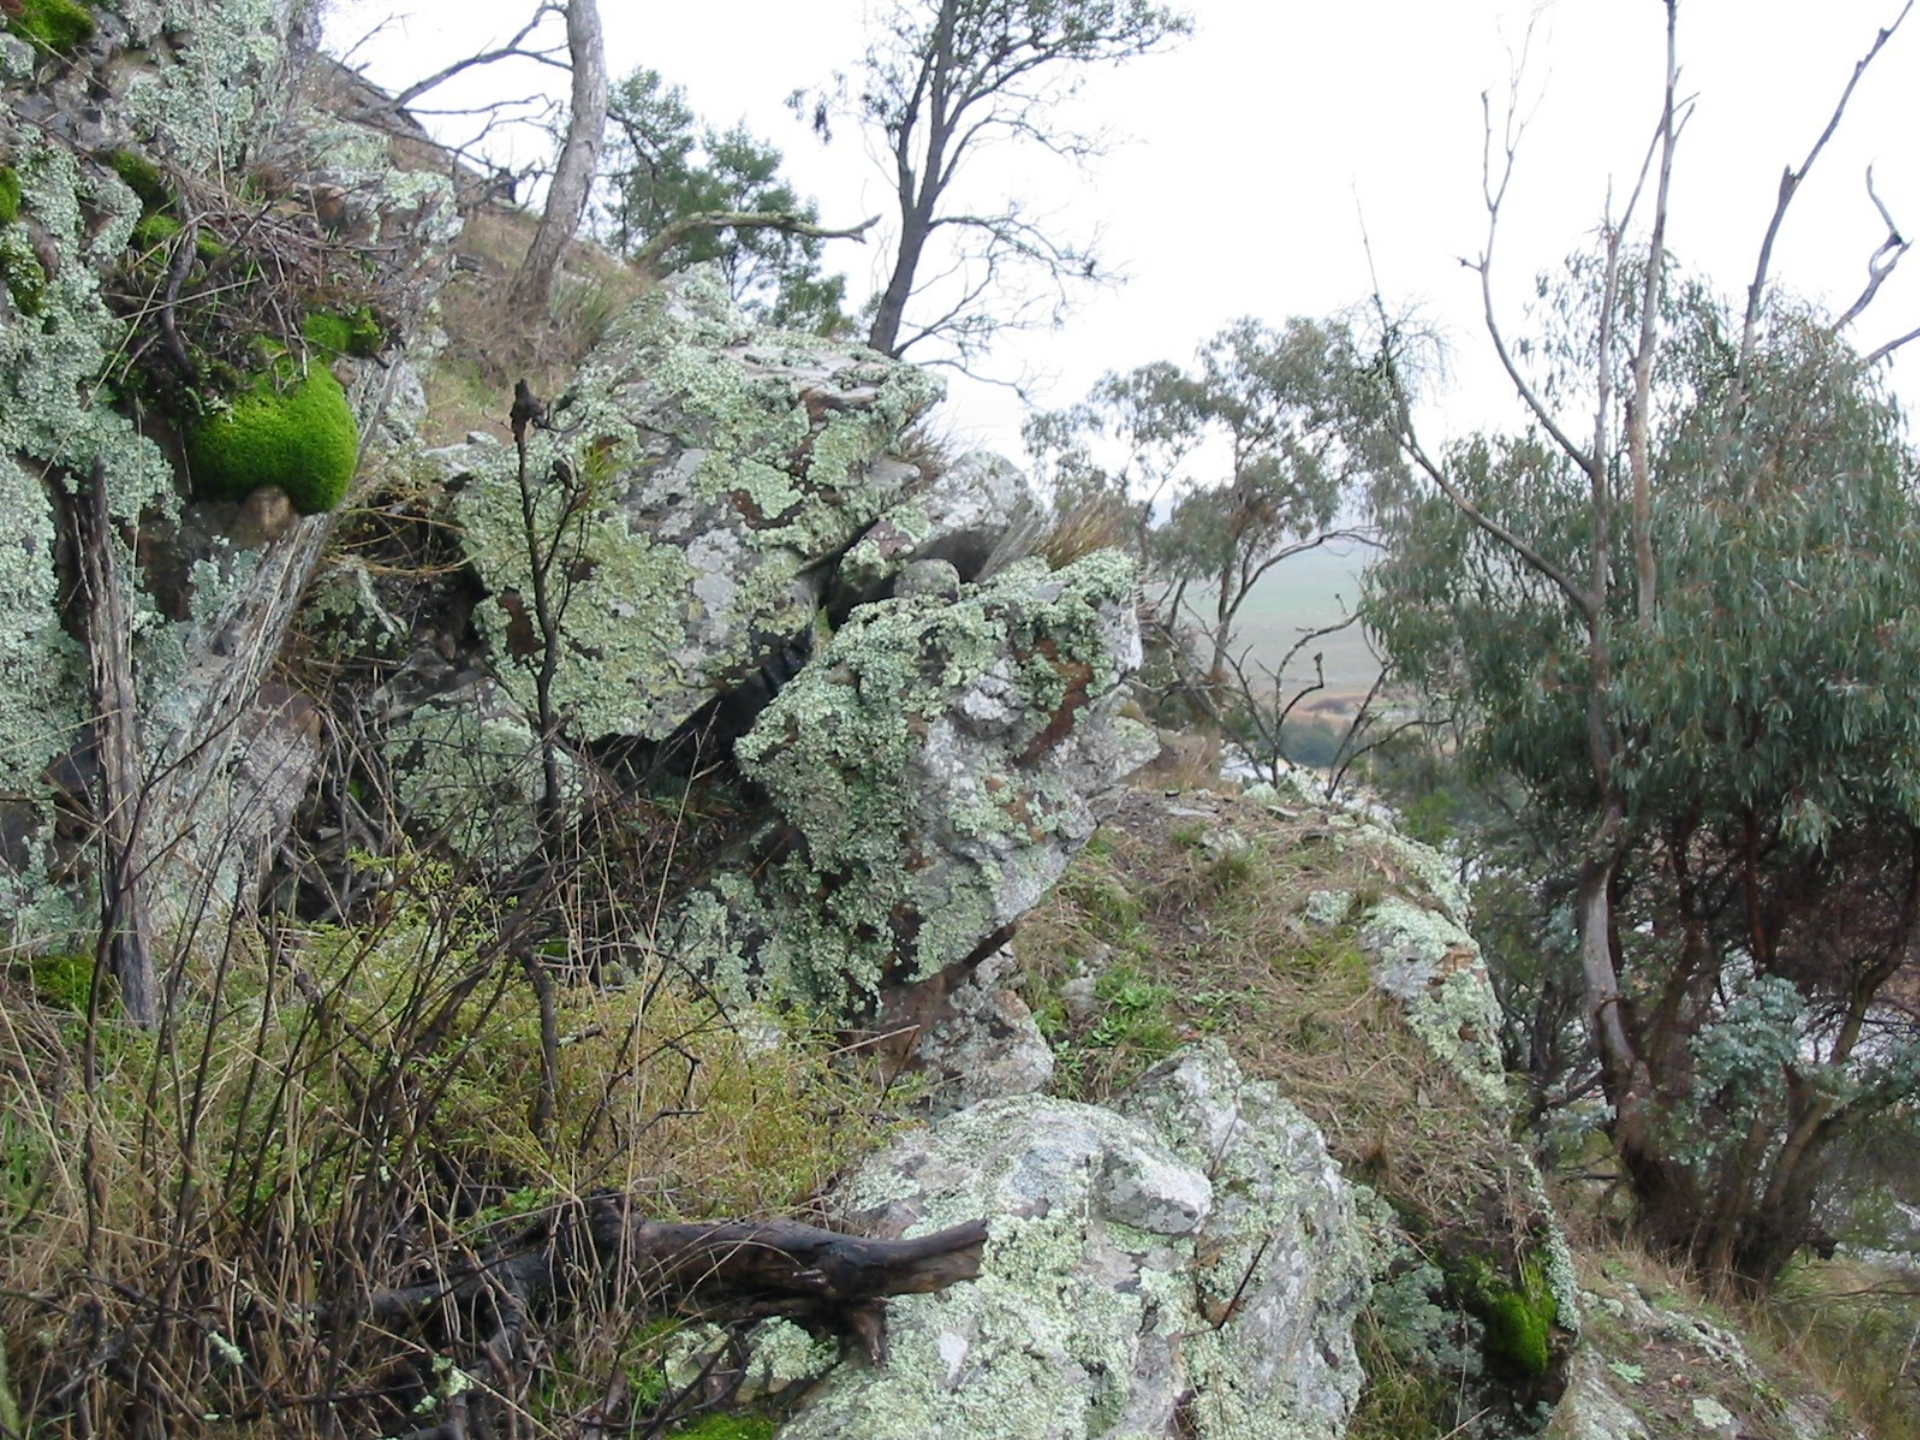
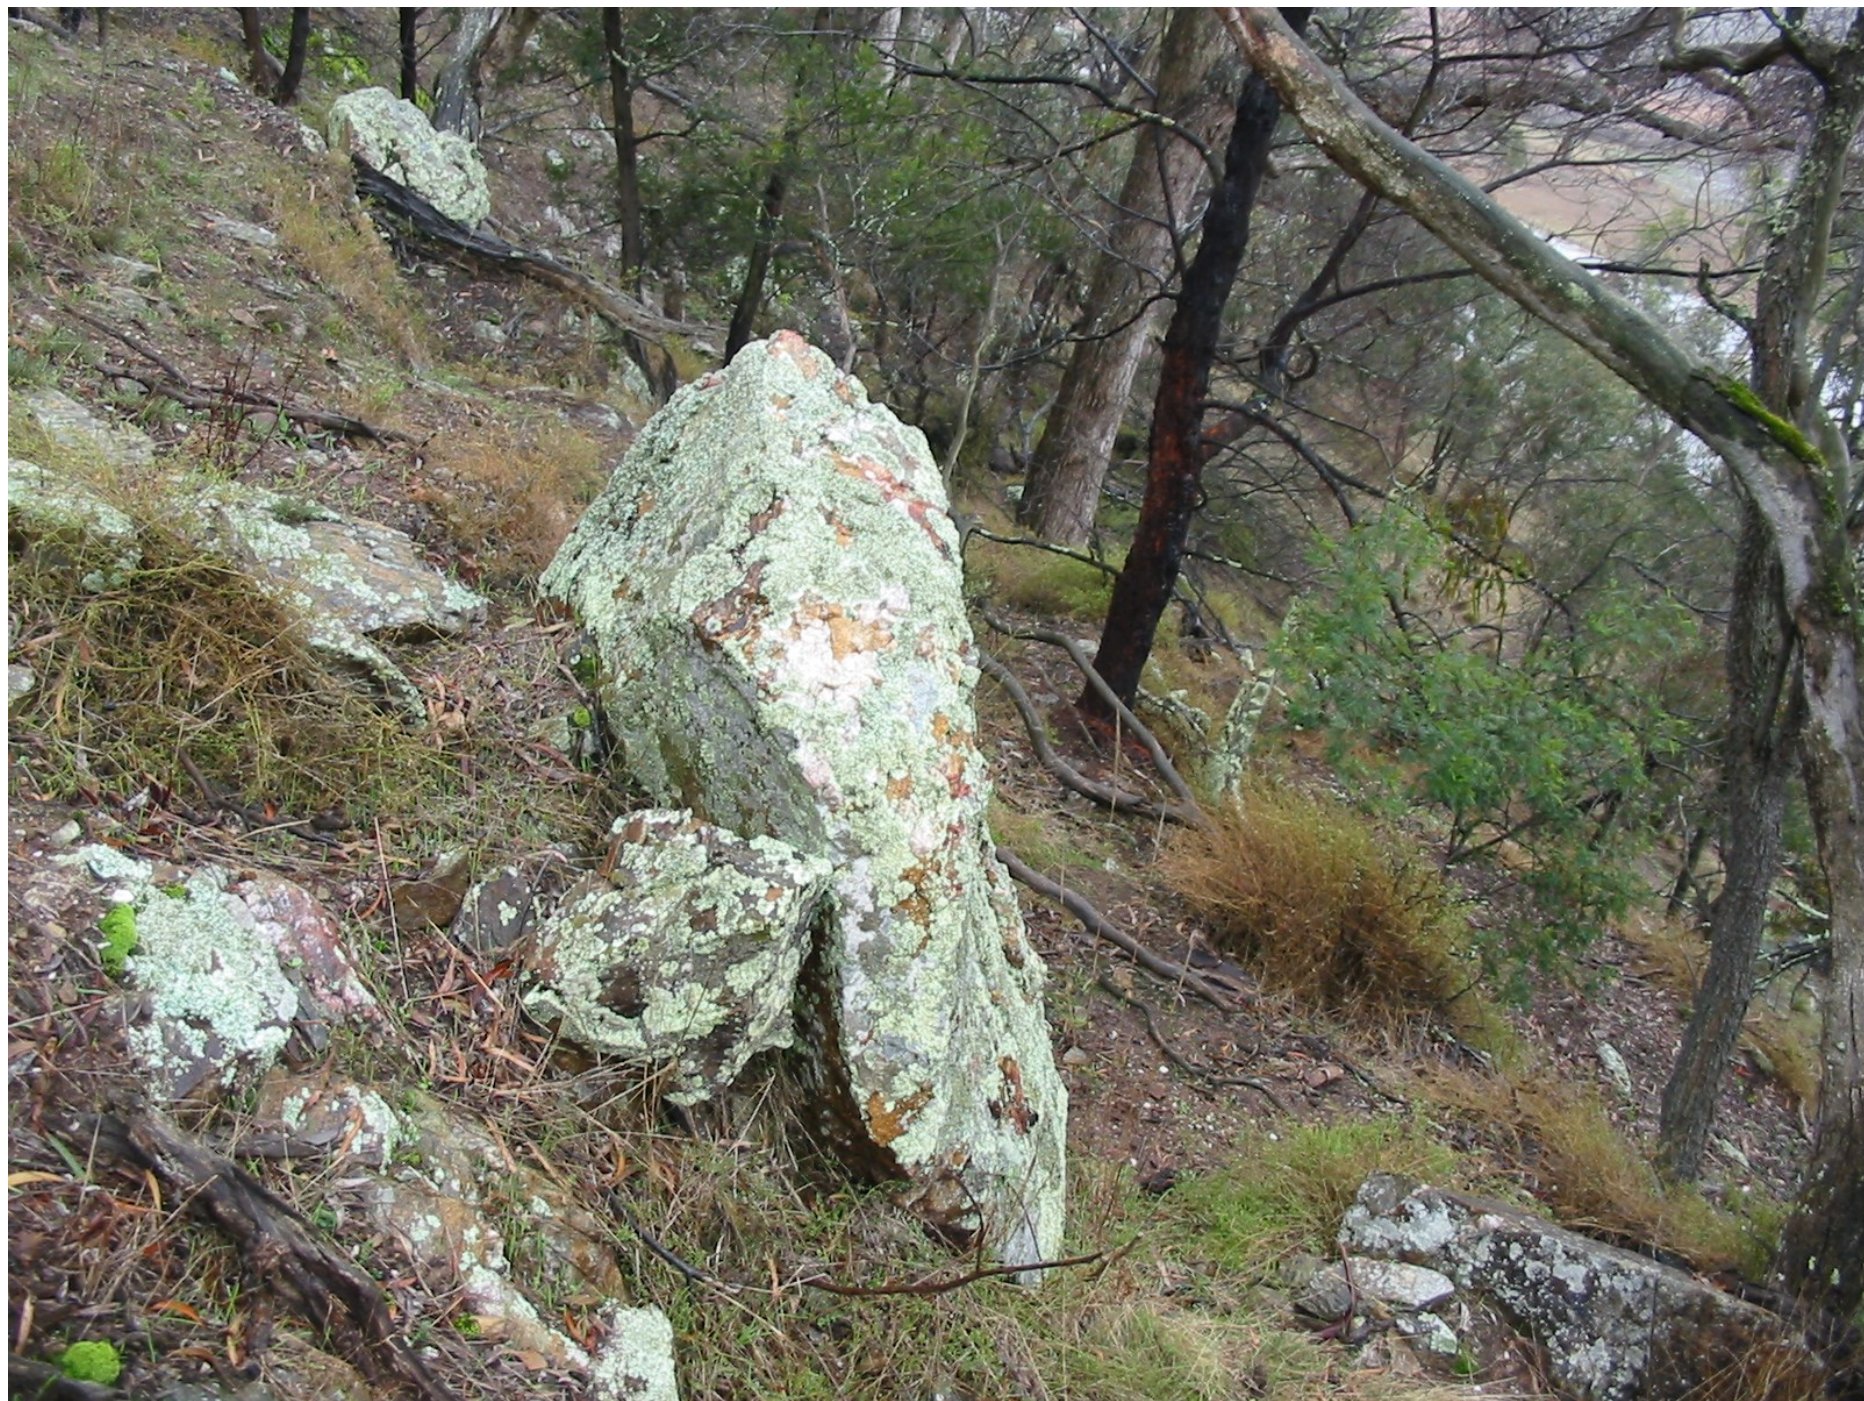
- The site of the rockfall release and surrounding slope condition on 27 June 2005.
- The release area was found to be just above the upper cliff line from where it is estimated at least 2-3m³ of rock was destabilised.
- It is likely that the impact of these rocks dislodged other unstable rocks on the slope surface adding to the over all quantity of the rock fall.

- Generally the slope was found to contain numerous potential rock release areas of varying sizes
- Several of the boulder sites could be easily triggered by heavy rain, erosion, progressive weathering, falling trees, bushfire, animal movement and or an earthquake.
- An inspection of the boundary fence also revealed the presence of rocks from recent falls along its length, indicating that the frequency of rock release is relatively high with falls generally contained on the slope or behind the fence.
