# Performance of Asphalt Concrete-faced Rockfill Embankment at Lam Ta Khong Pumped Storage Project, Thailand

# Features

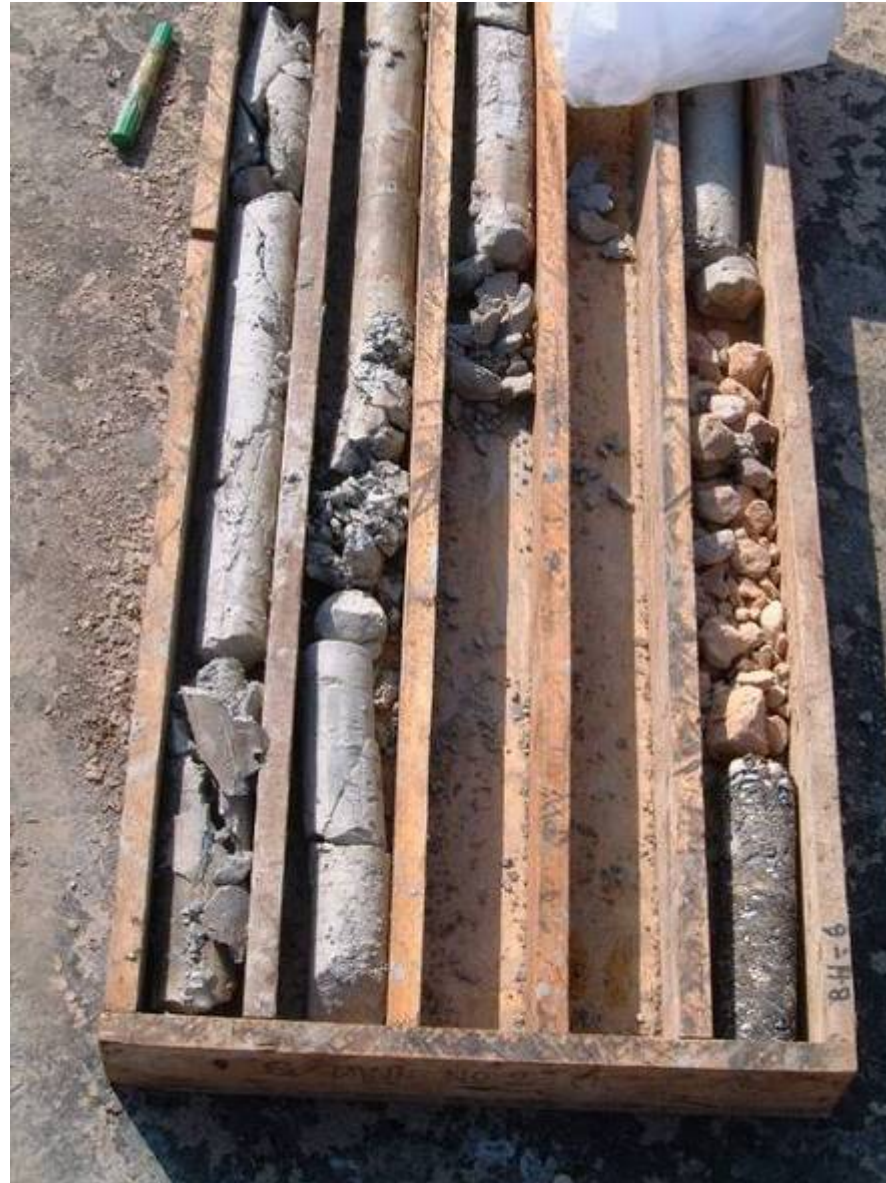
Claystone in the  
Upper Pond area

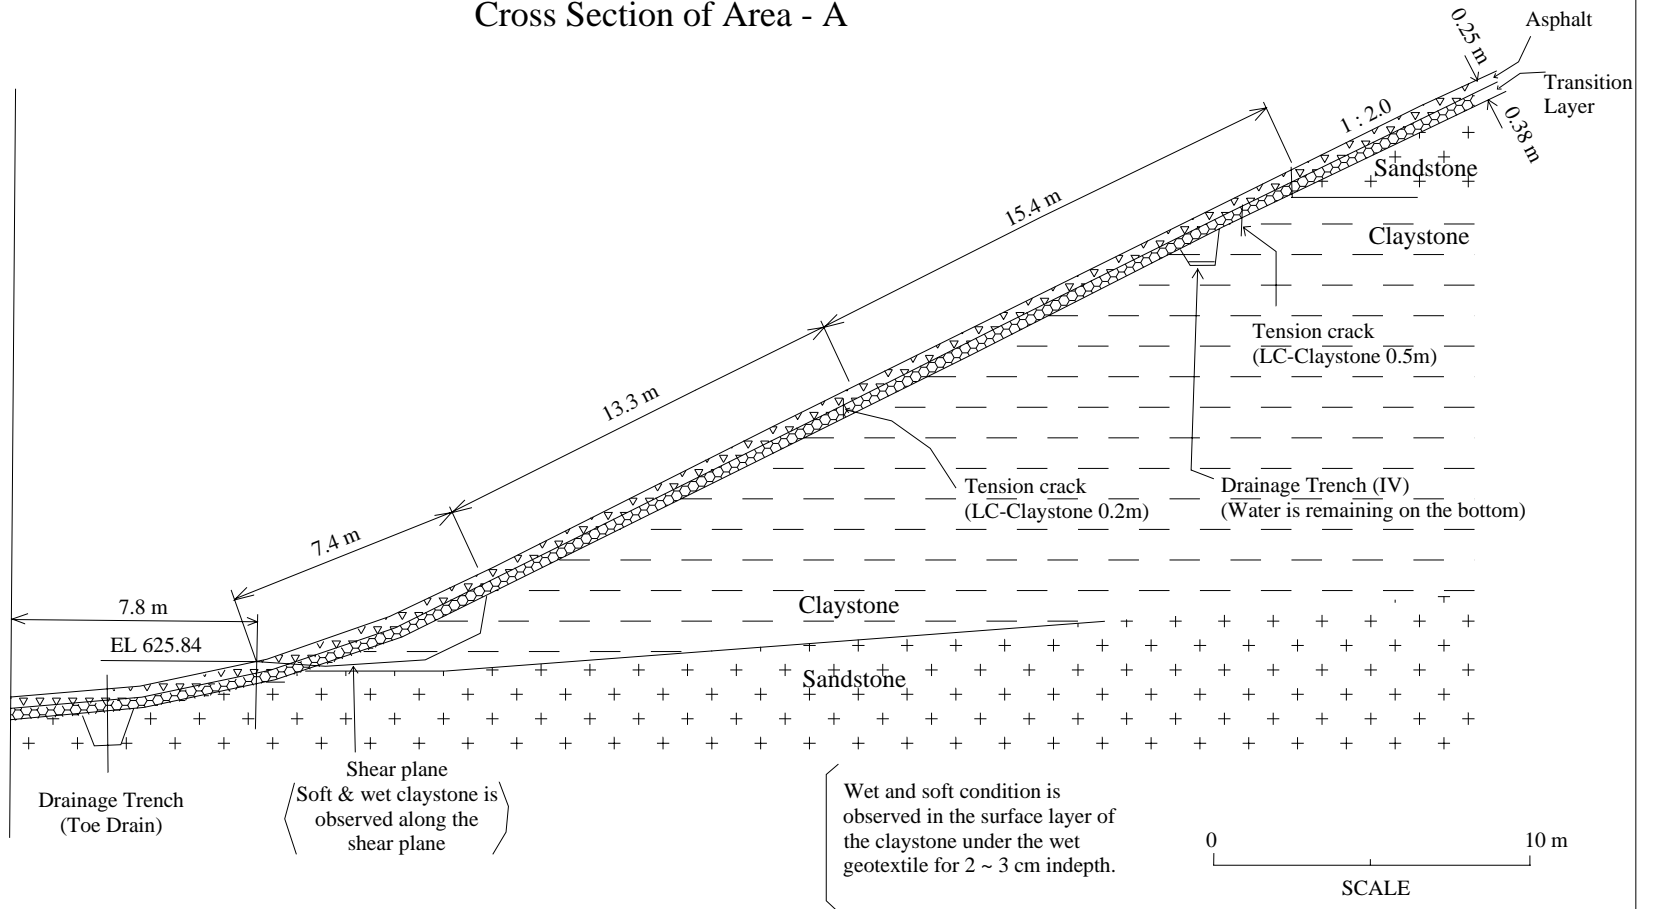
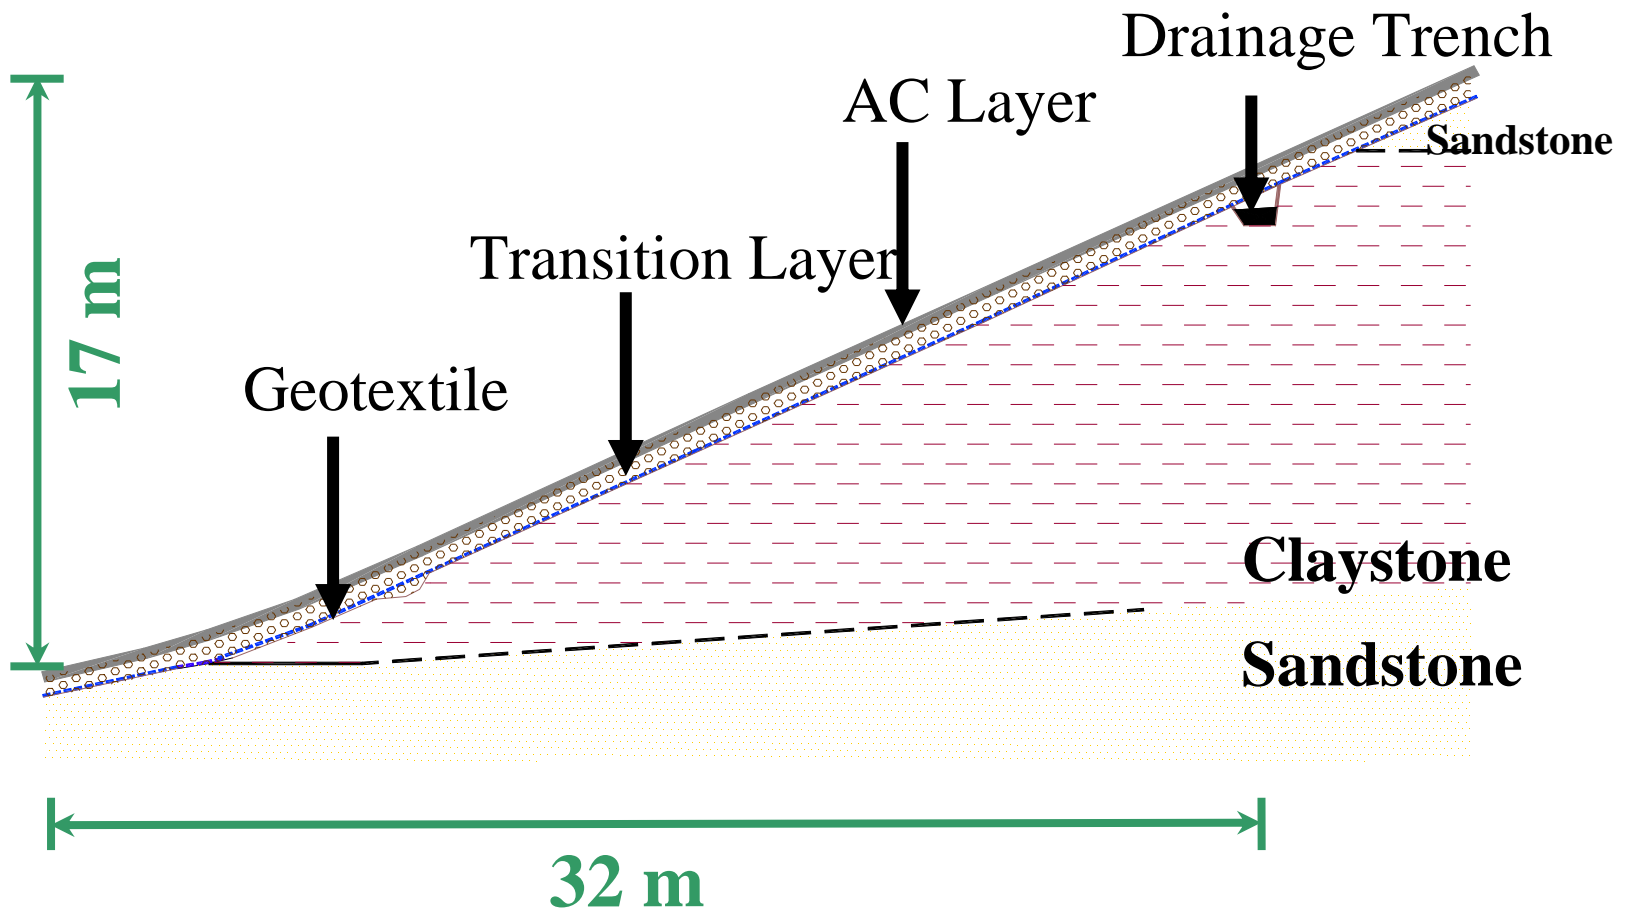
## Cross Section of Area - A

# Slippage Mechanism

- Thickening asphalt lining in toe areas of slopes in the damaged zones to serve as buttress and improved shear resistance.
- Avoided using geotextile sheet as the separator over claystone ( Geotextile sheet created planar sliding surface between claystone and transition layer).

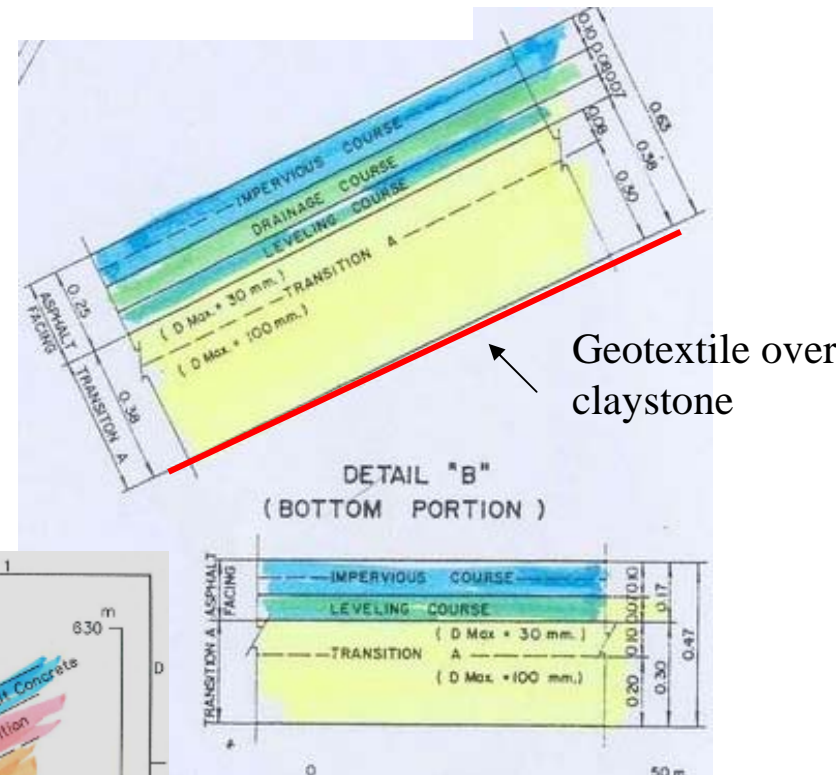
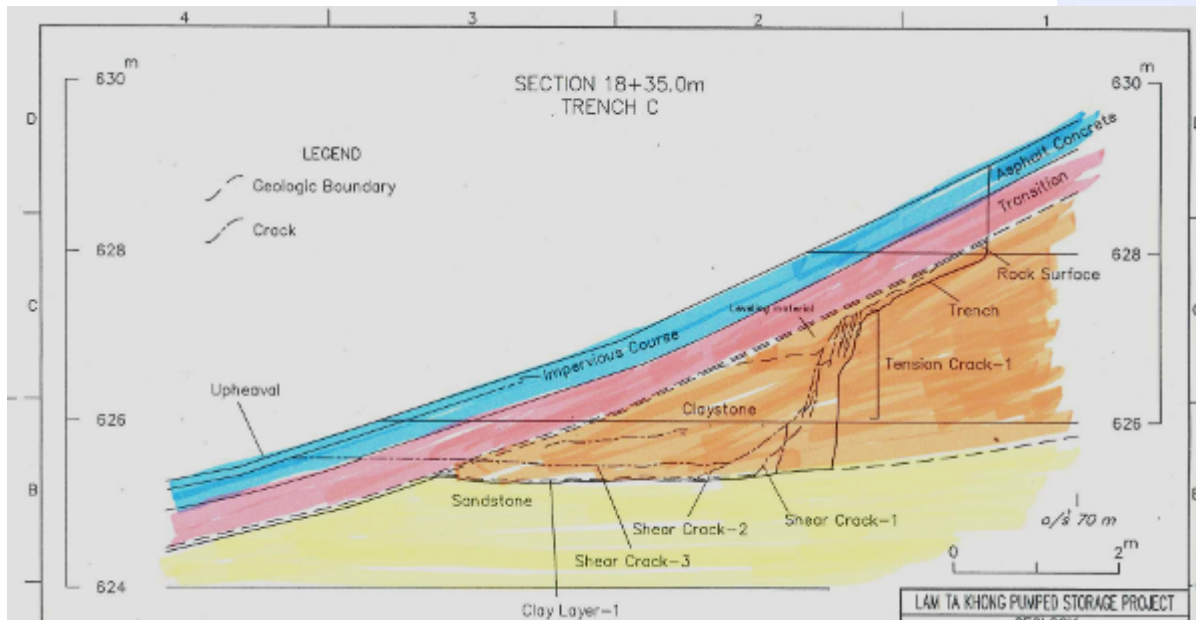
# Asphalt Facing Layers Design

Detail 1

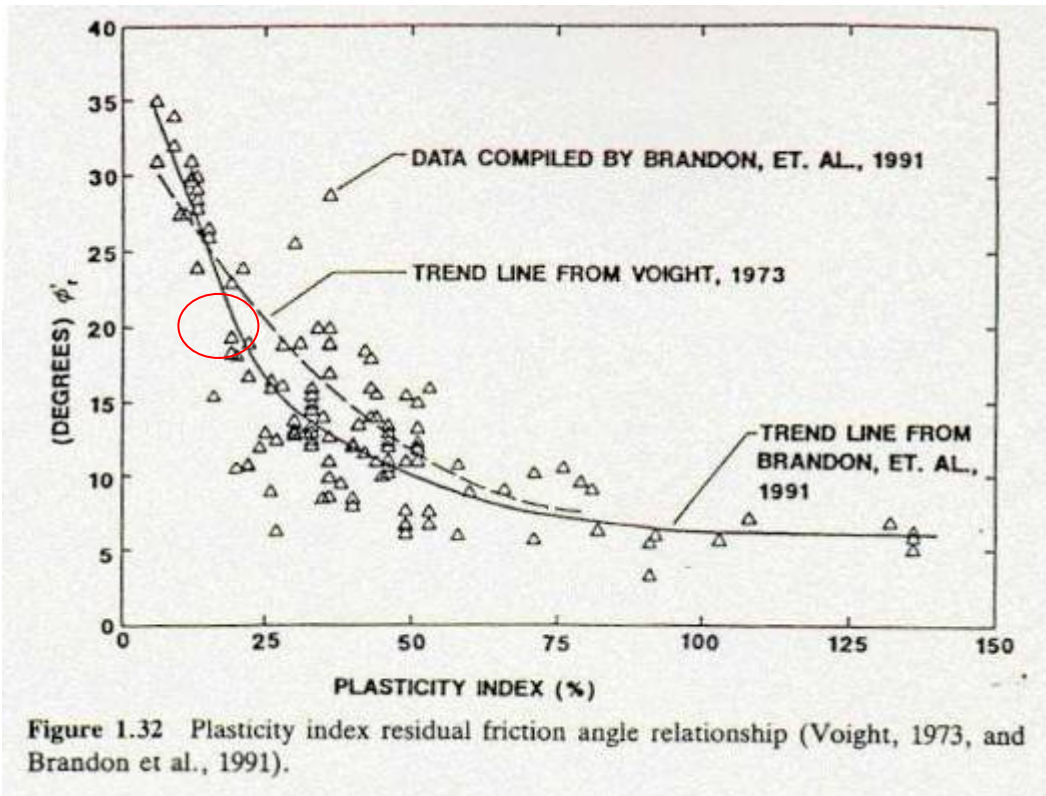
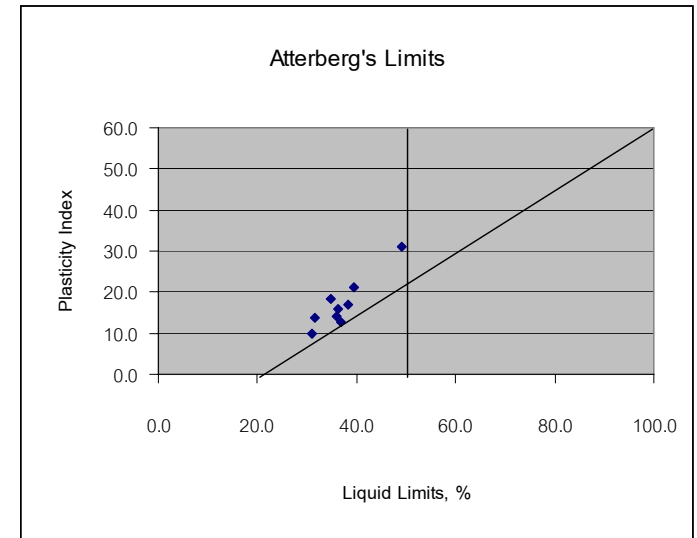
## Lam Ta Khong Claystones

# Shear Strength of Claystones

Core	15.30	0.2443	14.20	0.658	Quick test (2-3 hours)
Pre-cut surface	23.56	-	21.64	-	Quick test (30-45 min.),
Soaked pre-cut surface	26.76	-	25.50	-	Residual Stress taken at 8-10 mm displ.
Pre-cut surface with geotextile	11.09	0.0125	23.14	0.0049	Strain hardening behaviour

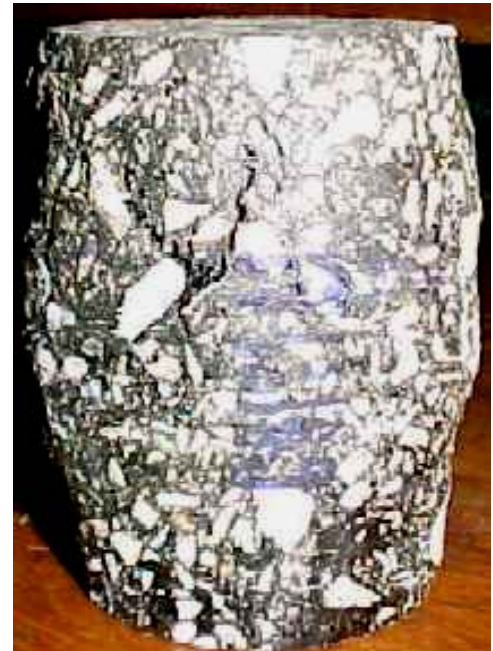
## Uniaxial Compression test (UCS) on asphalt

Sample No.	Axial Stress (MPa)	Remarks
At temperature 50 degree celsius		
South 1	0.50	Quick test (within 2-3 min.)
South 2	0.42	
East 1	0.36	
East 2	0.38	
At room temperature (~26 degree celsius)		
South 3	1.59	Quick test (within 2-3 min.)
South 4	1.41	
East 3	1.11	
East 4	1.15

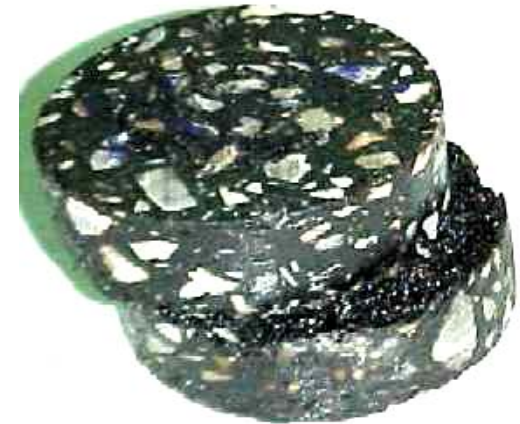
## Direct Shear Test of Asphaltic Concrete Lining

Sample No.	Normal Load (MPa)	Shear Stress (MPa)	Loading Rate (mm/sec)	Remarks
At temperature 40 degree celsius				
South 5	0.018	<b>0.175</b>	0.009	Slow test (3 - 4 hours to shear 10 mm) Test was performed using the Wykeham Ferrance shearbox as used for soil test.
South 6	0.018	<b>0.100</b>	0.001	
South 7	0.018	<b>0.115</b>	0.001	
South 8	0.018	<b>0.120</b>	0.001	
At room temperature (~26 degree celsius)				
South 9	0.018	<b>0.107</b>	0.001	
South 10	0.018	<b>0.119</b>	0.001	
At temperature 40 degree celsius				
South 11	0.018	<b>0.130</b>	0.030	Very quick test, (~5 min to shear 10 mm displ.) Initial temp.was 59 <sup>0</sup> C before test and final temp was ~40 <sup>0</sup> C after test.
South 12	0.018	<b>0.197</b>	0.030	
South 13	0.018	<b>0.127</b>	0.030	
South 14	0.018	<b>0.144</b>	0.030

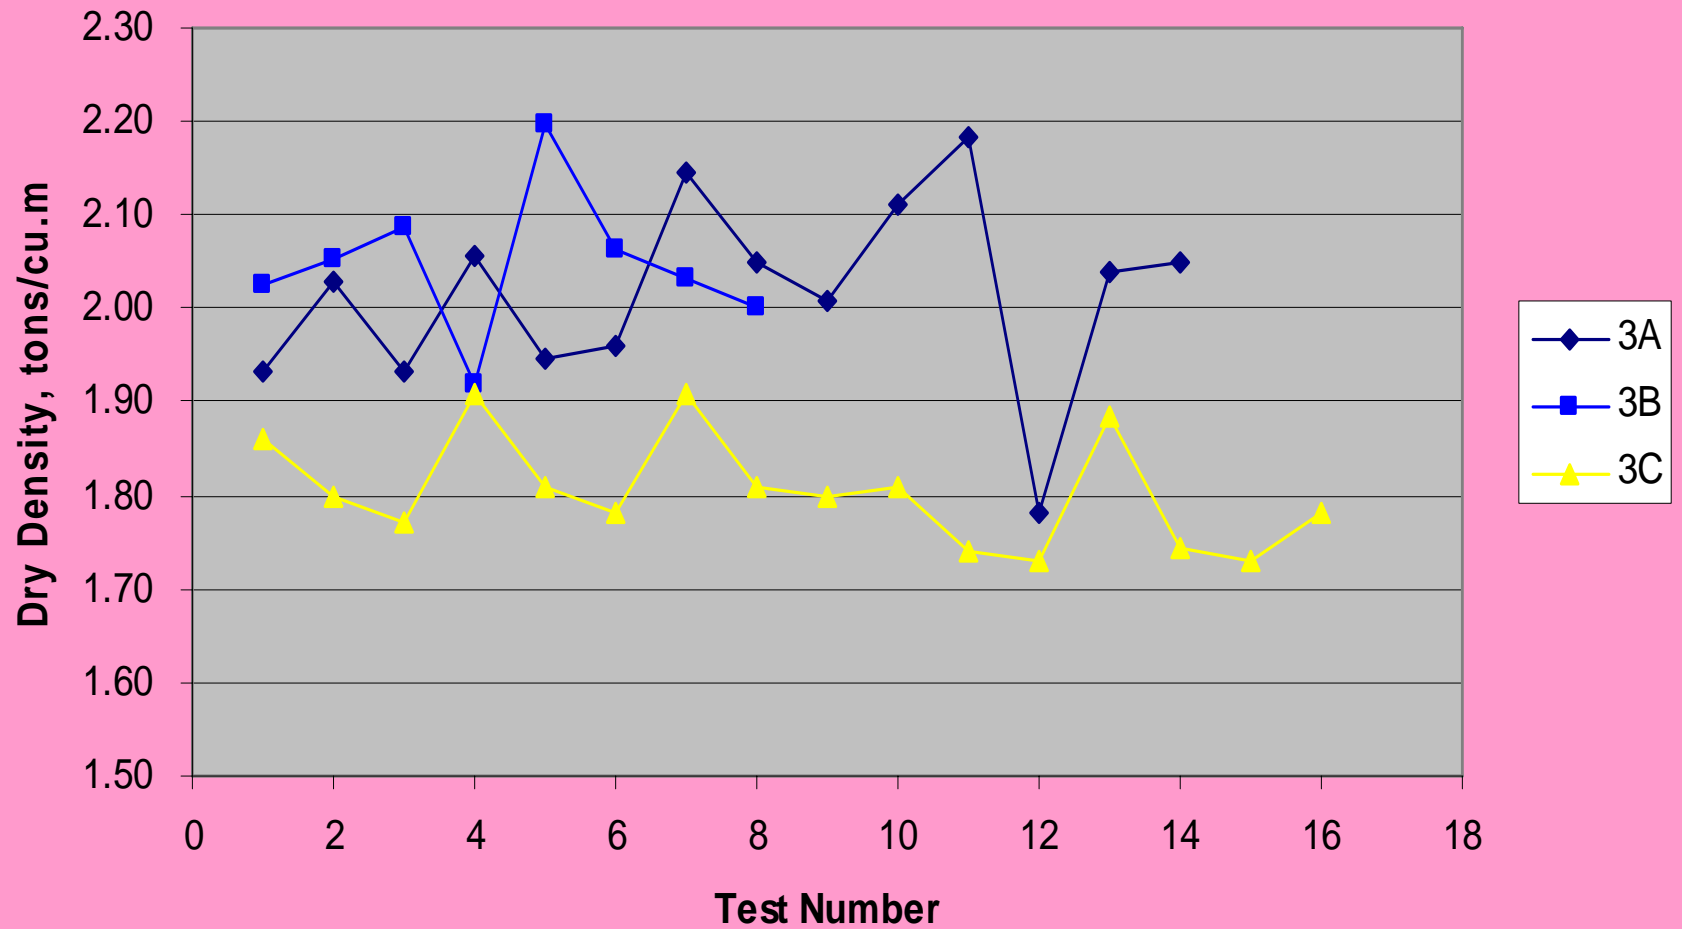
## Field Dry Density of Lam Ta Khong Rockfill

Cause of the problem: Possibly time-dependent troubled properties of Zone 3C Materials
