Learning from Slope Failures in Hong Kong

H. N. Wong & K. K. S. Ho

Geotechnical Engineering Office, Civil Engineering Department, Hong Kong

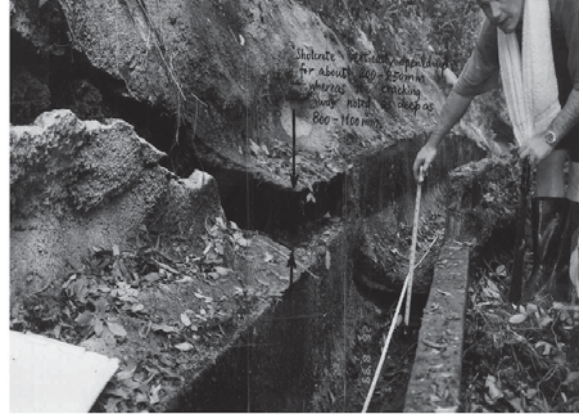
Based on a review of the 1997 and 1998 landslide data, at least 17 cases were confirmed to have involved significant progressive slope deformation, five of which had major detachments from part of the unstable mass. Seven of these 17 cases were previously engineered to current standards. This amounts to 17% of the total number of failures involving engineered slopes.

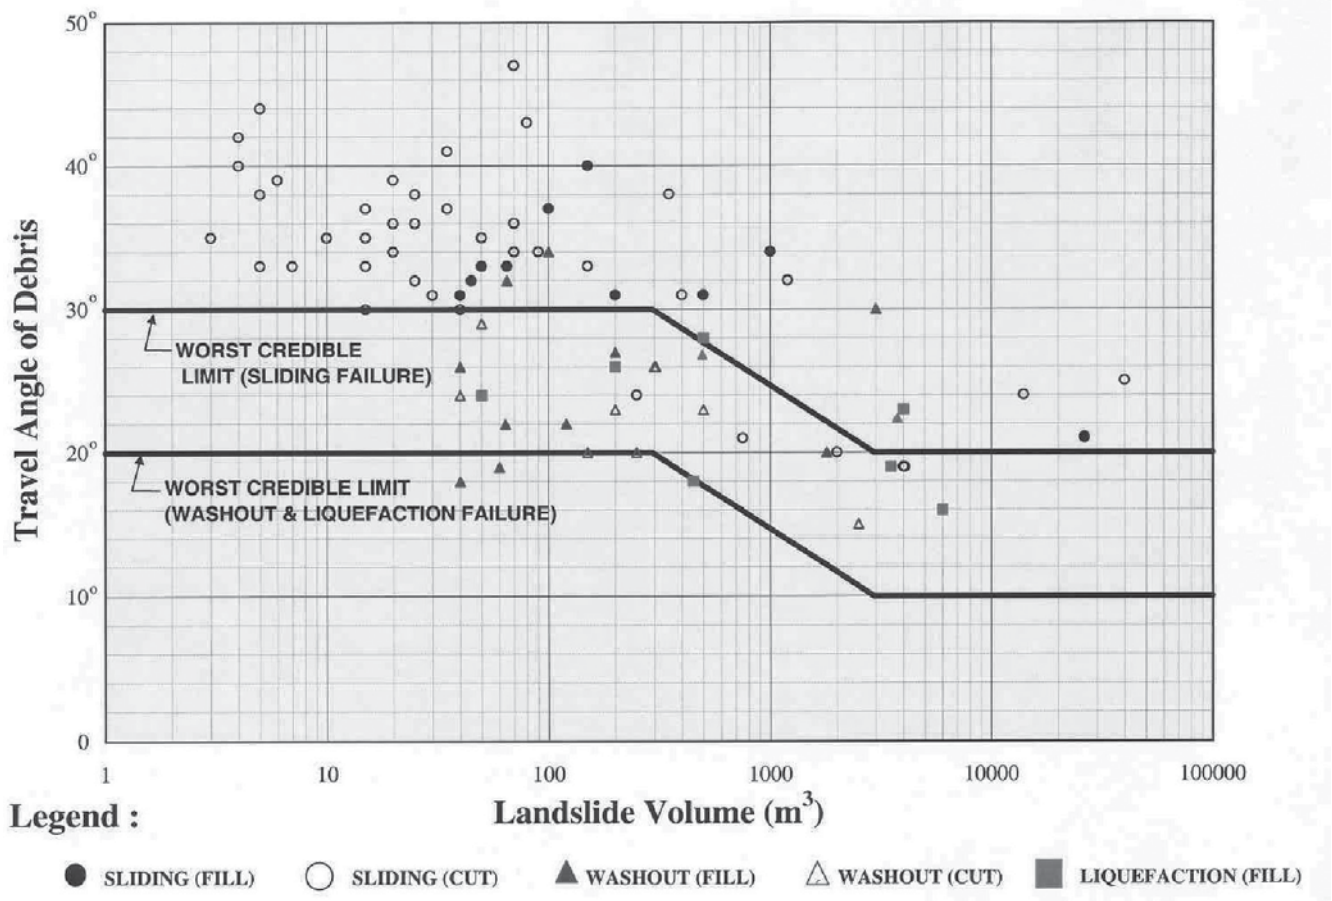
Figure 17. Data on debris mobility for different mechanisms and scale of landslides in Hong Kong

In terms of travel angle (Cruden & Varnes, 1996), the data in Hong Kong indicate that for typical rain-induced landslides involving small to medium scale failures (viz. landslide volume of $<2,000 \text{ m}^3$) generally ranges from 30° to 40° , which is similar to the angle of shearing resistance of saprolite (Figure 17). The field data indicate that the travel angle tends to reduce with

increase in landslide volume (i.e. the runout tends to increase), which is consistent with the trends reported elsewhere (e.g. Hutchinson, 1988).

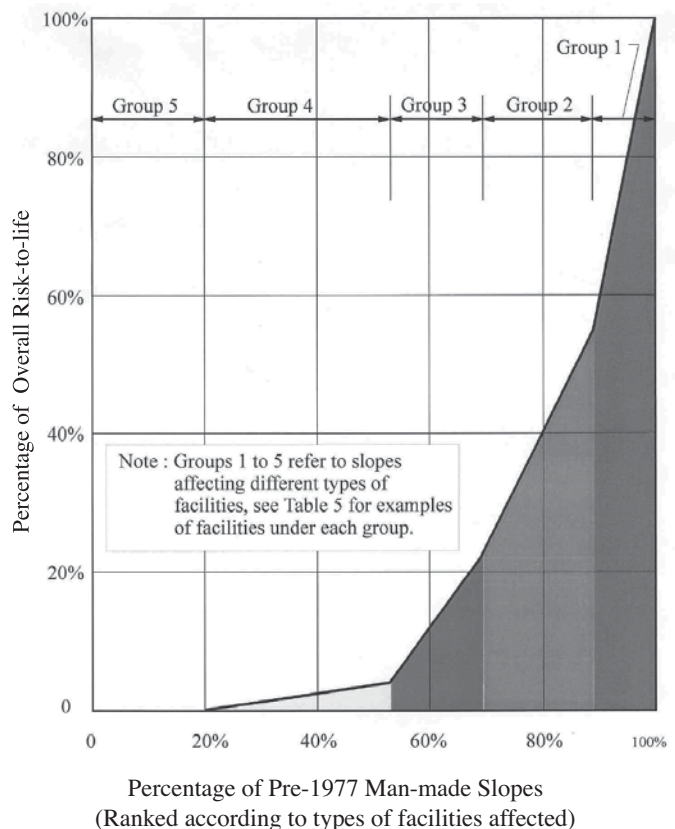
Figure 19. Risk profile of pre-1977 slopes

The risk profile shown in Figure 19 shows that about half of the overall risk is derived from approximately 10% of the slope population that has a higher potential risk (Wong & Ho, 1998). This means that the upgrading of a relatively small proportion of the old slopes posing the highest potential risk would result in a major risk reduction. It also emphasizes the importance of an appropriate risk-based ranking system for prioritizing landslide preventive actions.

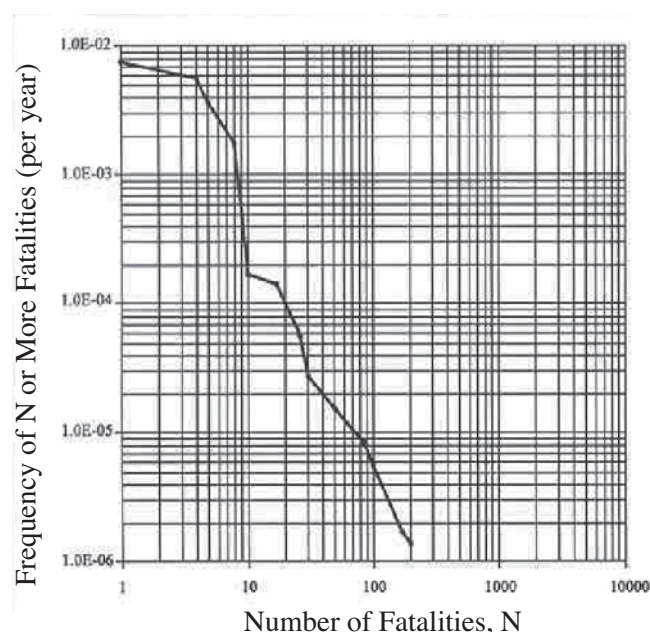
Figure 21. f-N curve for the 1995 Fei Tsui Road landslide

The second example concerns a site-specific QRA. The generalized consequence model was used to back-analyse the Fei Tsui Road landslide, which occurred in the early hours of 13 August 1995 with a failure volume of some 14,000 m³. The road in front of the slope was totally engulfed by landslide debris of up to about 6 m thick (Figure 20). The incident resulted in one fatality and one other person narrowly escaped injury. The theoretical consequence model predicts an average number of four fatalities arising from the given landslide. This illustrates the near-miss nature of the incident with only one fatality. The f-N curve derived from QRA calculations (Figure 21) shows the level of societal risk posed to the community by the Fei Tsui Road landslide.
