Successful mitigations of riverbank slope stabilizations and road failures caused by excessive rainfalls due to climate change at national road 1B (NR 1B) in Laos PDR

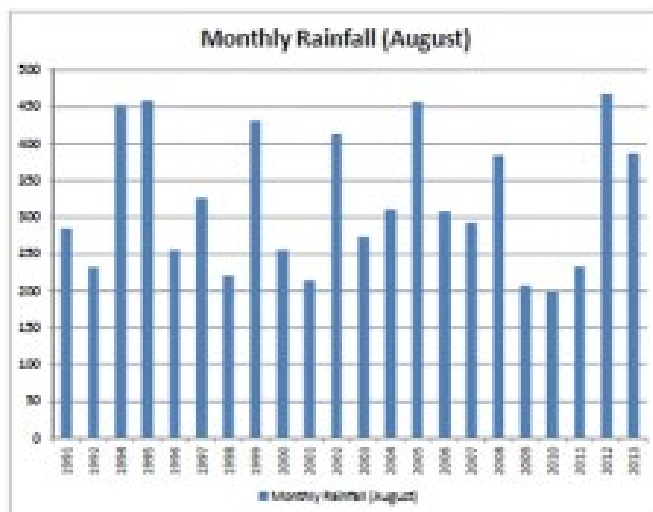
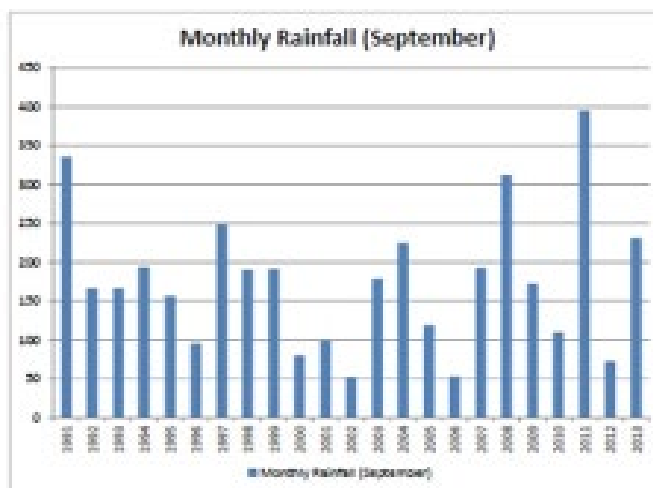
The records of heavy rainfall data during August and September (1991-2013) are shown in Fig. 4a,b.

(a) August (1991-2013)

(b) September (1991-2013)

Fig. 4. heavy rainfall data during August and September (1991-2013).
