## Analyses to elucidate the mechanism of the grabens that formed in Aso during the 2016 Kumamoto Earthquake in Japan

### ABSTRACT

The 2016 Kumamoto earthquake caused many grabens, approximately 50 m wide, in the caldera of the Aso Volcano in Japan. The authors conducted detailed site investigations to determine the mechanism of the grabens. The measurement of the displacement by SAR from satellites showed horizontal displacements of about 2 to 3 m occurred. Deep borings, microtremor array observation and reflection survey showed that soft clay is deposited from GL-17 m to GL-51 m and the bottom of this soft clayey layer is inclined. The analysis by ALID showed that the soft clay flowed due to the earthquake, causing the horizontal displacement of the surface soil layer and the graben at the ground surface.

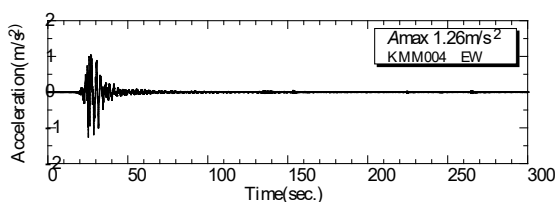
Figure 8. Input seismic wave.

Figure 8 shows the results of estimating the input seismic wave in the Kario district based on the observation records obtained in the Aso Valley during the Kumamoto Earthquake. Figures 9 and 10 show the
