Damage assessment of an ancient fort in India

Tamali Bhowmik¹, H. Haridasan¹, A. Menon¹, and S. Banerjee²

¹ National Center of Safety of Heritage Structure, Department of Civil Engineering, IIT Madras.

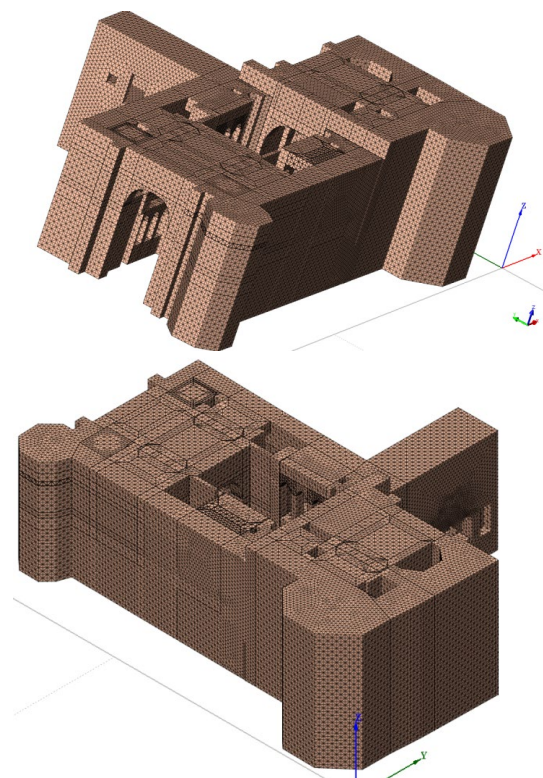
Figure 3. FEM Model of the gateways

Settlement analysis has been performed on the 3D Finite element model of the fort considering gravity load and earth pressure on the fort wall. Figure 3 demonstrate different view of the model. Finite Element analysis was carried out using TNO DIANA software package. The fort was modeled with solid tetrahedron element TE12L which is four-noded three-sided isoparametric element. It is based on linear interpolation and numerical integration. The basic variables of these solid elements are the translations u_x , u_y and u_z .

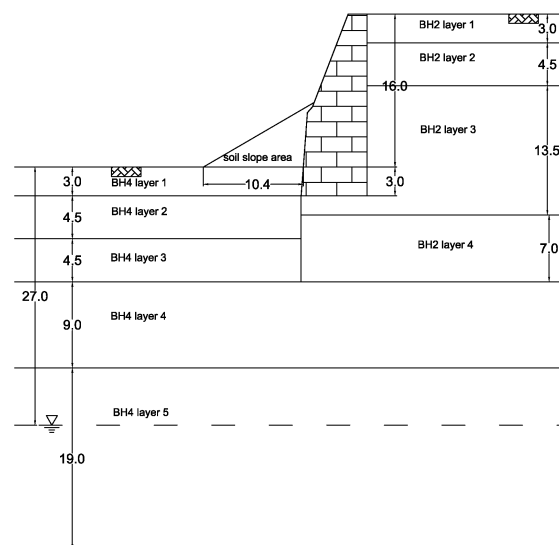
Figure 6. Section details and the depth of wall embedment (*all dimensions are in meter*)

In order to assess the stability of the existing fort wall, a numerical analysis was conducted. Detailed information regarding the cross section of the brick masonry wall and the foundation details are not available. The measurements of the brick masonry wall used in the analysis were approximated from the observation made during the site inspections showing the exposed section of the collapsed bastion wall. The wall dimensions and the foundation soil layers used in the analysis are shown in Figure 6. The curtain wall between the rounded bastion walls was analyzed with a soil slope in front of the wall. There were no details on the slope and height of the soil fills in front of the curtain wall and hence was assumed.

Two dimensional plane strain numerical analyses of the curtain wall of the fort between the bastion walls was carried out using PLAXIS 2D. The retained soil and the underlying foundation strata were modeled as homogeneous isotropic elastoplastic materials characterized by Mohr–Coulomb failure criteria. The soil profile used in the numerical analysis is shown in Figure 6 and the properties of the soil layers and the model used in the analysis are listed in Table 1.
