## Application of multipoint measurement using tilt sensor to slope failure and landslide monitoring

Lin Wang<sup>1</sup>, S. Nishie<sup>1</sup>, M. Fukuhara<sup>1</sup>, J.-J. Chang<sup>2</sup>, C.-W. Chen<sup>2</sup>, T. Uchimura<sup>3</sup>, and I. Towhata<sup>4</sup>

### ABSTRACT

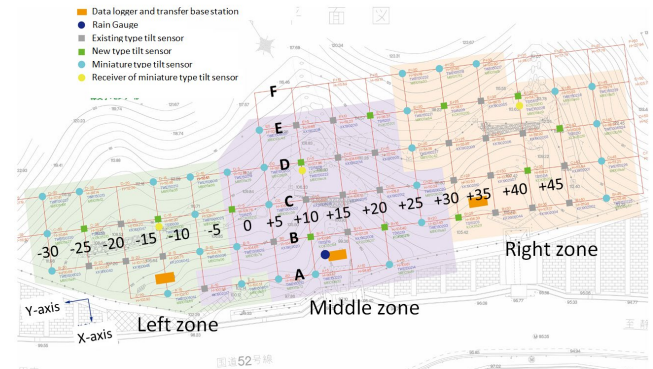
Fig. 4. Arrangement of the multi-point tilt sensors

Figure 3 shows the scale of Manzawa slope failure site, and Figure 4 shows the arrangement of the multi-point tilt sensors and locations. The arrangement interval of the sensor is designed to five meters. A total of 66 sets of sensors were deployed.

The 66 sensor units are divided into three groups (Fig.4), left/middle/right zone, and one data receiver unit and one logger/gateway unit for internet collect all the data from respective group. There were eight heavy rainfall events during summer of 2015, and the tilting rate averaged during each rainfall event is shown in Figure 5. Distribution of tilting behaviors is demonstrated out by multi-point monitoring.

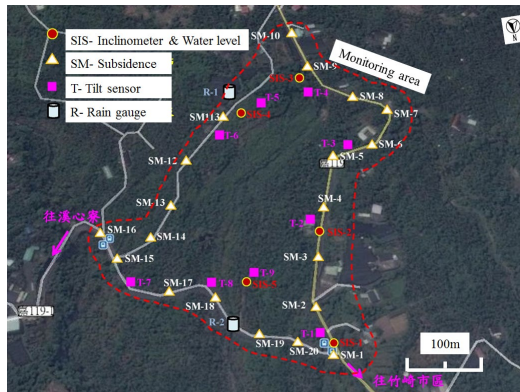
Fig. 10. Arrangement of the tilt sensors on the moving slope of the national route No.119

Another monitoring slope site is near to national route No.119 in Zhuqi, Chiayi County. Monitoring started with the same purpose as Zhongpu site (Fig.10). It also showed typical landslide phenomena of sliding down at top of slope, and cracks in the national route No.119 as shown in Figure 11.
