Cyclic drawdown of water causing the slope failure of canal and dam

Suttisak Soralump¹, P.W. Noppadol², K. Panthi³ and J. Sanmuang⁴

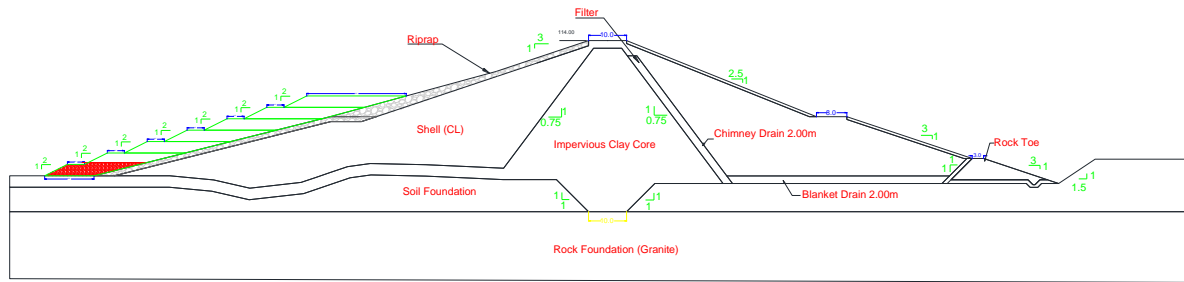
Figure 2: Cross Section of Pa Bon Dam

Pa Bon dam is a zoned dam located at southern part of Thailand. The typical cross section of the dam is shown in Figure 2. The operation of the dam started in 2004 and was operating without any hindrance until the year 2014 when the first movement was observed in the slope of embankment structure. The dam was operated after minor rehabilitation but it continued to move each year with drawdown of water. The actual water level

(Chen, Zhang, & Chan, 2018). The accumulation of shear strain was found to be directly proportional to the height of drawdown. Following the movement each year, upstream berm were designed to reduce the slope movement as shown in Figure 2. In a mean time, the reservoir water level is controlled and maintained at higher level until the dry season.

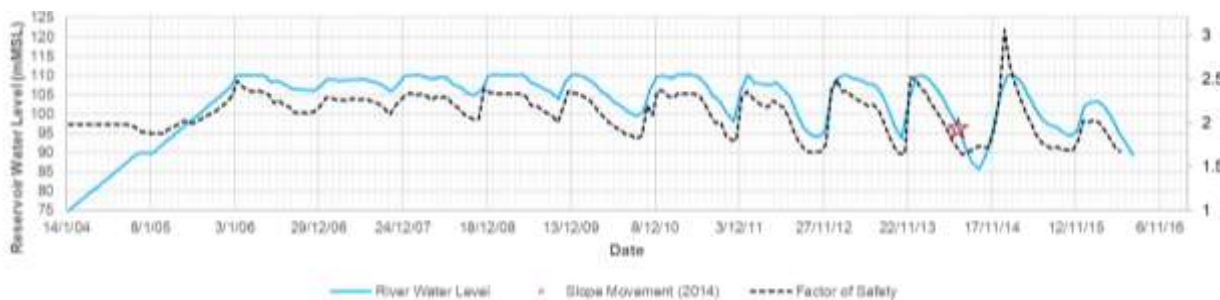
Figure 3: Variation of Safety Factor with Water Level of Pa Bon Dam

since the filling of dam is shown in Figure 3. It can be seen that the dam had experience several sudden drawdown before the observation of slope movement but no movement was observed prior to 2014. The fastest drawdown rate was 10.76 m/day and the largest drawdown distance is 24.33 m. Figure 1 shows the photo of the movement on the dam slope and this movement increased each year with the decrease in water level.

collected dam material (Head, 2011; Mesri & Huvaj-Sarihan, 2012; Stark & Hussain, 2010). Slope stability analysis showed that the factor of safety decreased with decrease in water level but no failure was obtained analyzing the slope at peak strength (Figure 3) hence, the analysis was based on the assumption that the strength of dam material had reached the residual stage due to cyclic loading of water leading to the movement of the slope. The shear strain with passage of time was calculated for the soil after reaching the residual state using both Mohr Coulomb and Modified Cam Clay Model as shown in Figure 4. Strain softening behavior leading to progressive failure on embankment has been successfully determined by using MCC model (Chai & Carter, 2009) .

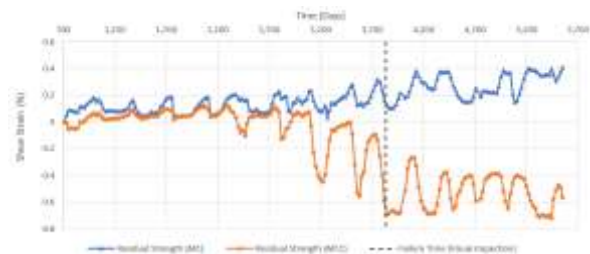
Figure 4: Shear Strain with Passage of Time for Pa Bon Dam (MC and MCC model)

It can be observed that the shear strain was accumulating with the passage of time and has been the cause for the reduction of shear strength. This result resembled to the numerical analysis and laboratory test conducted for the samples of three gorges dam

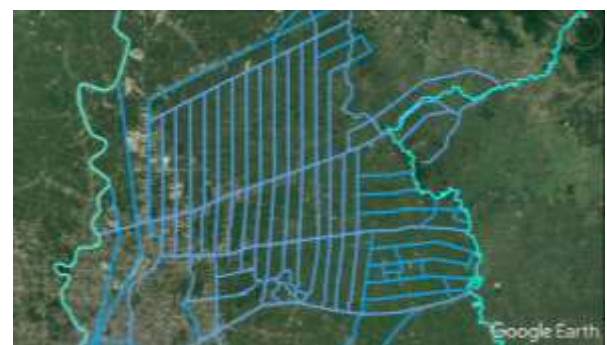
Figure 5 : Systematic Canal located at Lower Chao Phya Basin

Lower Chao Phya basin consist of marine clay deposit called Bangkok soft clay which thickness of 8-12m. These area are suitable for rice production and are in need of irrigation canal to supply water all year round. These canals were built systematically in this area as shown in Figure 5 and later was modified to be a foundation of road embankment (Figure 6).

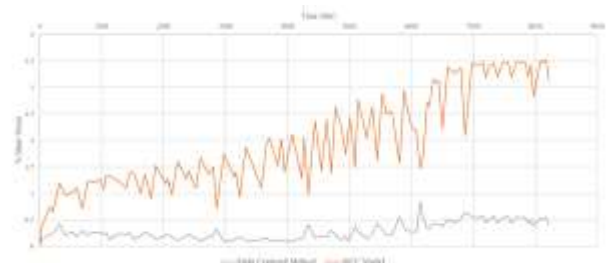
Figure 8: Shear Strain with Passage of Time for Pa Bon Dam (MC and MCC model)

as well. The slope stability analysis in this case too showed the fluctuation of safety factor with water level but no failure was obtained analyzing the slope in peak strength (Figure 9). The shear strain was calculated for the slope using both MC and MCC model and it showed that the shear strain was accumulating with passage of time. The accumulation observed in MCC model was very significant as compared to MC model.

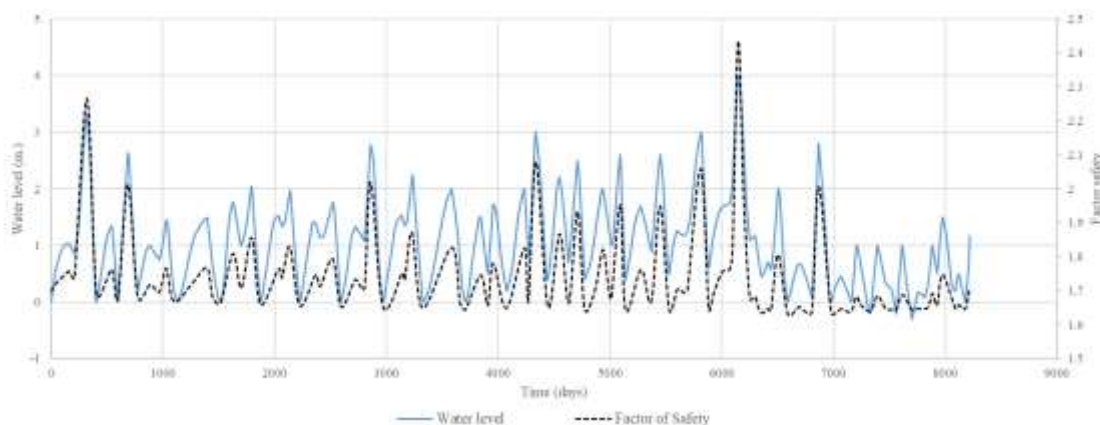
Figure 9 : Figure showing the variation of safety factor with water level with passage of time

several possible causes of failure, on the basis of information available, it was hypothesized that the failure had occurred due to sudden drawdown of water due to prolong drought. The fluctuation of water level in canal is presented in Figure 9.

Couple stress-pore water pressure analysis was carried out and it was determined that the factor of safety of slope greater than unity at the time of failure
