Stabilizing a highway in the fragile Himalayan terrain – Case study of Gulabkoti landslide

ABSTRACT

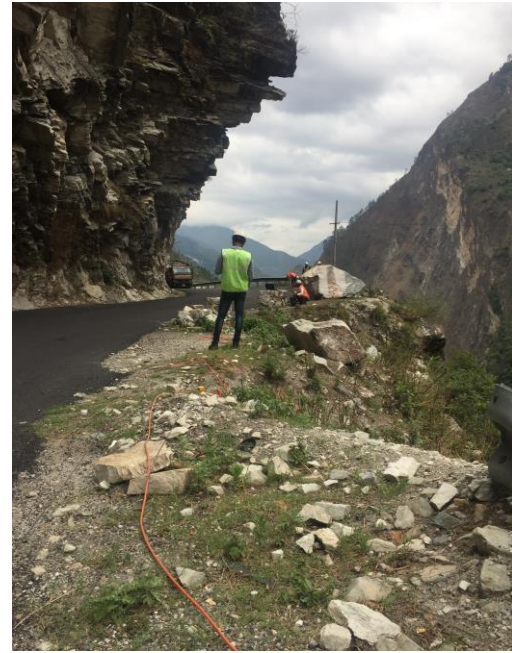
Fig. 3. Seismic Refraction test in progress

Fig. 3 is a photo of the seismic refraction test (SRT) in progress at site. A pictorial summary of the borelog illustrating the core recovery and RQD values is presented on Fig. 4. The geophysical litholog interpreted from one typical SRT is presented on Fig. 5.

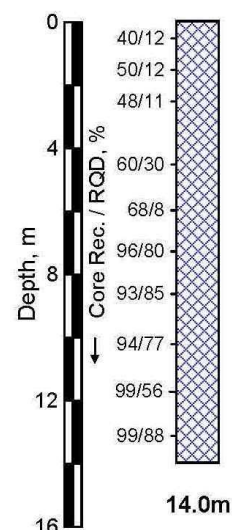
Fig. 4. Borelog

The rock at the borehole location classifies as quartzite. The quartzite zone is overlain at places by dolomitic limestone followed by siliceous marble.

The quartzites are highly sheared, highly jointed and fractured. Quartz veins and pockets containing mica, kyanite and tourmaline are abundant.
