Case History

Geotechnical structure damages during the 2009 Typhoon Morakot

Dr. Wei F. Lee (National Taiwan University of Science and Technology)
Prof. Ikuo Towhata (University of Tokyo)

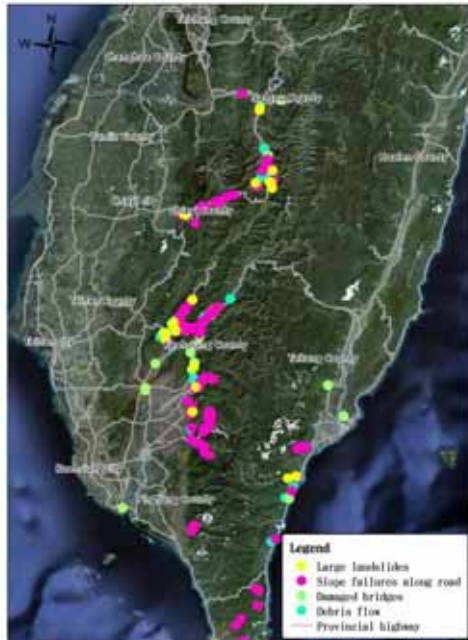
Most of them were concentrated in the mountainous region (Fig. 5). More details of the damages are introduced in the following chapters.

Figure 5. Locations of geotechnical damage

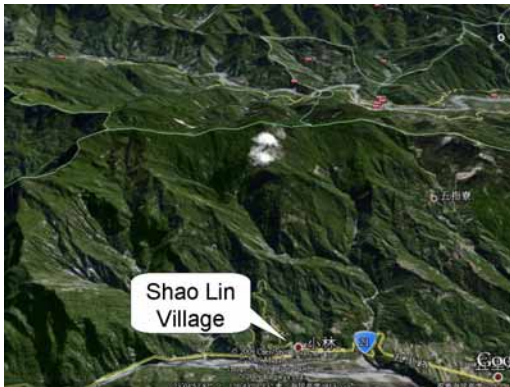
One of the most tragic events during the present typhoon was the total devastation of the Shao-Lin Village. In Fig. 21, minor streams behind the village had been considered vulnerable to possible occurrence of debris flow. During the present typhoon, a huge slope failure of $1.9 \times 10^7 \text{ m}^3$ in volume occurred (Fig. 22) and formed a landslide dam in the river channel on the upstream side of the village (Fig. 23). This dam breached shortly and totally destroyed the village (Fig. 24). The number of victims reached 474.

Figure 21. Areal view of Shao Lin Village before rainfall

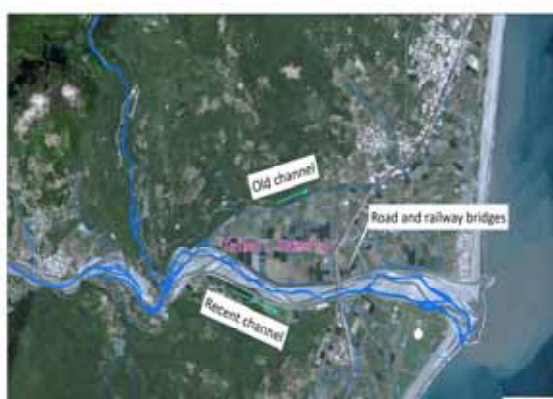
Figure 30. Air photograph of Taimali River channel before flooding

Figure 30 shows an air photograph of the previous topography in the mouth area of Taimali River. Although the ancient river flowed on the left (north) side, human activities shifted it towards the right bank. When the flooding occurred in 2009, the river flow destroyed the levees and came back to its original channel on the left side (Fig. 31). Consequently, both railway and road bridges were destroyed on that side. See Figs. 32 and 33 for those bridges during flooding and reconstruction.
