## Case History

### Geotechnical damage caused by the 2010 Maule, Chile earthquake

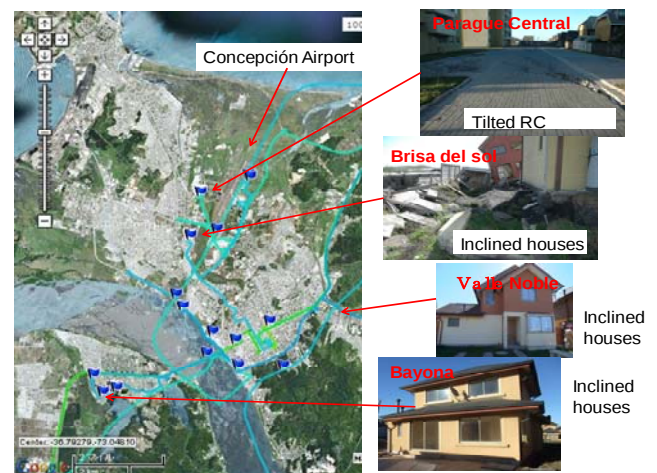
Fig. 3 Sites of liquefaction damage in Concepción

The actual number of liquefied sites was quite small in spite of the large earthquake magnitude. This is probably because the low level of annual precipitation does not make many water-saturated sandy subsoil. The reconnaissance survey detected liquefaction at fill or replaced backfill in and around Concepción only, except the tailing dam at Las Palmas. In Concepción area, subsoil liquefaction caused settlement of buildings and houses as well as uplift of underground tanks at sites shown in Fig. 3. Photo 1 demonstrates a 0.77-degree tilting of an 8-storied apartment building at Los Presidentes in Hualpén. Sand boils were found around the building to verify the occurrence of liquefaction. As the original topography here was swamp, subsurface soil was excavated down to the depth of 4 m and then sand was placed at the time of construction (see Fig. 4). Ground water table was as shallow as 1.0 m below the surface, and it made the effects of subsoil liquefaction more influential. Similar settlement occurred to a 5-storied hospital building in Curanilahue at about 30 km south of Concepción.

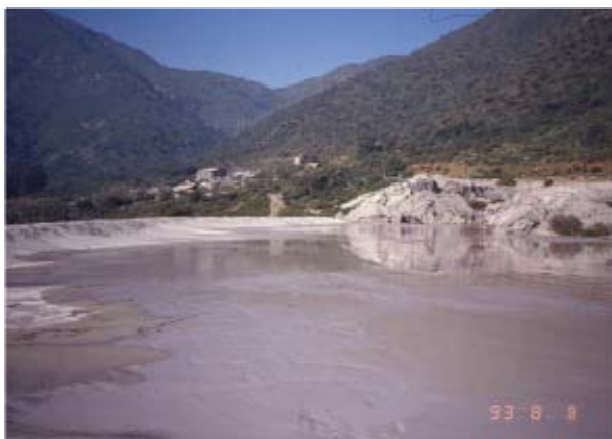
Photo 5 Reservoir of tailing dam at Veta del Agua in 1993.

Tailing is a waste material that is produced by mining industries. Valuable minerals are removed from powder of ores and the remaining stone powders are dumped into a water pond (Photo 5). Since the powders are as fine as silt, they sediment in water very slowly and form a loose and liquefiable deposit. Further problem is that this fine grain size reduces the permeability (hydraulic conductivity) of this material and, in case of liquefaction and high excess pore water pressure, the dissipation of high pore pressure is substantially delayed. Therefore, the adverse condition of high pore water pressure and low effective stress lasts for a long time. Moreover, this fine grain has no cohesion, thus increasing the liquefaction probability further. The entire tailing deposit is supported by an embankment made of coarse components of tailing as well. In case of up-stream construction, this embankment is nothing more than a surface coverage, and if the underlying tailings get liquefied, the coverage cannot maintain stability anymore. Hence, a tailing flow occurs.
