## Case History

### The Geotechnical Aspects of the Haiti Earthquake

Ellen M. Rathje, University of Texas

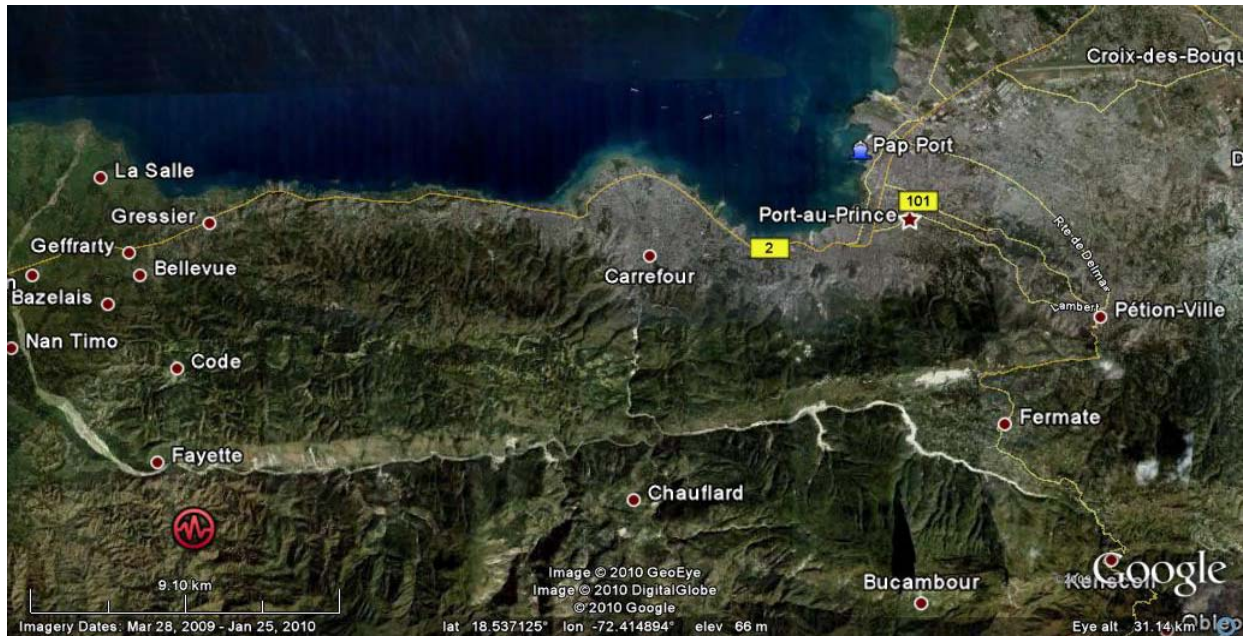
The main port in Port-au-Prince is located slightly north of downtown (Figure 5) and approximately 20 to 25 km from the fault rupture. The port consists of two separate facilities built in the late 1970's and designated as the North Wharf and South Pier. The entire facility was constructed using dredged, calcareous, hydraulic fill for the staging areas, and both the North Wharf and South Pier were pile-supported.

Figure 5 Location of main port in Port-au-Prince.

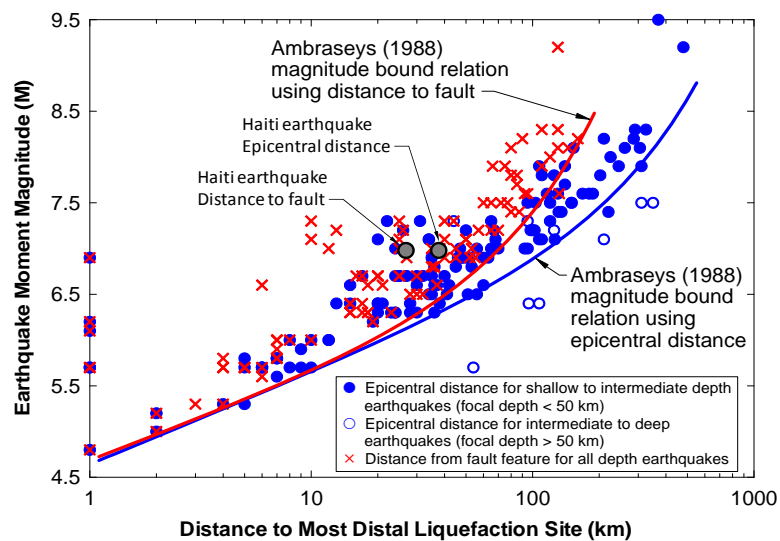
Numerous liquefaction features near the coastline were identified using aerial imagery, as shown in Figure 10. Potential liquefaction-induced failures were identified up to 38 km from the epicenter and up to 26 km from the fault trace. These data plot well within the boundaries for most distal liquefaction sites proposed by Ambraseys (1988) using worldwide data (Figure 11). This suggests that the natural coastal and alluvial soils near Port-au-Prince Bay are only moderately susceptible to liquefaction, although liquefiable Quaternary sediments were generally noted only within short distances from the coast.

Figure 11. Comparison of most distal liquefaction sites identified in Haiti from aerial photography with worldwide data collected by Ambraseys (1988)
