2010 Darfield (New Zealand) Earthquake: Impacts of liquefaction and lateral spreading

Misko Cubrinovski, University of Canterbury, Christchurch, New Zealand
Rolando Orense, University of Auckland, Auckland, New Zealand

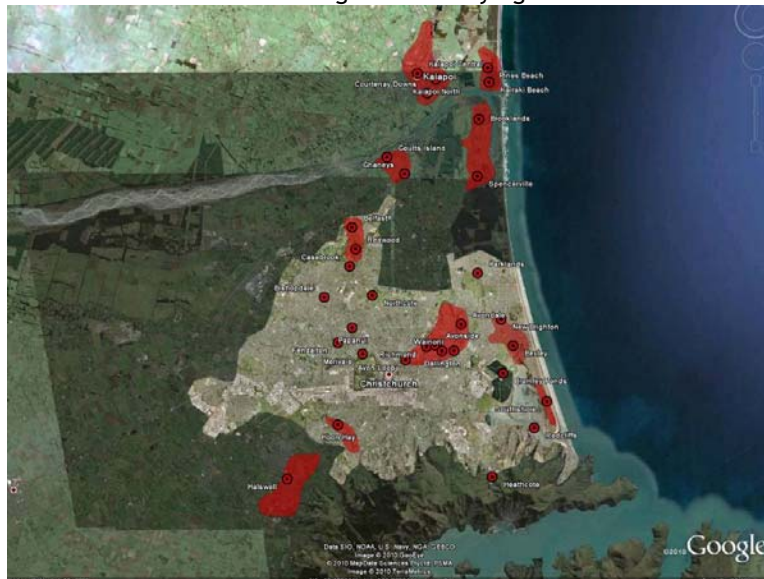
The earthquake caused widespread liquefaction in the suburbs of Christchurch along the Avon River, particularly to the east and north-east of the CBD. Widespread liquefaction also occurred in Halswell, at the southwest end of the city. Pockets of limited or partial liquefaction were observed in other parts of Christchurch, though these were much fewer to the west of the CBD. Figure 4 shows areas of observed liquefaction in the urban area of Christchurch based on surface manifestation of liquefaction visible in aerial photographs and initial observations from ground surveying.

Figure 4. Areas of liquefaction (red shaded regions and red points) in Christchurch and Kaiapoi caused by the 2010 Darfield Earthquake

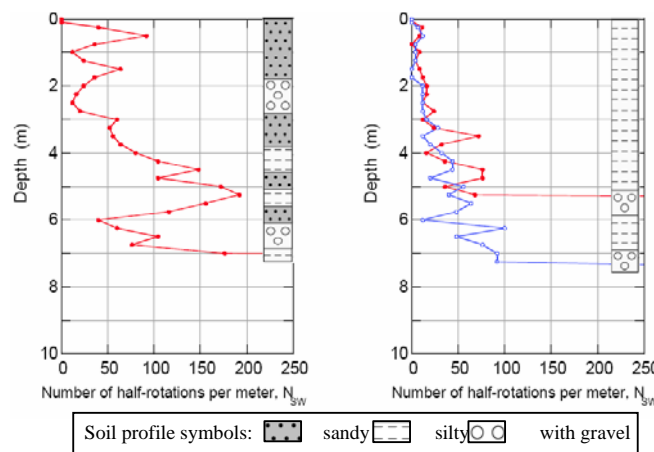
After the earthquake, Swedish Weight Sounding (SWS) tests were performed at numerous locations affected by liquefaction and lateral spreading. So far, about 150 SWS tests have been conducted in the areas of Christchurch and Kaiapoi. SWS is a simple manually operated penetration test under a dead-load of 100 kg in which the number of half-rotations required for a 25 cm penetration of a rod (screw point) is recorded (JIS, 1995). One of the advantages of the SWS test which was heavily utilized in this investigation is the ability to perform the test within a confined space in backyards of residential properties. Typical results of SWS tests conducted at two locations in Dallington and Avonside, expressed in terms of the number of half-rotations per metre, N_{SW} , are shown in Figure 12.

Figure 12. Post-event penetration resistance in Dallington and Avonside measured in SWS tests
