## Case History

### Attabad Landslide- Dam Disaster in Pakistan 2010

On January 4, 2010, in the remote Hunza Valley of Northern Pakistan a massive landslide buried the village of Attabad, destroyed 26 houses and killed 20 people. The landslide dammed Hunza River and formed an extensive lake of 100m depth. Until the end of July 2010, 381 houses were ruined; out of which 141 were directly affected by Attabad landslide, others were submerged due to expansion of the lake. By the end of May 2010 local authorities excavated a spillway to guide the flow of impounding lake over the natural dam. Until August, 2010, the spillway is performing well but internal response of the loosely deposited debris is unknown.

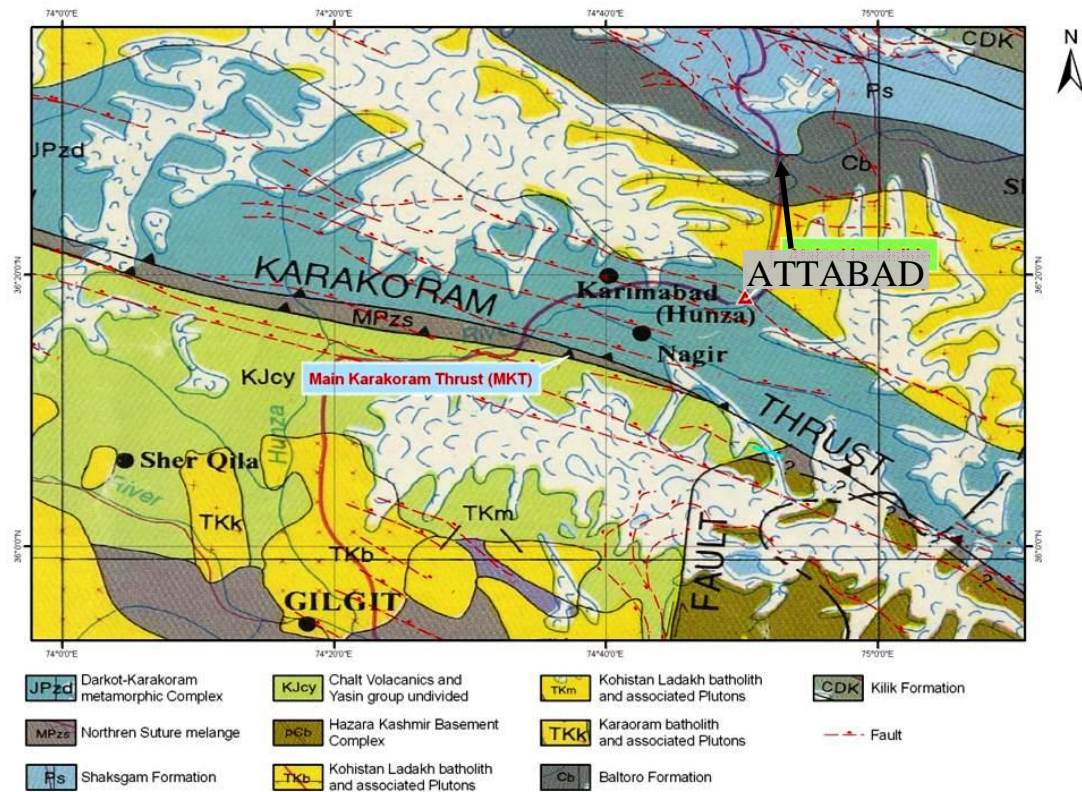
Figure 2 Geological map of Hunza valley and adjoining areas

The destroyed Attabad village was located on valley slope of glacio-fluvial deposits underlain by Gneissic rocks (orthogenesis and Para-gneisses of Baltit Group); Baltit group consists of gneisses, schist, quartzite, dolomite limestone and marble. Glacio fluvial deposits forming the site of Attabad village consist of boulders, cobbles and gravels with some silt and sand as cementing materials. The rocks exposed at crown and toe are highly fractured, sheared, jointed and weathered. A fault on the eastern side of the village is passing through Hunza River trending almost North-South.

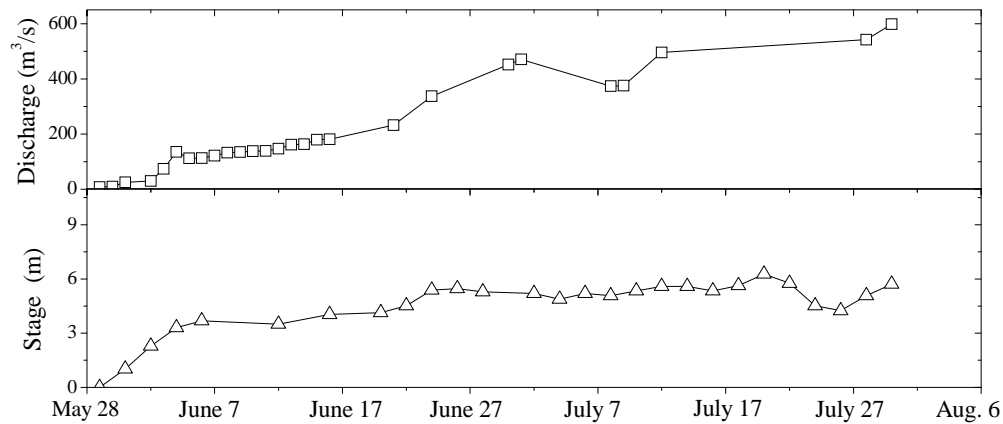
Figure 9 Time histories of discharge measured at Ganish Bridge and stage over spillway crest (drawn after daily pager report supplied by National Disaster Mitigation Authority Pakistan; NDMA)

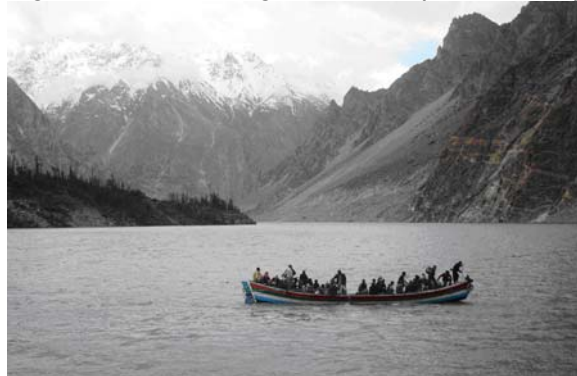
The disaster has social impacts on the daily life of community other than the displacement of residence. Karakoram Highway was the only route which connects the towns of Gulmit and Shishkat with Hunza, which has been blocked by landslide and impounded water. Now the mode of transport changed from vehicles to boat (Fig. 12). Directly or indirectly 25,000 peoples were affected by this disaster. The banks of the lake are highly vulnerable and small mass movements are frequent which restricts the boat service through the lake.

Figure 12 Modal change of transportation after the disaster from land to boat
