Geotechnical Damage due to the 2011 Christchurch, New Zealand

Suguru Yamada, Assistant Professor, University of Tokyo
Rolando Orense, Senior Lecturer, University of Auckland
Misko Cubrinovski, Associate Professor, University of Canterbury

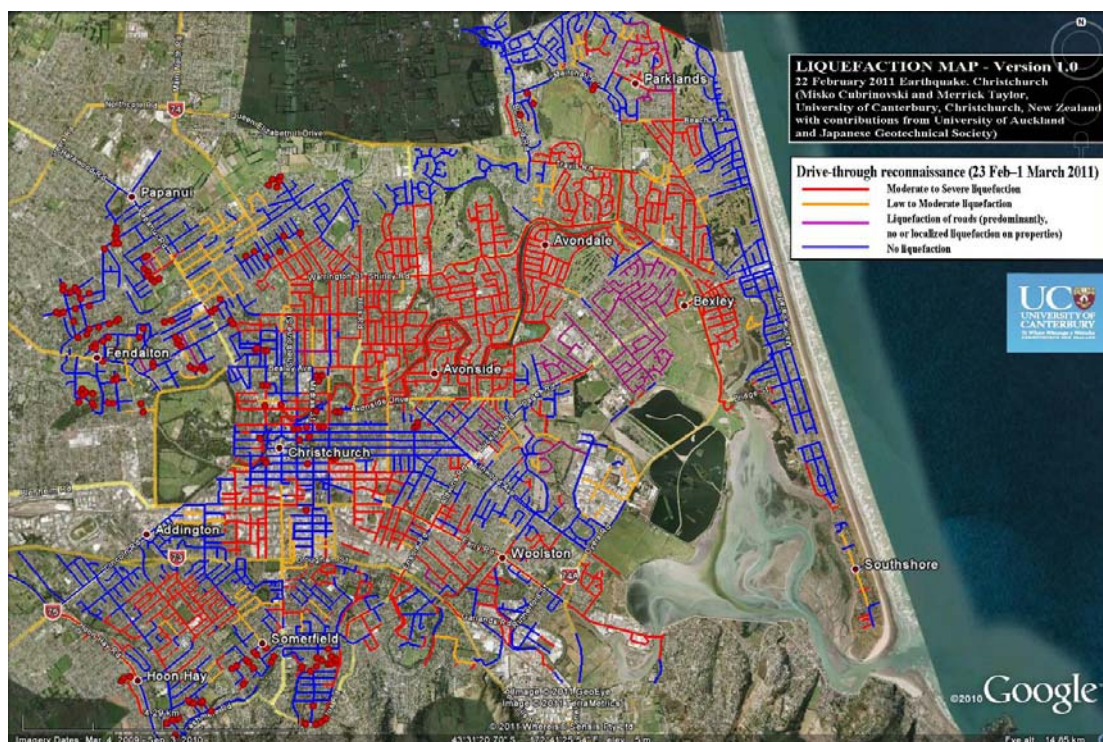
The earthquake caused widespread liquefaction in the eastern suburbs of Christchurch city as well as in Central Business District (CBD). The liquefaction-affected area in Christchurch during this earthquake was much wider than the one in September 2010. While major liquefied sites in the September 2010 earthquake were distributed along the Avon River (northeast of CBD), liquefaction was observed in the 2011 earthquake across a wide areas in suburbs north to south of Christchurch city. Figures 7 and 8 show the areas of observed liquefaction in urban area of Christchurch after the 2010 Darfield earthquake and 2011 Christchurch earthquake, respectively. These two maps were based on surface manifestation of liquefaction visible in aerial photographs and initial observations from ground surveying. The survey to understand areas of liquefaction caused by each quake was conducted immediately after the earthquake occurrence by a reconnaissance team of the University of Canterbury.

Figure 8. Areas of liquefaction in Christchurch caused by the 2011 Christchurch Earthquake. (Cubrinovski and Taylor, 2011, <http://www.nzsee.org.nz/>)

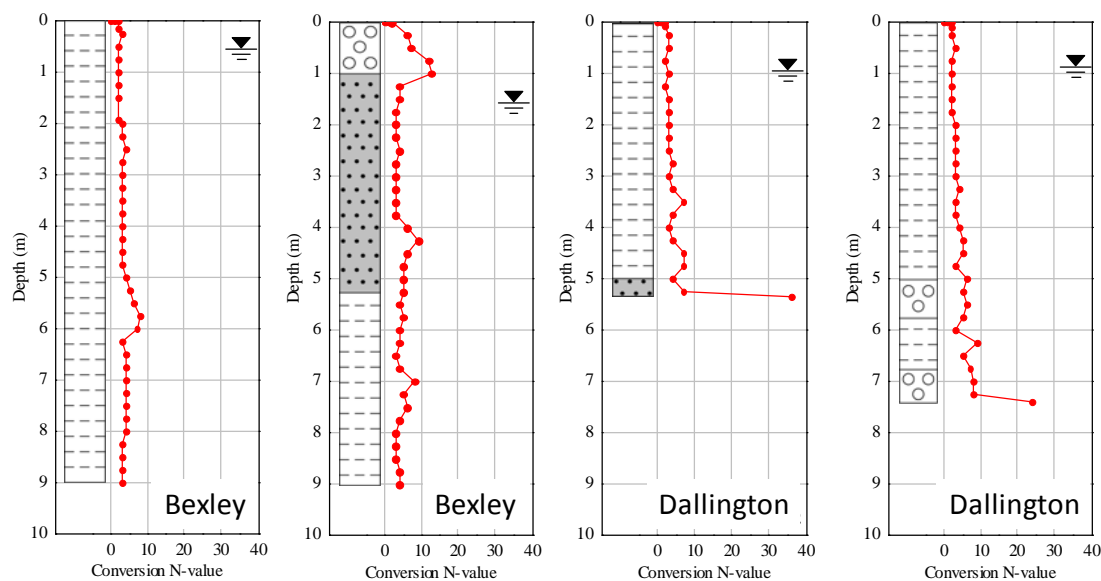
Typical results of SWS tests in Christchurch are shown in Figure 9. It can be understood from the figures that there are strata of very loose ($N < 5$) silt/sand, at about 5 m or deeper below the ground water table.

Figure 9. Converted N-Value profile in Bexley and Dallington. Ground survey was conducted by University of Canterbury and JGS Reconnaissance teams in September 2010 (JGS, 2010).

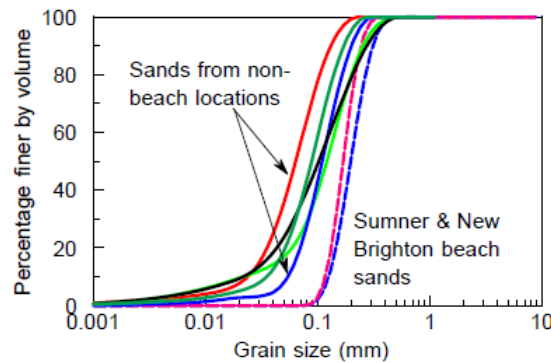
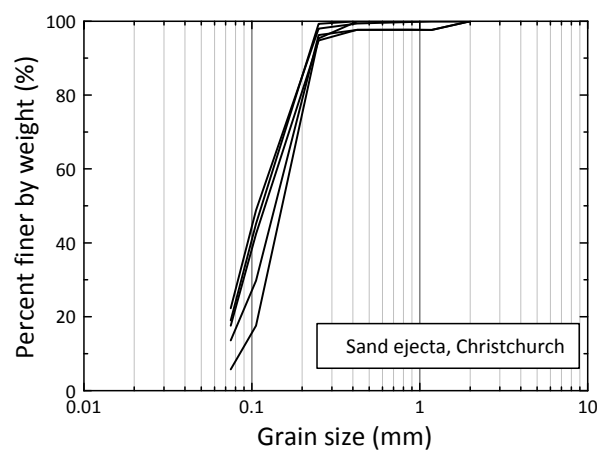
The ejecta from sand boils found at liquefied areas in Christchurch were generally similar and had distinctive features, like presence of non-plastic fine sand and silty sand with grey/blue color. Figures 10 (a) and (b) show the grain size distribution curves of sand ejecta collected at several sites in Christchurch after 2010 Darfield earthquake and 2011 Christchurch earthquake, respectively. In general, the sand ejected in both earthquakes had very similar grain size distributions.

Figure 10. Grain size distribution curves of sand ejecta collected in Christchurch city.

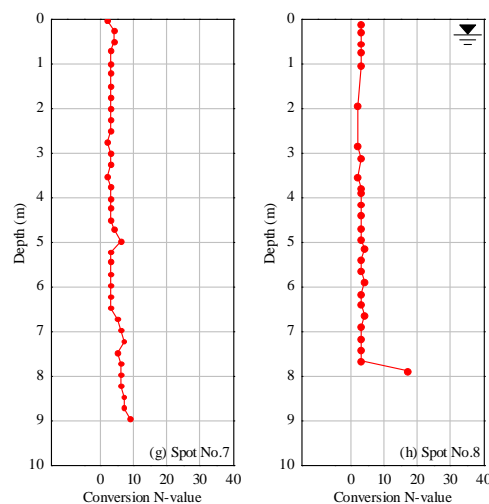
After the 2010 Darfield earthquake, SWS tests were conducted at a residential property shown in Figure 23 (Cubrinovski et al., 2010 and JGS, 2010). The profiles of converted N-value from SWS tests are shown in Figure 25. The upper portion of the ground consists of very loose sand, with depth more than 7 m and the ground water table was very shallow. Figure 26 shows the grain size distribution curves of sand ejecta collected in Kaiapoi. The solid curve with red color in the figure indicates the grain size distribution of soil collected after this earthquake, while the other dashed curves correspond to soils taken after the 2010 Darfield earthquake. The sands ejected in both earthquakes have generally similar grain size distribution. Moreover, they have similar grain size distributions as the sand ejecta in Christchurch, which are shown in Figure 10.

Figure 25. Converted SPT N-value profile in North Kaiapoi. Ground survey was conducted by University of Canterbury and JGS Reconnaissance team on September 2010 (JGS, 2010).
