## Earthquake News

### On Gigantic Tohoku Pacific Earthquake in Japan

Ikuko Towhata, Professor, University of Tokyo  
 Hiroyuki Goto, Assistant Professor, Kyoto University  
 Motoki Kazama, Professor, Tohoku University, Sendai  
 Takashi Kiyota, Assistant Professor, University of Tokyo  
 Susumu Nakamura, Professor, Nihon University, Fukushima  
 Kazue Wakamatsu, Professor, Kanto Gakuin University, Yokohama  
 Akihiko Wakai, Professor, Gunma University, Kiryu  
 Susumu Yasuda, Professor, Tokyo Denki University, Saitama  
 Nozomu Yoshida, Professor, Tohoku Gakuin University, Tagajo

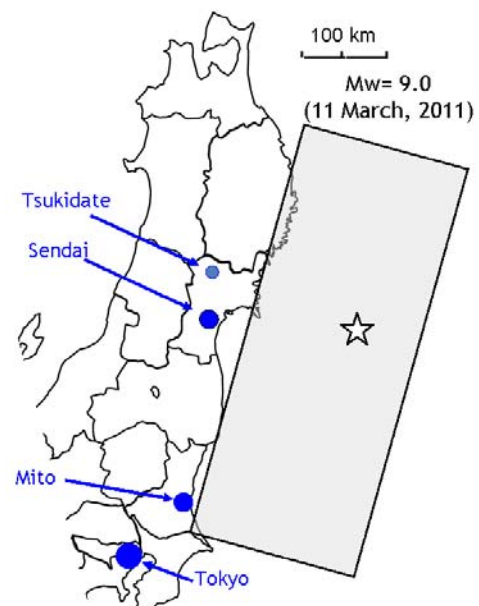
The causative fault of this earthquake is located in the Pacific Ocean off east Japan where an oceanic tectonic plate has been subsiding under the archipelago (Fig. 1). In the area of Sendai City, that is one of the biggest cities in the eastern part of Japan, there had been warning about a possible big earthquake in the coming years. It was anticipated that a part of the plate subduction to the east of Japan would cause this extreme event. The reality was, however, more than anticipated, the size of the causative mechanism being 500 km in length in the NS direction and the width being 200 km.

Fig. 1 Location of causative mechanism and major damage areas (Fault model by National Research Institute for Earth Science and Disaster Prevention)

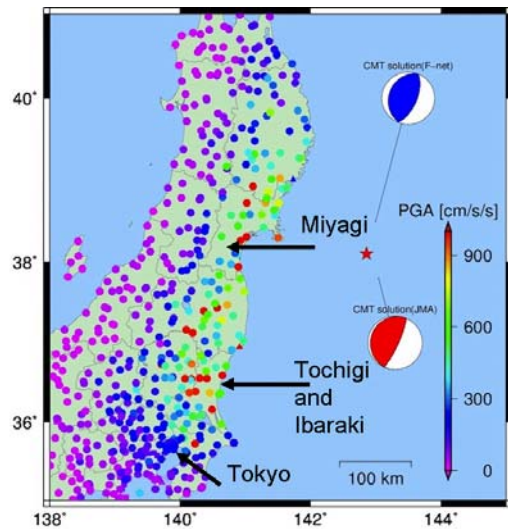
Figures 3 and 4 show the distribution of peak ground acceleration (PGA) and peak ground velocity (PGV) of horizontal components, respectively. PGA values do not simply attenuate from the east coast, but major two clusters are recognized in 1) Miyagi Prefecture (around N38.5° E141.0°), and 2) Tochigi and Ibaraki Prefectures (around N36.5° E140.5°). This implies that the rupture process during the earthquake was not uniform, and contained several asperities radiating strong ground motions. Another point to note is that Tokyo and its surrounding area near the bottom of the figures were subjected to strong shaking. Therefore, damage occurred at many places therein. Fig. 5 illustrates the acceleration records at K-NET Ishinomaki station to the east of Sendai City in Miyagi. It is evident here that there are at least two strong earthquake events that are superimposed on each other. Thus, it is reasonable to assume several asperities in the source mechanism. Another important issue is the long duration time of strong shaking. Increasing the number of seismic loading cycles, this long duration time made the extent of subsoil liquefaction more serious.

Fig. 3 Distribution of peak ground acceleration provided by NIED, ERI (the University of Tokyo), AIST, and PARI

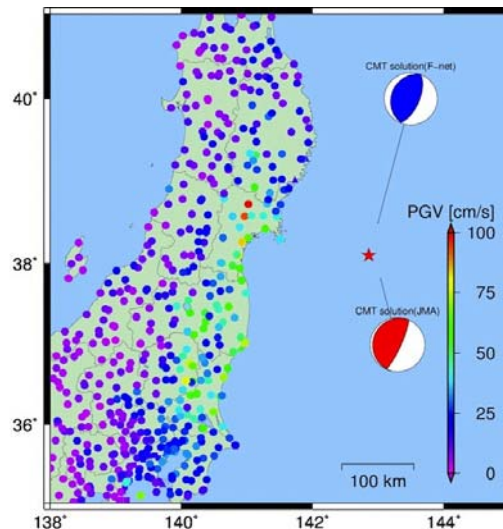
Fig. 4 Distribution of peak ground velocity provided by NIED, ERI (the University of Tokyo), AIST, and PARI

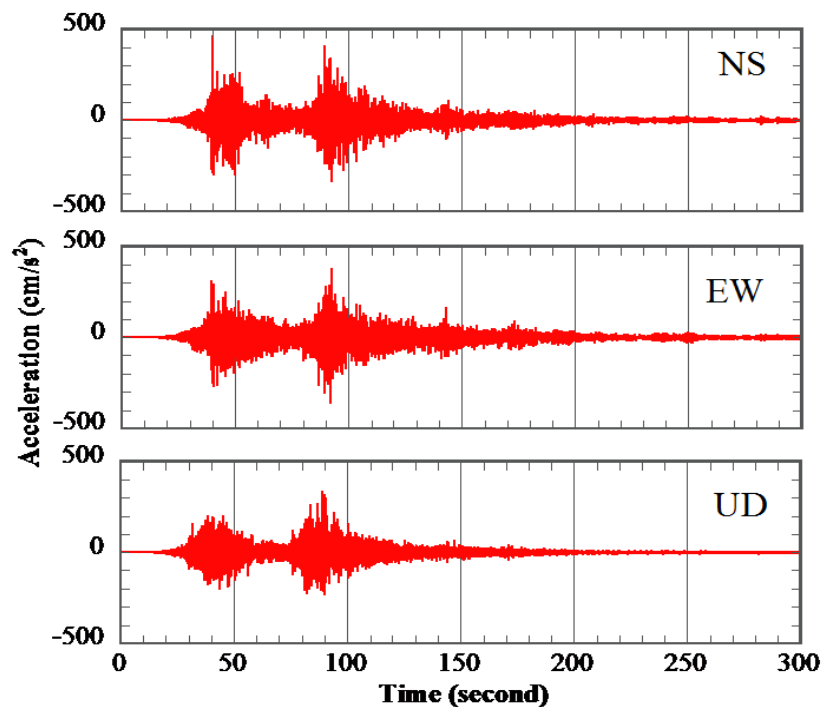
Fig. 5 Strong earthquake motion record at Ishinomaki to the east of Sendai City, Miyagi Prefecture (K-NET MYG010)

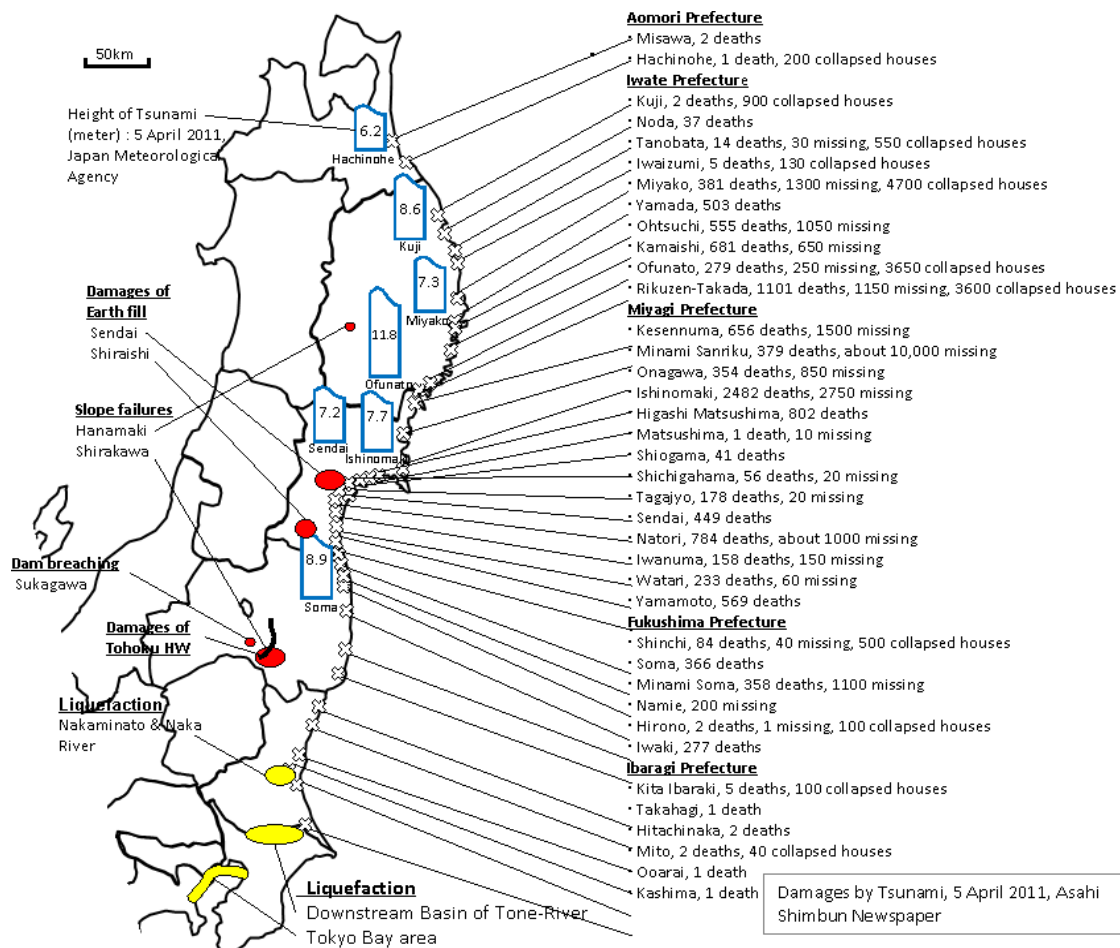
Many kinds of damage were caused by the earthquake over a large area in the eastern part of Japan (Fig. 6), ranging over 500 km in NS direction. The number of victims is not yet finalized in the middle of April because tsunami brought many people into sea and also debris of destroyed houses have made searching very difficult. It is anticipated that the total number of victims would be more than 25,000, most of which were killed by tsunami, while the total amount of debris is 26.7 million tons.

Fig. 6 Distribution of seismic damage

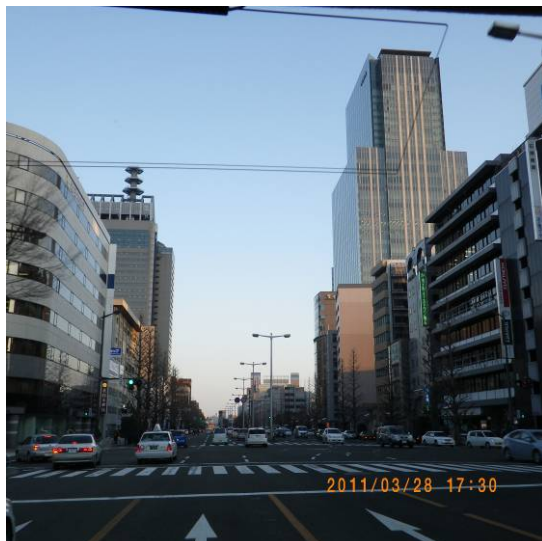
The major induced damages are classified into tsunami-related ones, liquefaction of sandy ground, and instability of slope and embankment. It is noteworthy that structural damage was not so significant as in the cases in previous gigantic earthquakes in the concerned region. Fig. 7(a) indicates the central part of Sendai City where many high-rise buildings survived the earthquake without problems. Of particular interest is illustrated in Fig. 7(b) in which Tsukidate Township survived the quake without structural damage despite that the Meteorological Agency issued the highest seismic intensity scale of 7 here. A local dentist was interviewed to mention that the shaking was long and strong, he could not keep standing up, but his old wooden house survived this event without structural damage. Information about lifeline damage is not yet available.

(a) Intact buildings in central Sendai City (b) Houses and shops without damage in Tsukidate Township

Fig. 7 Good performance of buildings and houses in the affected region

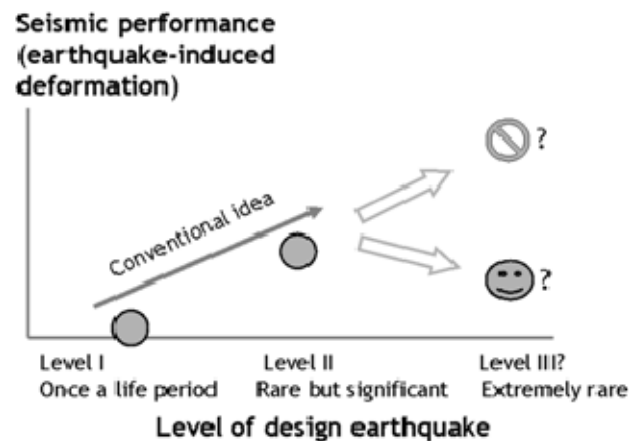
Fig. 45 Contradictory ideas in seismic performance-based design principle

These experiences raise a question to the principle of seismic performance-based design. The recent trend towards the seismic performance-based design stated that more damage (deformation) should be allowed for less frequent and stronger earthquake action. In this regard, in Fig. 45, Level I design earthquake that may occur once during a life time of a structure allows nearly no residual deformation, while Level II earthquake, that is considered rare, allows some but not fatal damage. Because the 2011 earthquake, which was extremely rare after the previous Jogan earthquake in 869, made a very significant impact on the national and international community, it may be felt that the allowable damage caused by this very rare Level III (?) earthquake should be made smaller than so far considered. Then a question arises why deformation has to be made smaller for less frequent (Level III) earthquake.
