Geotechnical Damage due to the 2011 Christchurch, New Zealand

On Gigantic Tohoku Pacific Earthquake in Japan

Ikuro Towhata, Professor, University of Tokyo
 Hiroyuki Goto, Assistant Professor, Kyoto University
 Motoki Kazama, Professor, Tohoku University, Sendai
 Takashi Kiyota, Assistant Professor, University of Tokyo
 Susumu Nakamura, Professor, Nihon University, Fukushima
 Kazue Wakamatsu, Professor, Kanto Gakuin University, Yokohama
 Akihiko Wakai, Professor, Gunma University, Kiryu
 Susumu Yasuda, Professor, Tokyo Denki University, Saitama
 Nozomu Yoshida, Professor, Tohoku Gakuin University, Tagajo

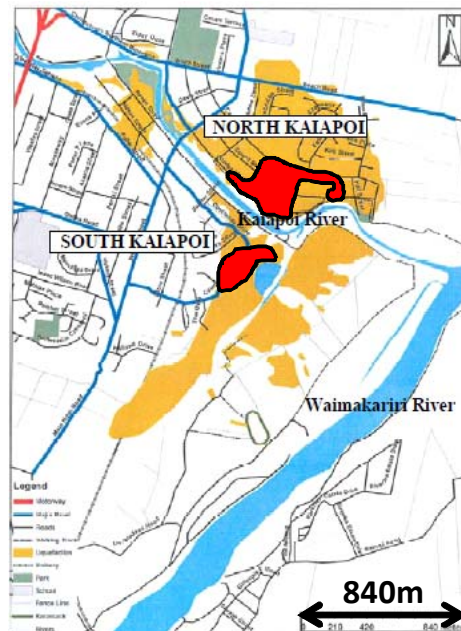
Figure 24. Comparison of liquefied area in Kaiapoi between 2010 Darfield and 2011 Christchurch earthquakes (Modified from Cubrinovski et al., 2010).

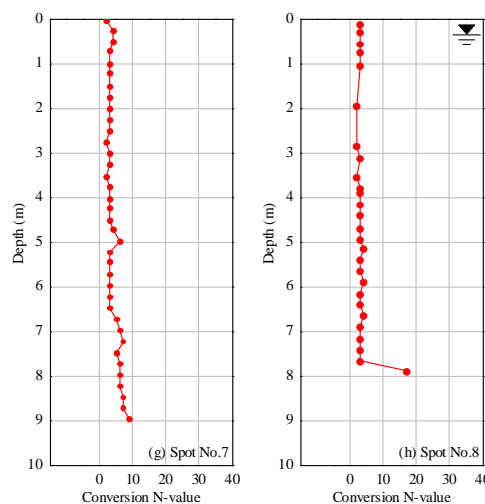
After the 2010 Darfield earthquake, SWS tests were conducted at a residential property shown in Figure 23 (Cubrinovski et al., 2010 and JGS, 2010). The profiles of converted N-value from SWS tests are shown in Figure 25. The upper portion of the ground consists of very loose sand, with depth more than 7 m and the ground water table was very shallow. Figure 26 shows the grain size distribution curves of sand ejecta collected in Kaiapoi. The solid curve with red color in the figure indicates the grain size distribution of soil collected after this earthquake, while the other dashed curves correspond to soils taken after the 2010 Darfield earthquake. The sands ejected in both earthquakes have generally similar grain size distribution. Moreover, they have similar grain size distributions as the sand ejecta in Christchurch, which are shown in Figure 10.

Figure 25. Converted SPT N-value profile in North Kaiapoi. Ground survey was conducted by University of Canterbury and JGS Reconnaissance team on September 2010 (JGS, 2010).

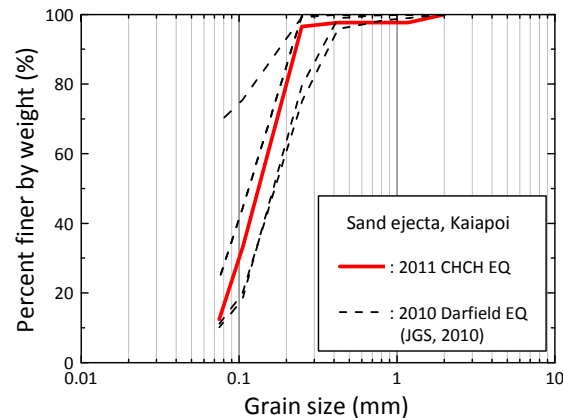
Figure 26. Grain size distribution curves of sand ejecta collected at Kaiapoi.

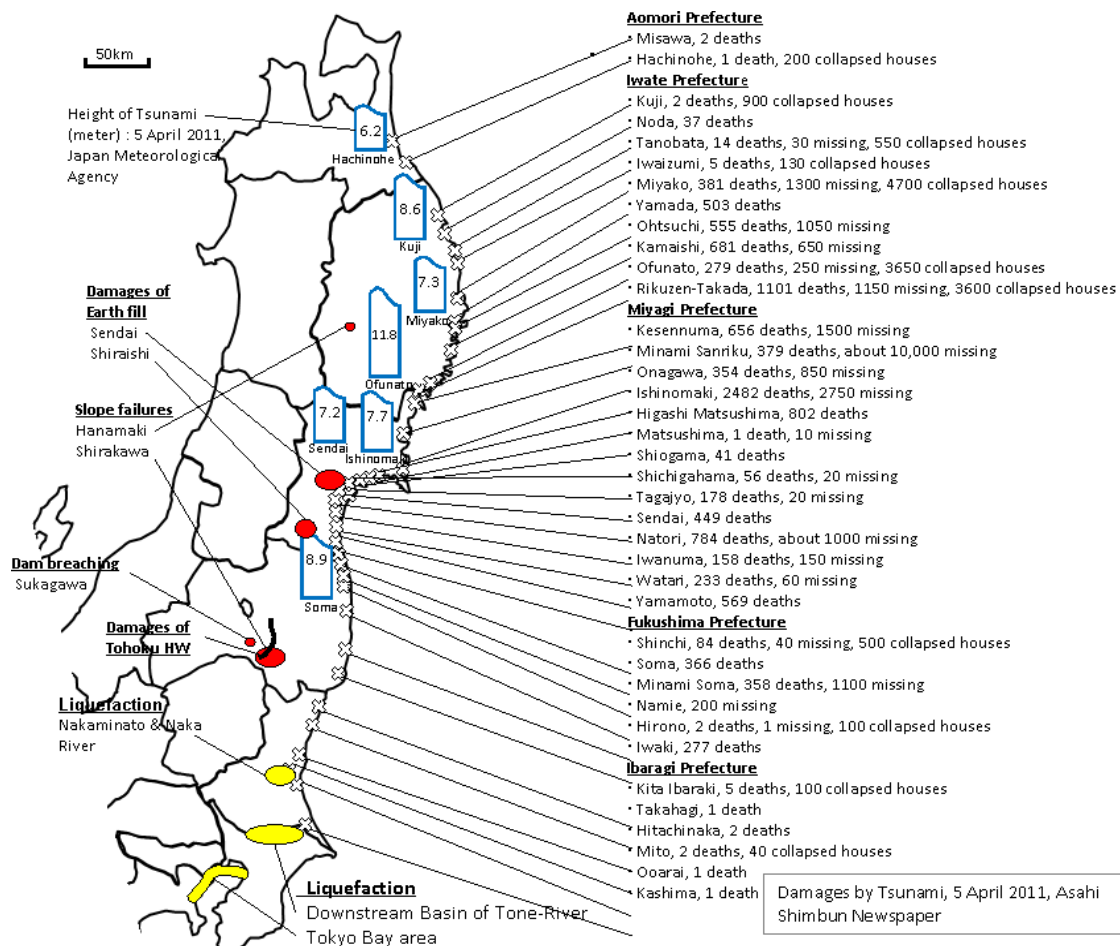
Many kinds of damage were caused by the earthquake over a large area in the eastern part of Japan (Fig. 6), ranging over 500 km in NS direction. The number of victims is not yet finalized in the middle of April because tsunami brought many people into sea and also debris of destroyed houses have made searching very difficult. It is anticipated that the total number of victims would be more than 25,000, most of which were killed by tsunami, while the total amount of debris is 26.7 million tons.

Fig. 6 Distribution of seismic damage

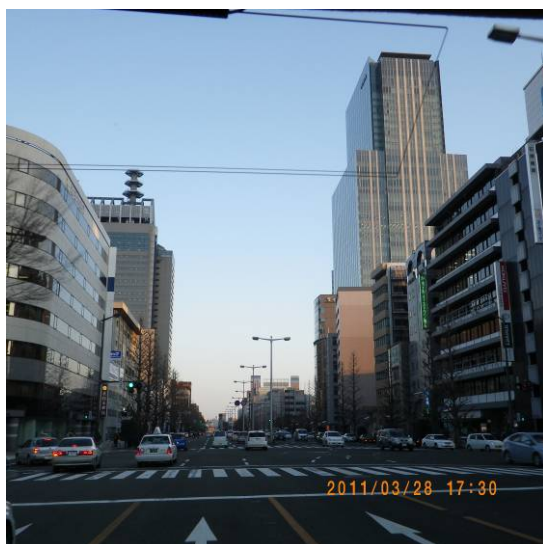
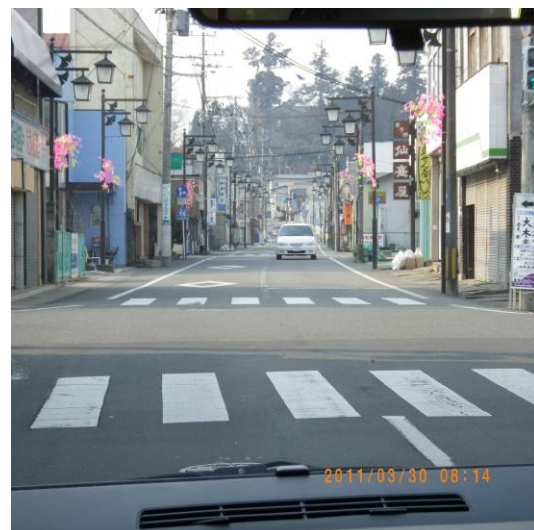
The major induced damages are classified into tsunami-related ones, liquefaction of sandy ground, and instability of slope and embankment. It is noteworthy that structural damage was not so significant as in the cases in previous gigantic earthquakes in the concerned region. Fig. 7(a) indicates the central part of Sendai City where many high-rise buildings survived the earthquake without problems. Of particular interest is illustrated in Fig. 7(b) in which Tsukidate Township survived the quake without structural damage despite that the Meteorological Agency issued the highest seismic intensity scale of 7 here. A local dentist was interviewed to mention that the shaking was long and strong, he could not keep standing up, but his old wooden house survived this event without structural damage. Information about lifeline damage is not yet available.

(a) Intact buildings in central Sendai City (b) Houses and shops without damage in Tsukidate Township

Fig. 7 Good performance of buildings and houses in the affected region

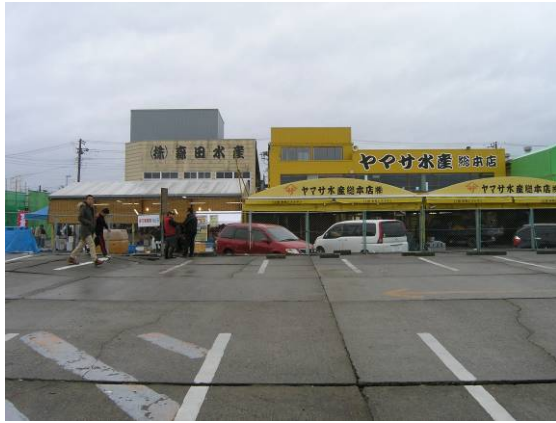
Fig. 12 Resuming business of fish restaurants after tsunami strike (Nakaminato Harbor, Ibaraki)

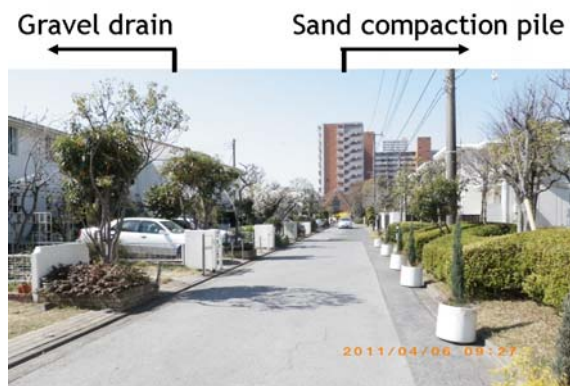
Fig. 30 Successful soil improvement in Irifune-Kita area of Urayasu residential area

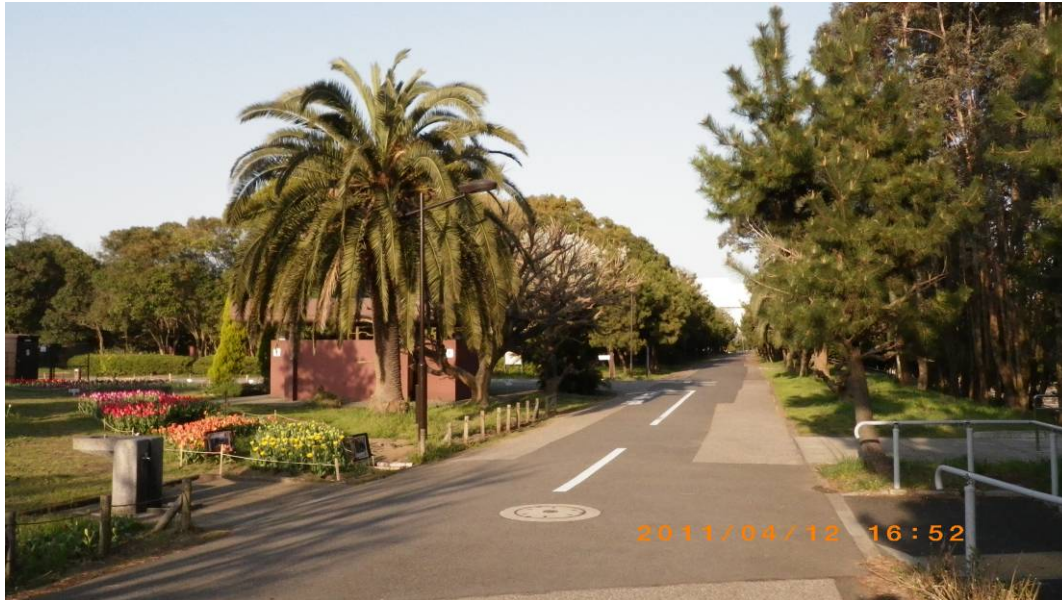
Fig. 44 Intact shape of municipal waste landfill at Yumenoshima of Tokyo

Concern was addressed to the behavior of a solid municipal waste landfill at Yumenoshima in Tokyo. As shown in Fig. 44, no subsidence or instability was triggered therein by the earthquake motion.
