VISIT OF ATC3 COMMITTEE ON SLOPE INSTABILITY SITES IN BHUTAN

Ikuo Towhata, University of Tokyo, towhata@geot.t.u-tokyo.ac.jp
Mitsu Okamura, Ehime University, okamura@cee.ehime-u.ac.jp
Hirofumi Toyota, Nagaoka University of Technology, toyota@vos.nagaokaut.ac.jp

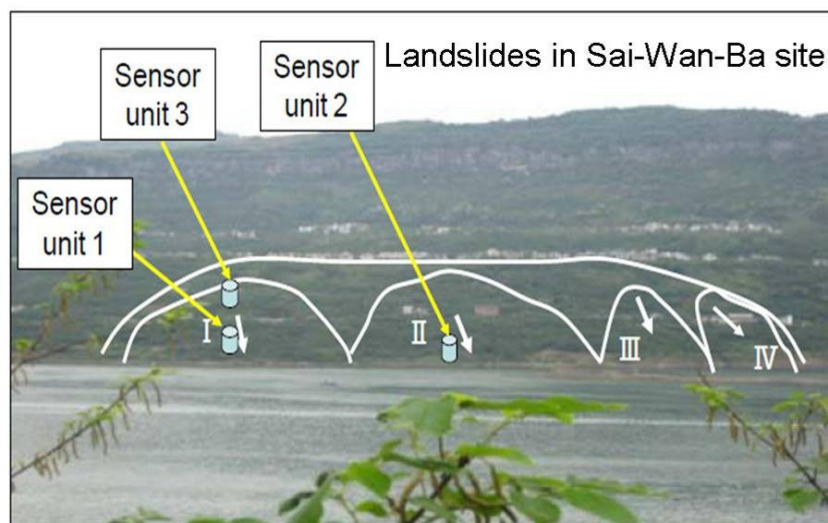
The Three Gorge Dam in China produced a huge reservoir and the rising of the water level caused slope instabilities along the lake. The proposed tilting sensors were installed at one of such sites (Fig. 16). The slope had been distorted already upon the installation.

Fig. 16 Validation site at Three Gorge Dam Reservoir in China.

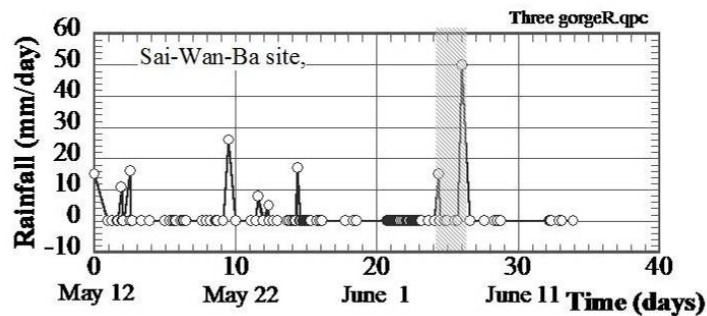
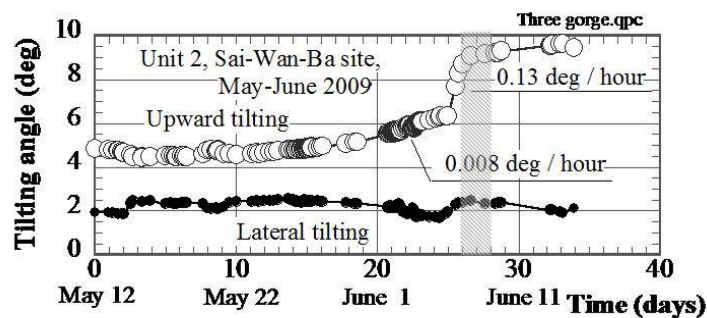
One of the monitored slopes failed on June 7th and 8th, 2009, during rain (Fig. 17). Fig. 18 shows the monitored records of tilting angles and precipitation. It is seen that the final failure (large angle) was preceded by minor rate of ground distortion. By comparing the recorded rate of tilting with the current proposal of threshold rates of tilting;

it is found that these warning thresholds are consistent with the records. However, it is thought that the threshold for the first caution is still subject to discussion.

Fig. 18 Monitored records at the Three Gorge Dam Reservoir.

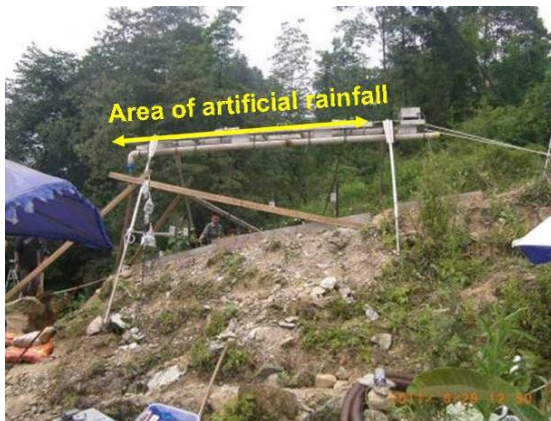
An artificial rainfall test was conducted in Sichuan Province of China in June 2011 in collaboration with the Chengdu Institute of Mountain Hazards and Environment. Fig. 19 illustrates the ongoing artificial rainfall, and finally an excavated trench face fell down (Fig. 20). The obtained record in Fig. 21 demonstrates that the rate of tilting angle is consistent with the proposed threshold as mentioned above.

Fig. 19 Artificial rainfall on slope in Sichuan Province, China.

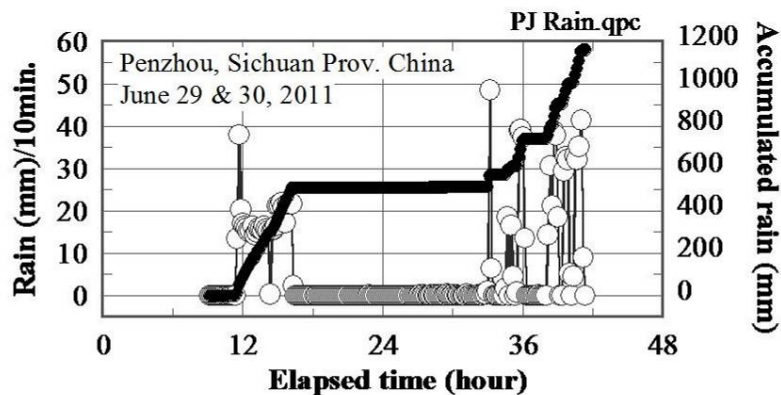
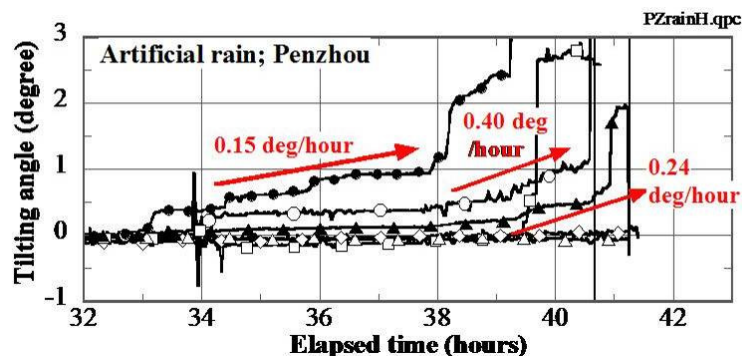
Fig. 21 Monitored records during artificial rainfall.

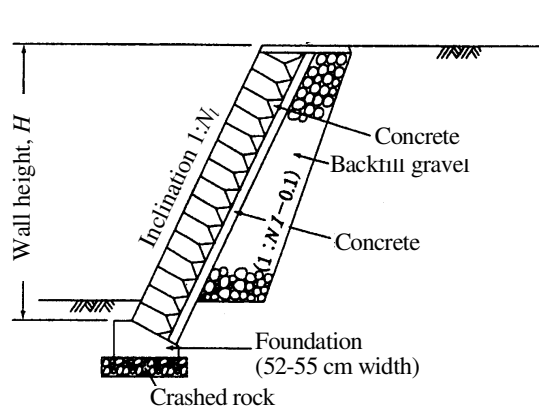
An attempt was made to interpret the seismic stability of road embankments resting on sloping ground with retaining walls (Fig. 23). For pseudostatic calculation of stability, appropriate values of seismic coefficient were assessed by using an empirical correlation with the JMA scale of seismic intensity. The bearing capacity of a retaining wall was determined simply on the basis of cone penetration tests. As a consequence, Fig. 24 illustrates that the extent of damage is well correlated with the factor of safety greater than or less than unity. Thus, the use of seismic factor of safety with a CPT correlation of soil strength and pseudostatic seismic action is meaningful in evaluation of damage extent in the concerned type of structures.

Fig. 23 Standard cross section of masonry retaining wall.

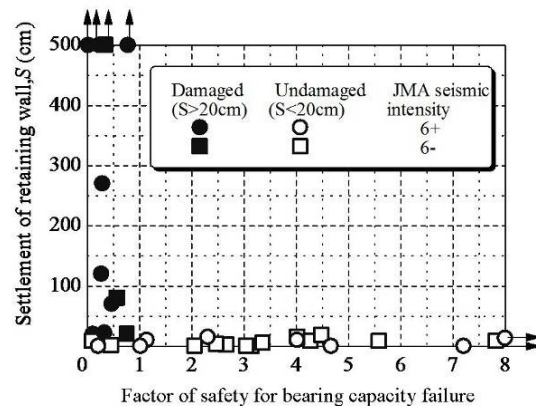
Fig. 24 Relationship between settlement of retaining wall and factor of safety.

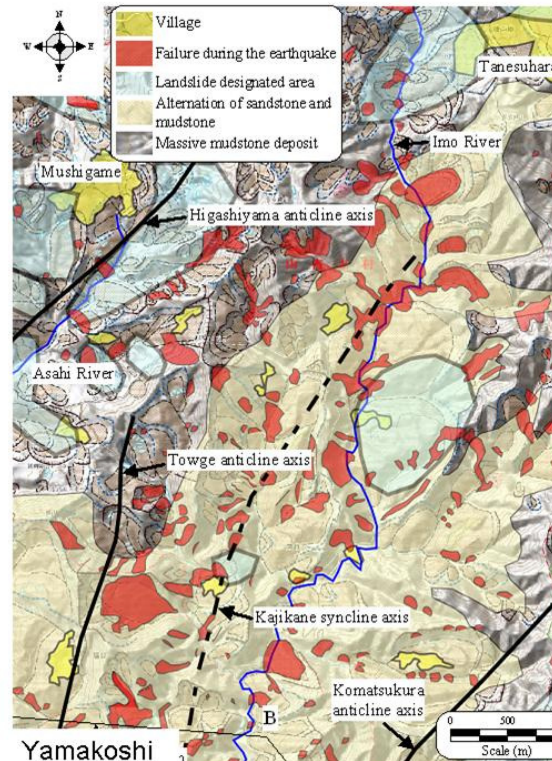
Figure 25 illustrates a geological map of the severely damaged area during the Chuetsu Earthquake. More than 3,000 slope failures occurred during the earthquake. Although there had been many landslide-prone areas in the massive mudstone area, most slope failures during the earthquake occurred in the sandstone-dominated area despite that there had been only a small number of the landslide-designated slope therein.

Fig. 25 Slope failures during the Chuetsu Earthquake on simplified geological map.

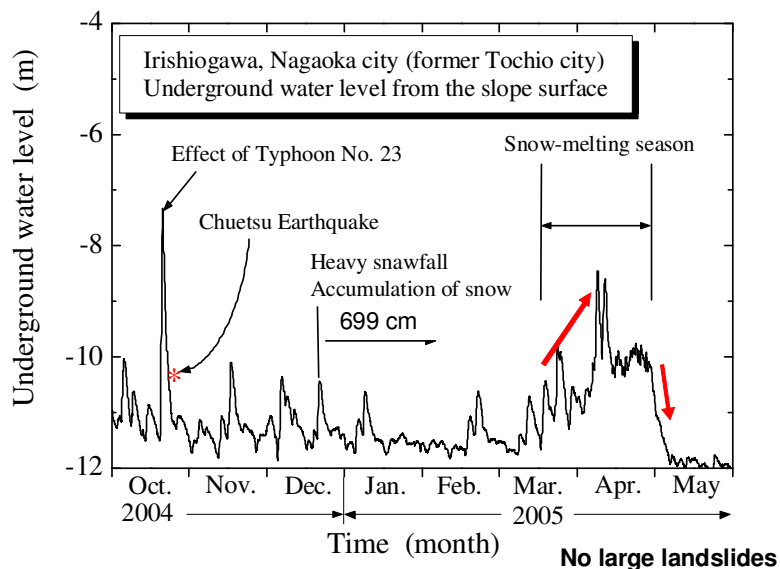
Figure 26 shows the general behavior of ground water level in the concerned area. Ground water level was high at the time of the Chuetsu earthquake because of the typhoon rain a few days before. In general, groundwater level rises during the snow-melting season and suddenly drops after snow melting in May. Hence, landslides frequently occur in April and May. However, large mass movement did not occur significantly during the snow-melting season after the quake, probably because the seismically-affected slopes became stable after the quake and the seismically-induced deformation.

Fig. 26 Ground water level measured in an old landslide area.
