TECHNICAL ARTICLE

OVERVIEW OF GEOTECHNICAL DAMAGE CAUSED BY THE 2010 CHILE EARTHQUAKE

Ramon Verdugo, Ph.D. and Principal of CMGI - Chile rverdugo@cmgi.cl

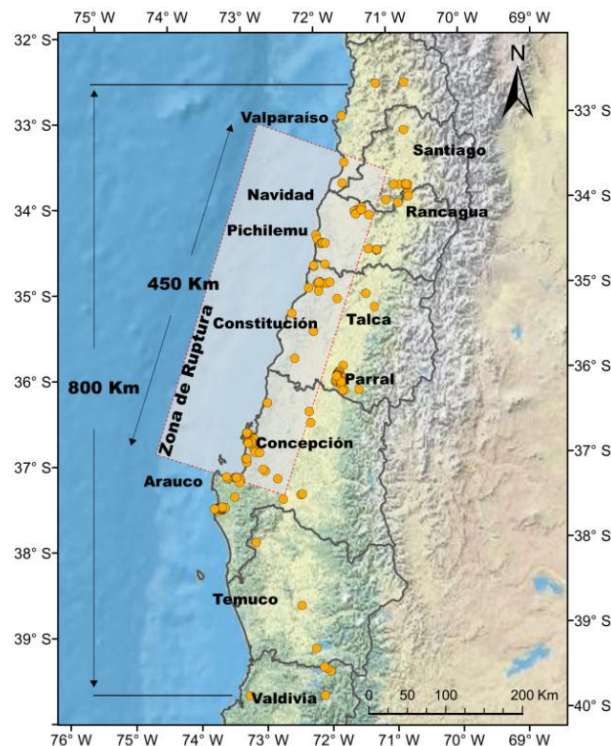
Field observations have shown that the earthquake triggered liquefaction in more than 100 different sites, whose distribution is presented in Fig. 8. The northernmost site with evidence of liquefaction corresponds to the deformation experienced by the slope of Veta del Agua tailings dam (located approximately 13 km north-east of La Calera), while the southernmost liquefied site occurred in Calafquén Lakes (located 250 km to the south of the rupture zone) and the city of Valdivia. Consequently, the area with evidence of liquefaction covers a north-south distance of about 800 km, which corresponds to an area close to twice the rupture zone.

Fig. 8.- Site where liquefaction was observed
