# Singapore Downtown Line 3 - Tunnelling Challenges in Soft Soil and under Conserved Structures

**ABSTRACT:** The opening of Downtown Line 3 (DTL3) in October 2017 marked the longest underground and driverless MRT line in Singapore. The complicated technical challenges in DTL3, especially Package A, were associated with the nature of its geological strata and construction of underground infrastructure below existing buildings and structures which were conserved by the Authority to some extent of the alignment. Due to its vertical alignment, tunnelling works in DTL3-A was carried out within the Kallang Formation which was recent deposits consisting of soft/loose soils. At some extent of the alignment, tunnelling works was significantly close to conserved shophouses which were very sensitive to induced settlements. Settlement predictions, risk assessments and mitigation measures were therefore carried out to ensure safety during TBM tunnelling. The monitoring regime and protection measures were successfully implemented with actual ground movements to be well within the design predicted movements. This paper presents some of the technical challenges in DTL3 Package A in relation to t

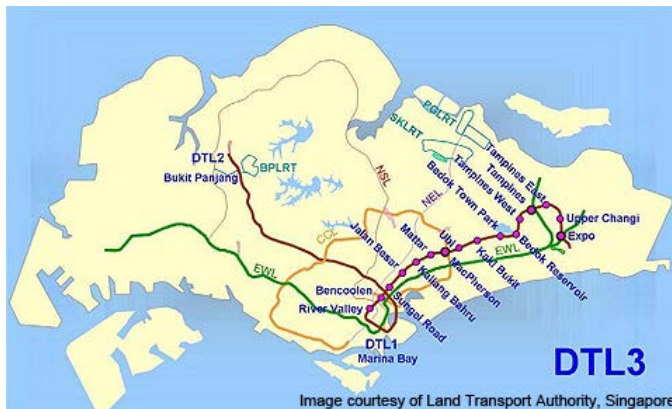
Figure 1 DTL3 alignment route

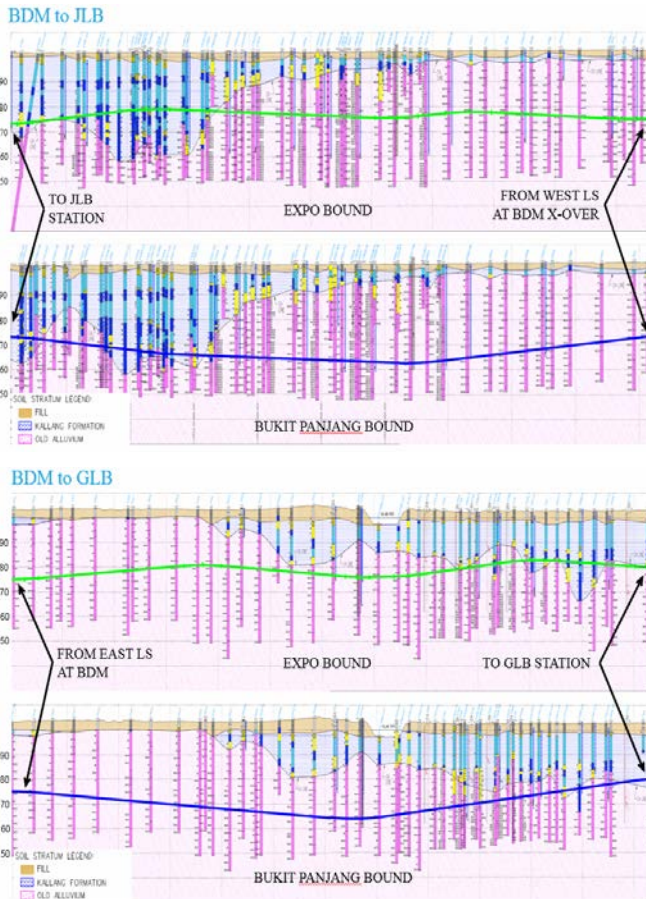
Figure 3 Geological profile along DTL3A – C933 bored tunnel

At some of the alignment extent, tunnelling works will encounter full face of Kallang Formation beneath the made ground along DTL3A, notably in Contract C933. Underlying the Kallang Formation is the Old Alluvium formation. The Kallang Formation soils itself comprise the marine clay, fluvial sand, fluvial clay and estuarine clay. Marine clays notably present at Jalan Besat and Kallang Bahru area, sandwiching the fluvial sand and/or fluvial clay layers. The existence of both upper and lower marine clays are found at Jalan Besar area.

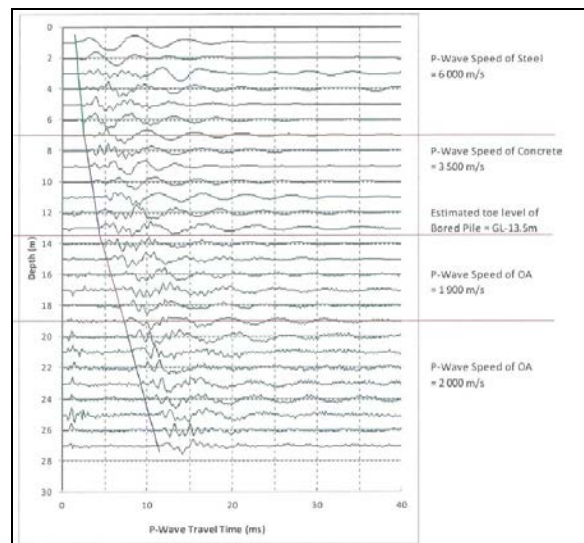
Figure 8 Seismic logging result

A typical seismic logging set-up and test result are shown in Figure 7 and Figure 8, respectively. Based on the logging test result, the toe level of bored pile was estimated at 13.5m below ground level, approximately 9 m above the tunnel.

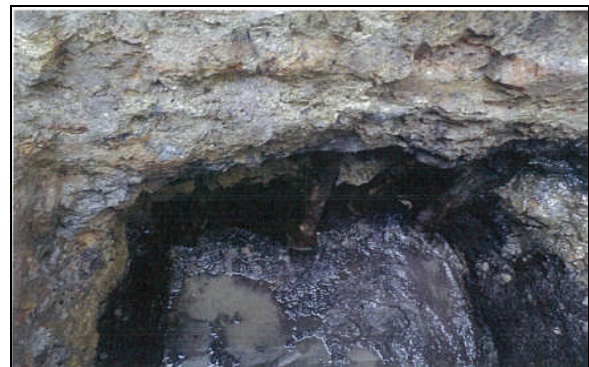
Figure 9 Trial Pit

Figure 9 shows trial pit involving a careful mining process to expose the foundation. Existence of bakau pile foundations was found confirming foundations were of shallow type and will not impede the tunnel construction.

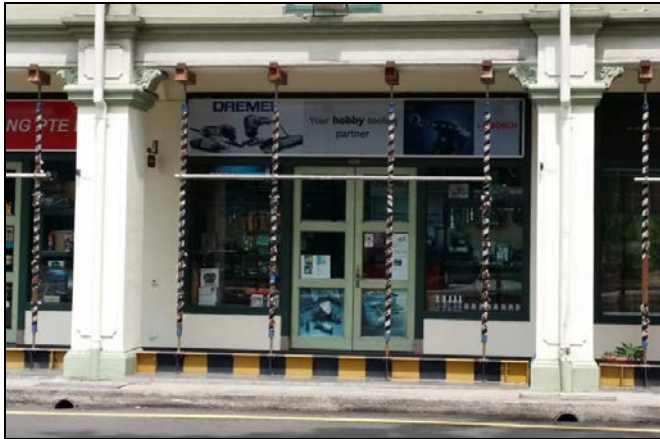
Figure 10 Typical arrangement for building protection propping

Building protection measures were installed for conserved shophouses along Jalan Besar area that did not pass the damage assessment criteria. The reason of these buildings not passing the damage assessment criteria was often due to the differential settlement between five-foot way façade and the rest of the building. The adopted strategy was then to allow the differential settlement and install adjustable props to stabilize the five-foot way façade and provide tie beams at first floor level to anchor the base of the five-foot way façade to the main building. Extensive instrumentation and monitoring regime was implemented to facilitate better observation on the affected structures. A typical arrangement for building protection propping is shown in Figure 10.

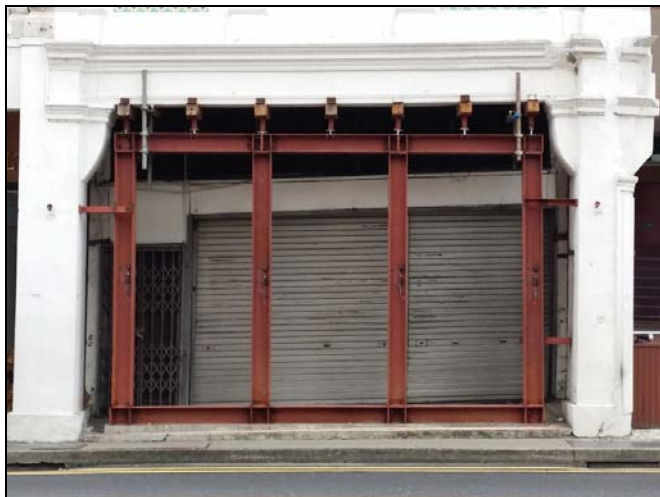
Figure 11 Typical enhanced external building protection measures

Based on visual inspection report, a number of shophouses were found to be in poor condition. The defects recorded included very large structural cracks and large areas of concrete spalling. For these particular shophouses, enhanced strengthening and protection works were installed prior to commencement of the bored tunnelling works.

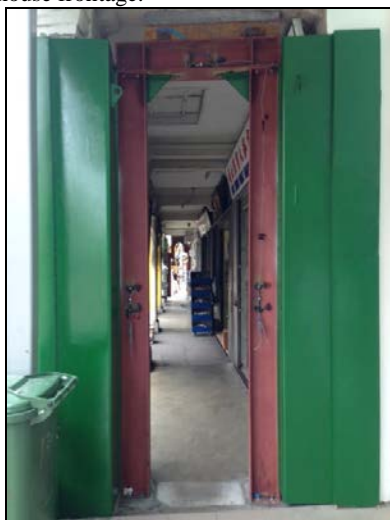
Figure 12 Five-foot way protection system

In addition to the building protection measures, temporary five-foot way propping system was installed to restrain potential differential movement of the five-foot way columns as shown in Figure 12, comprising of a steel casing wrapped around the five-foot way column joined to a steel frame that was then tied into the existing shophouse frontage.
