A Method for Identification of Pipe Failure Hotspots

ABSTRACT: This study provides a methodology that can be utilised for identifying pipe sections, which can be considered under high risk of failure. Application of the proposed methodology is demonstrated using a case study involving an in-service large (~1.7 km) critical water main in Sydney, Australia. Geospatial features from Google Earth Pro™ and Google Street View™ were used to assess and quantify typical urban environmental attributes, which can be used for identifying pipe failure hotspot locations. Failure history was used to verify the basis of the methodology developed. It was demonstrated that a sound assessment of the pipe conditions is possible through inexpensive geospatial feature analysis. This development can greatly enhance and reduce costs associated with current pipe condition assessment processes.

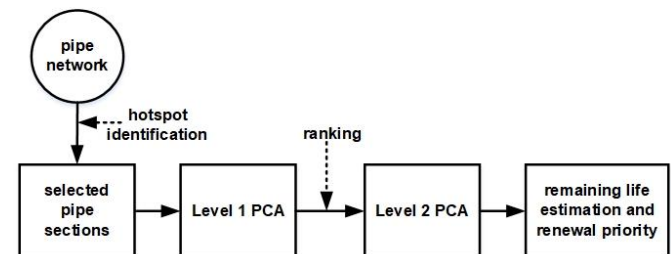
Successful identification of correct at-risk subsections at the end of the PCA process is highly dependent on the series of process steps undertaken. For illustration purpose, the complete PCA process is conceptualised in Figure 1. Note the reduction in size of the pipe network through each stage. For an efficient PCA process, the initial reduction of the pipe network to a collection of selected pipe sections for Level 1 PCA is very important. This hotspot identification can be achieved through information on failure histories or known age and protection methodologies in place for the sections. Alternatively, the cohort approach developed by Jiang *et al.*, (2017) can be utilised to identify pipes with high possibility of longitudinal fracture. In addition, it is possible to employ statistical or failure data-driven analysis at network level (*e.g.*, Li *et al.*, (2014); Lin *et al.*, (2015); Chik *et al.*, (2017) to screen pipes that require attention for hotspot determination and further Level-based analysis.

Figure 1 Pipeline condition assessment process leading to lifetime estimation and identification of priority pipes for renewal

With the systematic analysis procedure adopted in this study and the observed results, a methodology can now be specified to allow reduction of the pipe network sizes through hotspot identification as desired in Fig. 1. This methodology is presented in Figure 7 with the detailed reduction process summarised within the dashed box. For an efficient hotspot identification process, it is desirable to have failure history within the network in order to permit calibration of important parameters (e.g., critical HSD). This would allow network specific reductions to be conducted. Nevertheless, even in the absence of failure histories, a critical HSD can be adopted by gleaning through the distribution of HSD present in the dataset.

It is emphasised here that the purpose of hotspot identification is not to identify exact pipe failure locations. It is rather to identify segments within a network or a section, where potential failure is expected so that the next step involving Level 1 PCA can be strategically focussed on those locations (see Figure 1). The basis for the reduction methodology or the hotspot identification methodology is that typical urban environmental attributes such as driveways, road intersections, and trees can provide a favourable environment for pipe deterioration through stresses and corrosion. In this context, it is highlighted that some of the hotspots identified through the reduction process in Figure 6 maybe due to stress, or corrosion, or a combination of stress and corrosion, i.e., an identification of the predominant deterioration mechanism cannot be conducted within the hotspot identification methodology. Nevertheless, this is not an important requirement within this stage.

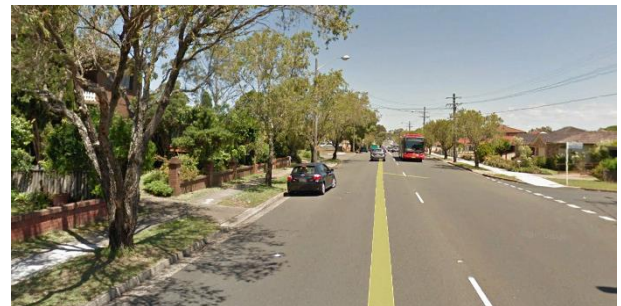
On the other hand, the total number of trees ($\sum T$) between consecutive stations were counted at the street level view using GSV as shown in Figure 2. All estimations described were conducted manually without the need for any automated image processing since the length of the SWC12 pipe section was manageable.

Figure 2 Tree counting between stations along the water main was conducted using Google Street View™

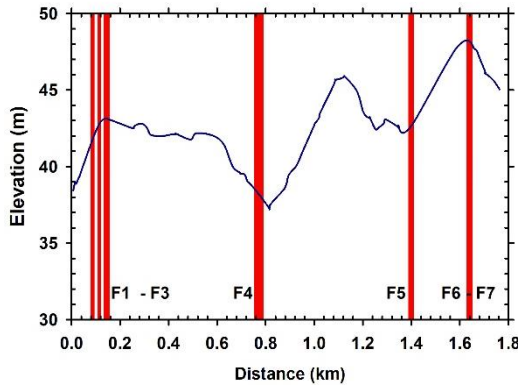
The ground elevation along the SWC12 pipe section is shown in Figure 3. Note, the pipes are assumed to be buried at a nominal depth of ~1 m below the elevation shown. The past 7 pipe approximate failure locations (red shaded regions) are also illustrated in Figure 3 and summarised in Table 2.

From the elevation profile and the failure locations, no strong conclusions can be drawn. However, it is noted that the failures generally occurred nearer to sharp changes in elevation gradients. Failures F4 and F5 occurred near to the elevation troughs along the SWC12 profile. A plausible explanation is that given the groundwater migration pathway follows the natural elevation gradients, the pipe sections at these locations will be exposed to wet soil most of the time. This can lead to a conducive environment for pipe deterioration due to corrosion. However, in the absence of any supporting data related to groundwater migration patterns in the study region, this cannot be confirmed with certainty. Other failures (F1 – F3, and F6 – F7) are

observed to have occurred nearer to the elevation crests. These failures, as well as F4 and F5, may be due to stress conditions of the pipes at such locations. Nevertheless, whether the changes in altitude gradients for a pipe's local elevation profile can constitute a potential hotspot location should be investigated further.

Figure 3 Elevation profile along the SWC12 water main. Approximate past failure locations (F1 – F7) are identified within the red shaded regions.

The hotspot density profile along the SWC12 pipe section is illustrated in Figure 4. Note that the past failure locations presented in Fig. 3 are also shown in Figure 4.

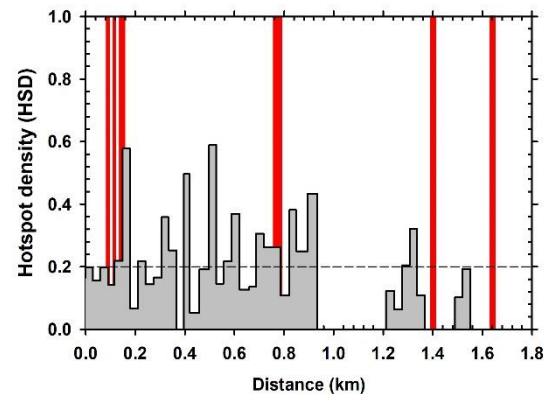
The HSD feature reveals a maximum density of 0.589 along the pipe, which is due to one of the large road intersection (17.2 m) as discussed earlier. The initial ~1 km of the pipe section is along the residential area, while the missing HSD at different locations correspond to absence of housing areas. It is emphasised here that road sections were included in this work, since they can inflict the same effect as driveways; creating artificial boundaries resulting in differential aeration and differential ground movement.

From Figure 4, it is noted that the past failures generally coincide with locations, where the HSD ≥ 0.2 , except for failures F5, F6, and F7. This HSD limit is adopted after a careful examination of the failures at F1, F2, and F3. In the absence of accurate failure locations, the approximated locations suggest that the HSD = 0.2 can be adopted as a limiting value. Additionally, the nearby failures, F1, F2, F3, are seen to have occurred near one of the highest HSD (~0.578) along the profile. These observations lend credibility to the notion that pipes traversing underneath covered regions such as driveways and road intersections can be vulnerable to failures. Hence, segments of the pipe section with a critical HSD ≥ 0.2 should be immediately considered as hotspot locations. Under this criterion ~660 m of the section (39%) can be considered as hotspots, corresponding to a 61% reduction in the SWC12 pipe section based solely on the HSD analysis.

Figure 4 Hotspot density profile along the SWC12 pipe section suggests some association with past failure locations as discussed in the paper

The tree count profile along the SWC12 pipe section is shown in Figure 5. For clarity purposes, the past failure locations are also identified as in Figure 4. Along the pipe, a background count of $\sum T = 1$ amongst stations is noted. Deviations from this ($\sum T > 1$) are seen to generally coincide with the approximated past failure locations (e.g., F2, F3, and F4). A notable feature observed during the GSV analysis was that some segments of the pipe sections ran alongside empty fields with large tree coverage. These trees were not incorporated into $\sum T$ since they were farther away from the pipe alignment. However, their sizes suggested that tree root intrusion towards to the pipe was highly possible. The length over which these trees were seen are also identified in Figure 5 as G1 and G2. Interestingly, it is seen that the failure F5 corresponds to location to near one of the dense tree coverage (G2) length.

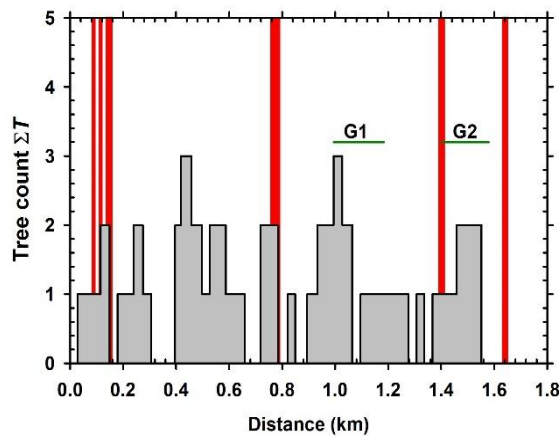
Given the failure locations (F2 through to F5) reasonably fall near areas of high tree counts and dense tree coverage, these features can be classified as hotspot locations. The length of SWC12 for which $\sum T > 1$ is ~460 m. Similar to the results of HSD analysis, the entire SWC12 pipe section can be reduced by ~73% as hotspot sections based solely on the tree count analysis. However, this interpretation needs to be taken with a level of caution. The analysis here did not account for the tree sizes, which can severely impact their influence on buried pipes. Consequently, locations at which the $\sum T = 1$ can still constitute hotspot locations and their influence will need to be assessed through their actual sizes. Although such quantification can be achieved through real field surveys, automated image analysis from GSV can also be an option for virtual surveys. In this regard, it is noted that automated processing of urban tree features is possible (e.g., Branson *et al.*, (2018)). However, this is beyond the scope of the work conducted in this paper and should be investigated in future work.

Figure 5 Tree count profile along the SWC12 pipe section with previously identified failure locations. Note G1 and G2 represent dense tree coverage along the indicated length

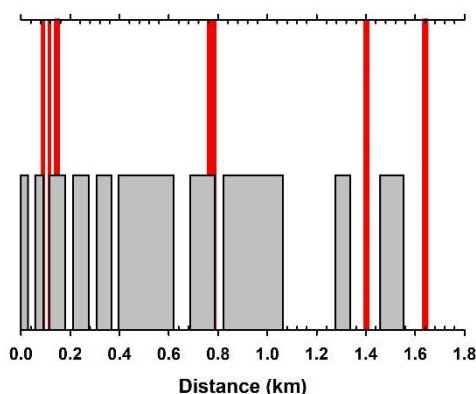
The combined hotspot sections from the HSD and ΣT analyses ascertained for the SWC12 water main are illustrated in Figure 6. It is noted that 57% (4/7) of the past failures to date have occurred within the hotspot sections. From the combined hotspot sections, it is seen that the entire water main can be reduced by 41% for further Level-based analysis. It is important to deliberate on the absence of any recorded failures at the other combined hotspot sections, especially where large HSD and (or) ΣT were observed in isolated assessments from Figures 4 and 5. There are two possible circumstances to explain such absences. Firstly, these hotspot sections maybe coming to immediate failure conditions and consequently failures at these locations can be expected within a few years. Secondly, the actual soil conditions at these locations may not be corrosive or relatively reactive enough to lead to coupled stress and corrosion induced failures. It shall be noted that there are several influencing factors that can cause failures and the present work is exclusively based on the perspective from typical urban features. If other hotspot identification methodologies (e.g., soil sampling and analysis) are integrated with the method advocated in this work, then it is possible to either further reduce (or perhaps increase) the hotspot sections. Such an effort can should be investigated in future studies.

Figure 6 Hotspot sections from the combined analysis of the driveways, road intersections, and tree features along the SWC12 water main compares well with past failures

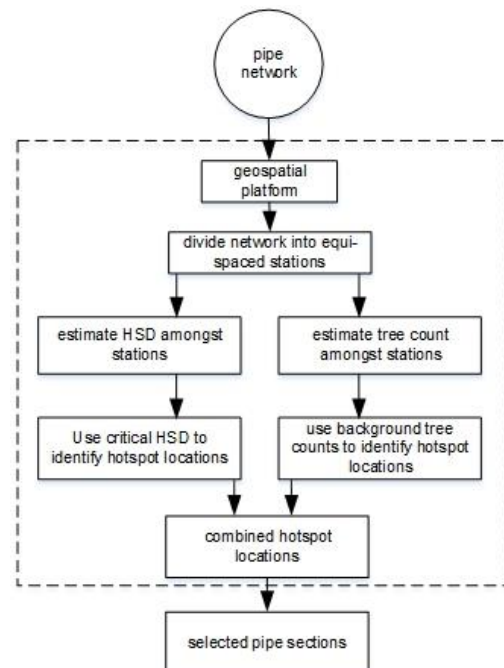
Figure 7 Proposed methodology for reducing pipe network to selected pipe sections through hotspot identification. The series of procedures enveloped within the dashed box can be utilised for size reduction.
