# Geophysics Case Studies: Road & Embankment Collapses

**Prof. Bob Whiteley**  
**Senior Principal**

## Case studies

- **Road settlement over tunnel – SUBS**
- **Embankments- MASW testing**
- **Embankment testing- Seismic imaging**
- **Soil conditions over Sewer – SEWREEL imaging**

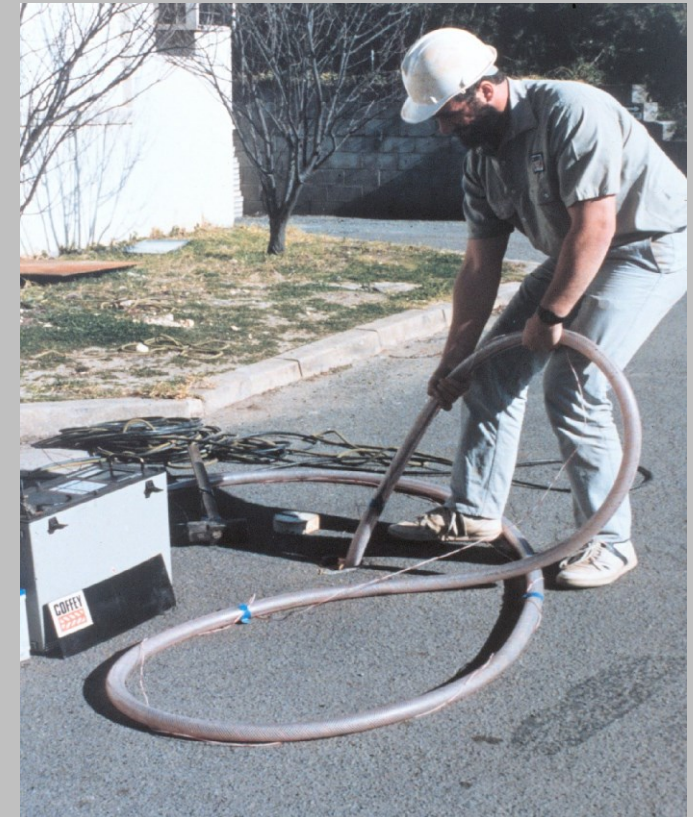
# Site Uniformity Borehole Seismic (SUBS) Testing

borehole

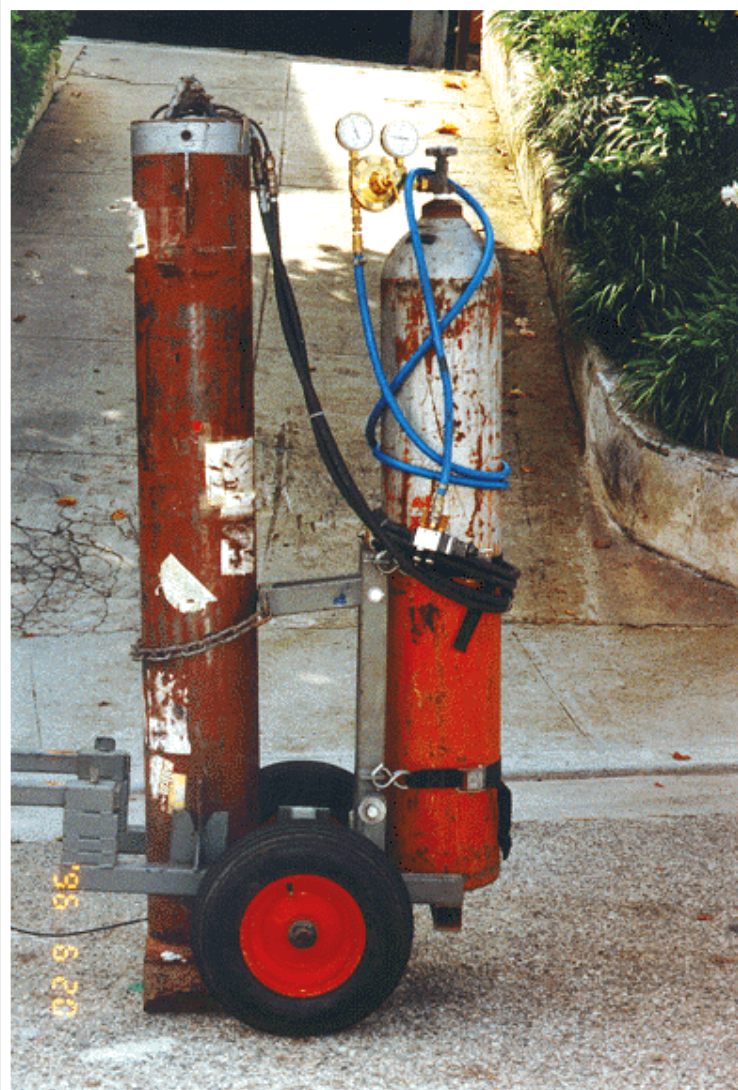
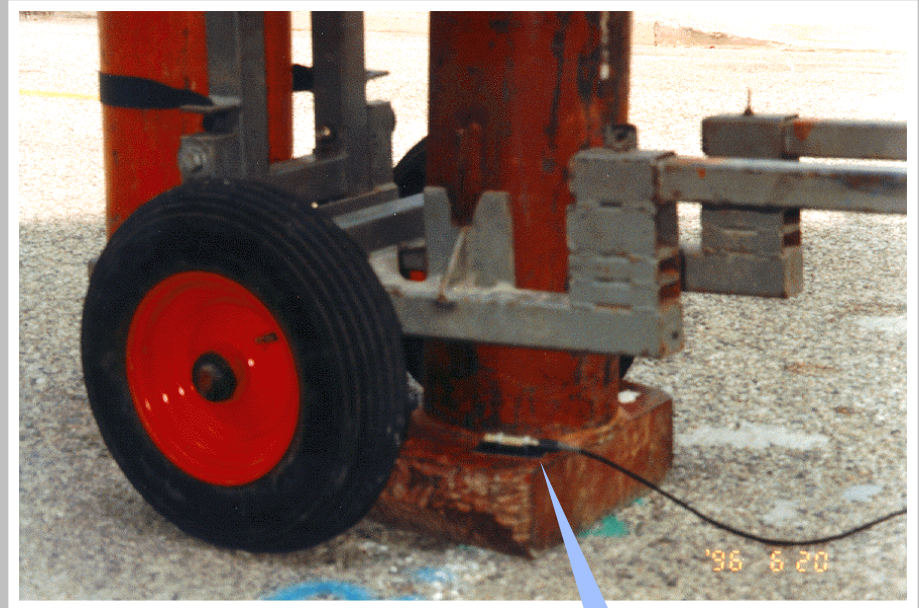
# Energy Device: The Hiss Hammer

**Seismograph  
Trigger**

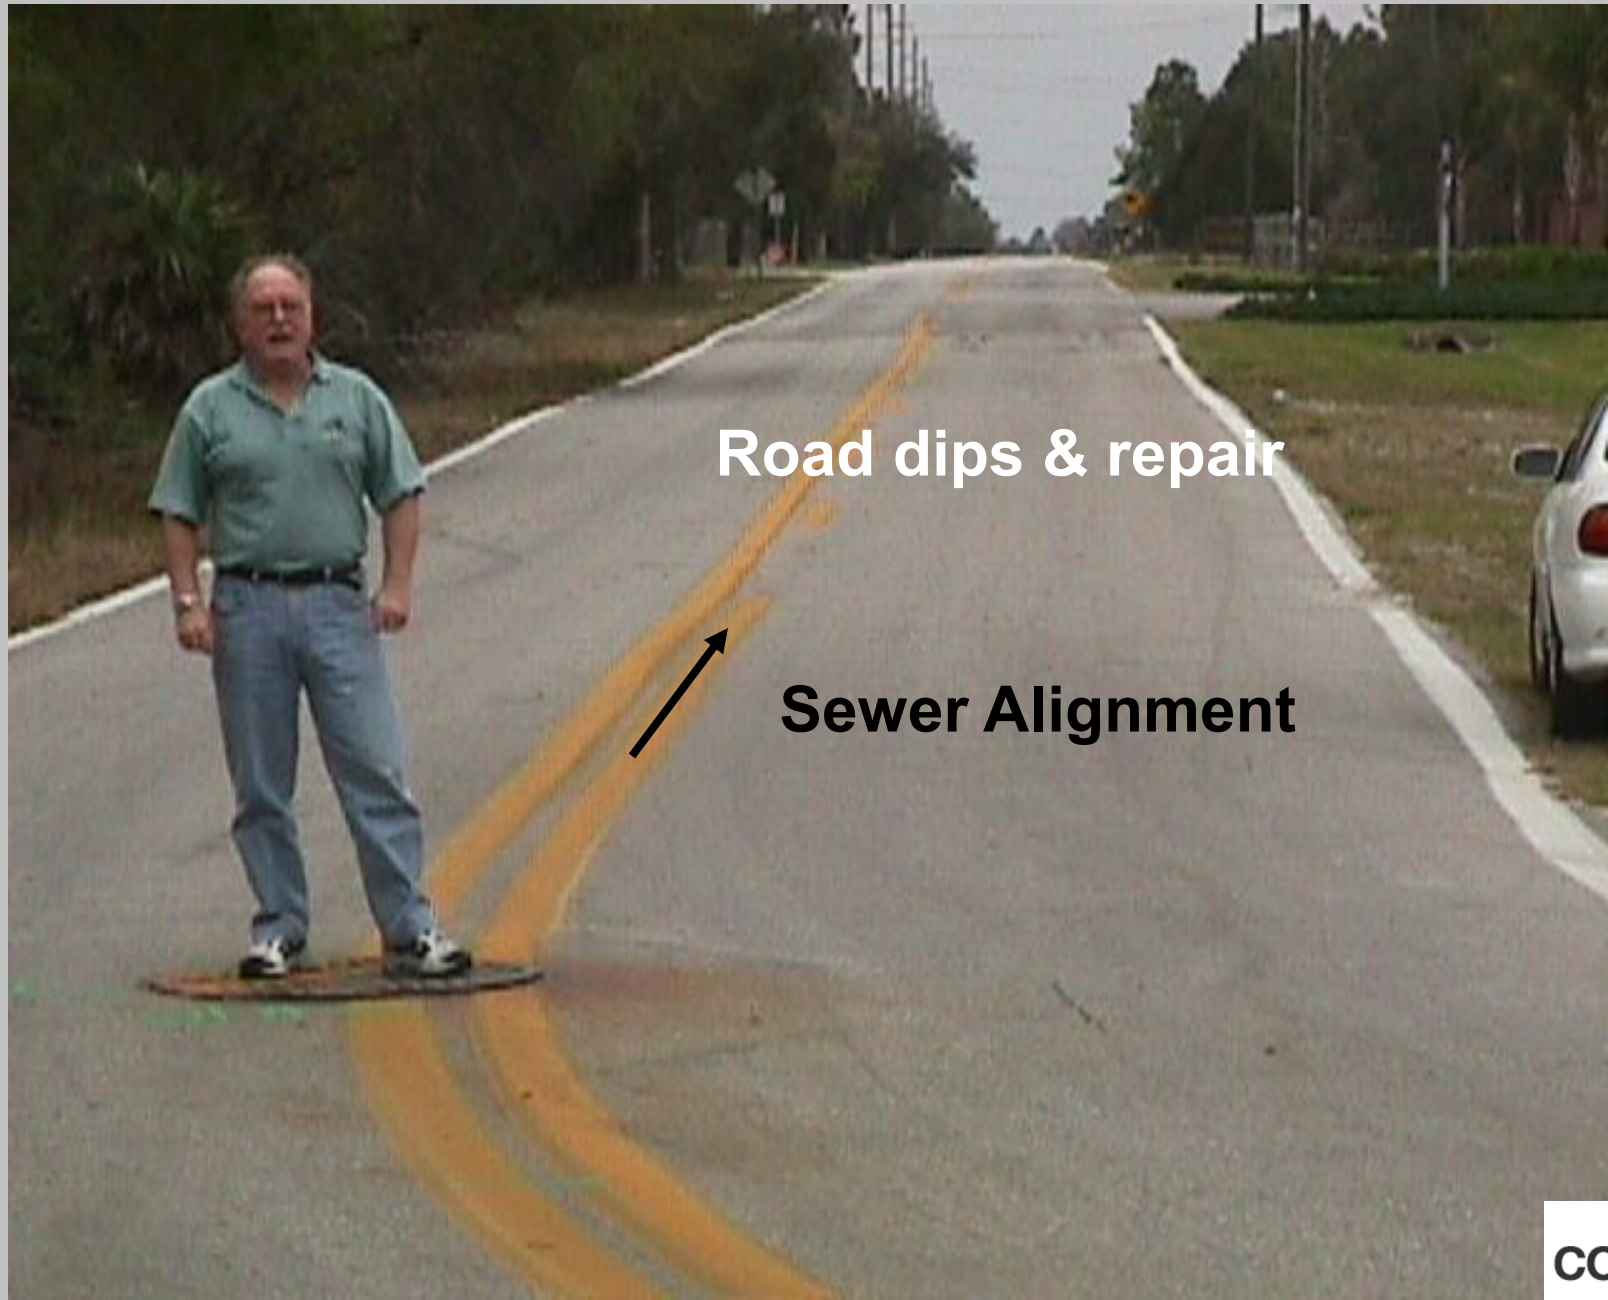
# Orlando -Site Conditions

**Road dips & repair**

**Sewer Alignment**
