ENGINEERING GEOLOGY & GEOTECHNICAL MODELS

# ENGINEERING GEOLOGY

## Geological Models

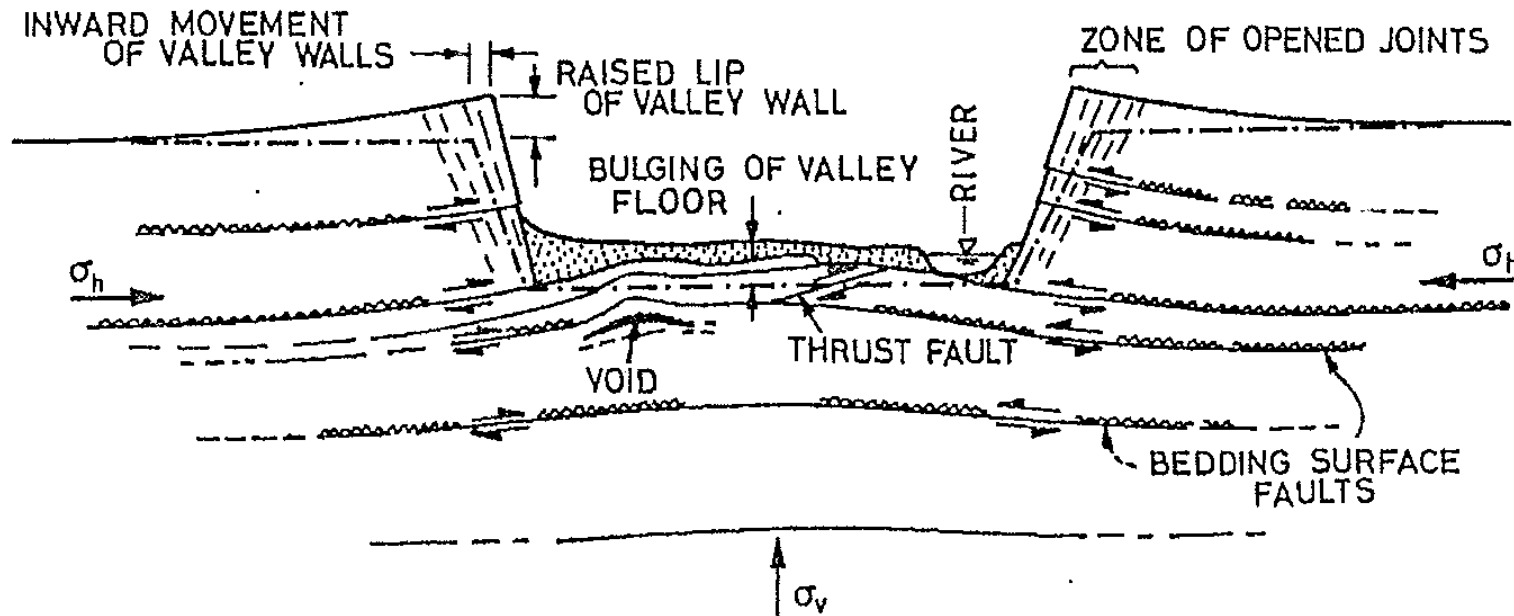
Figure 3.7. Complex valley structures related to stress release in weak, flat-lying rocks (based on Patton & Hendron 1972).

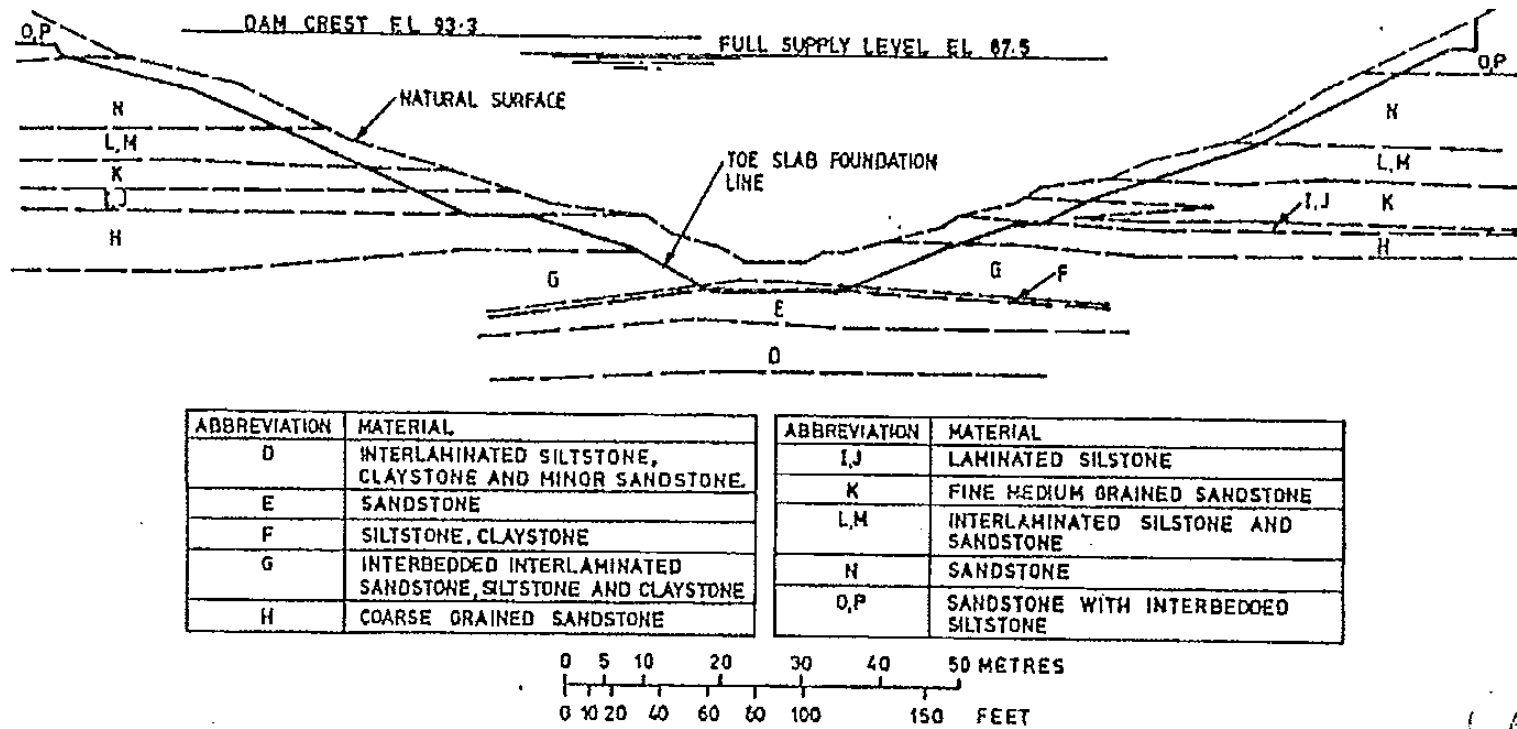
Figure 3.8. . Cross-section along the grout cap foundation at Mangrove Creek Dam. From MacKenzie & McDonald (1985).

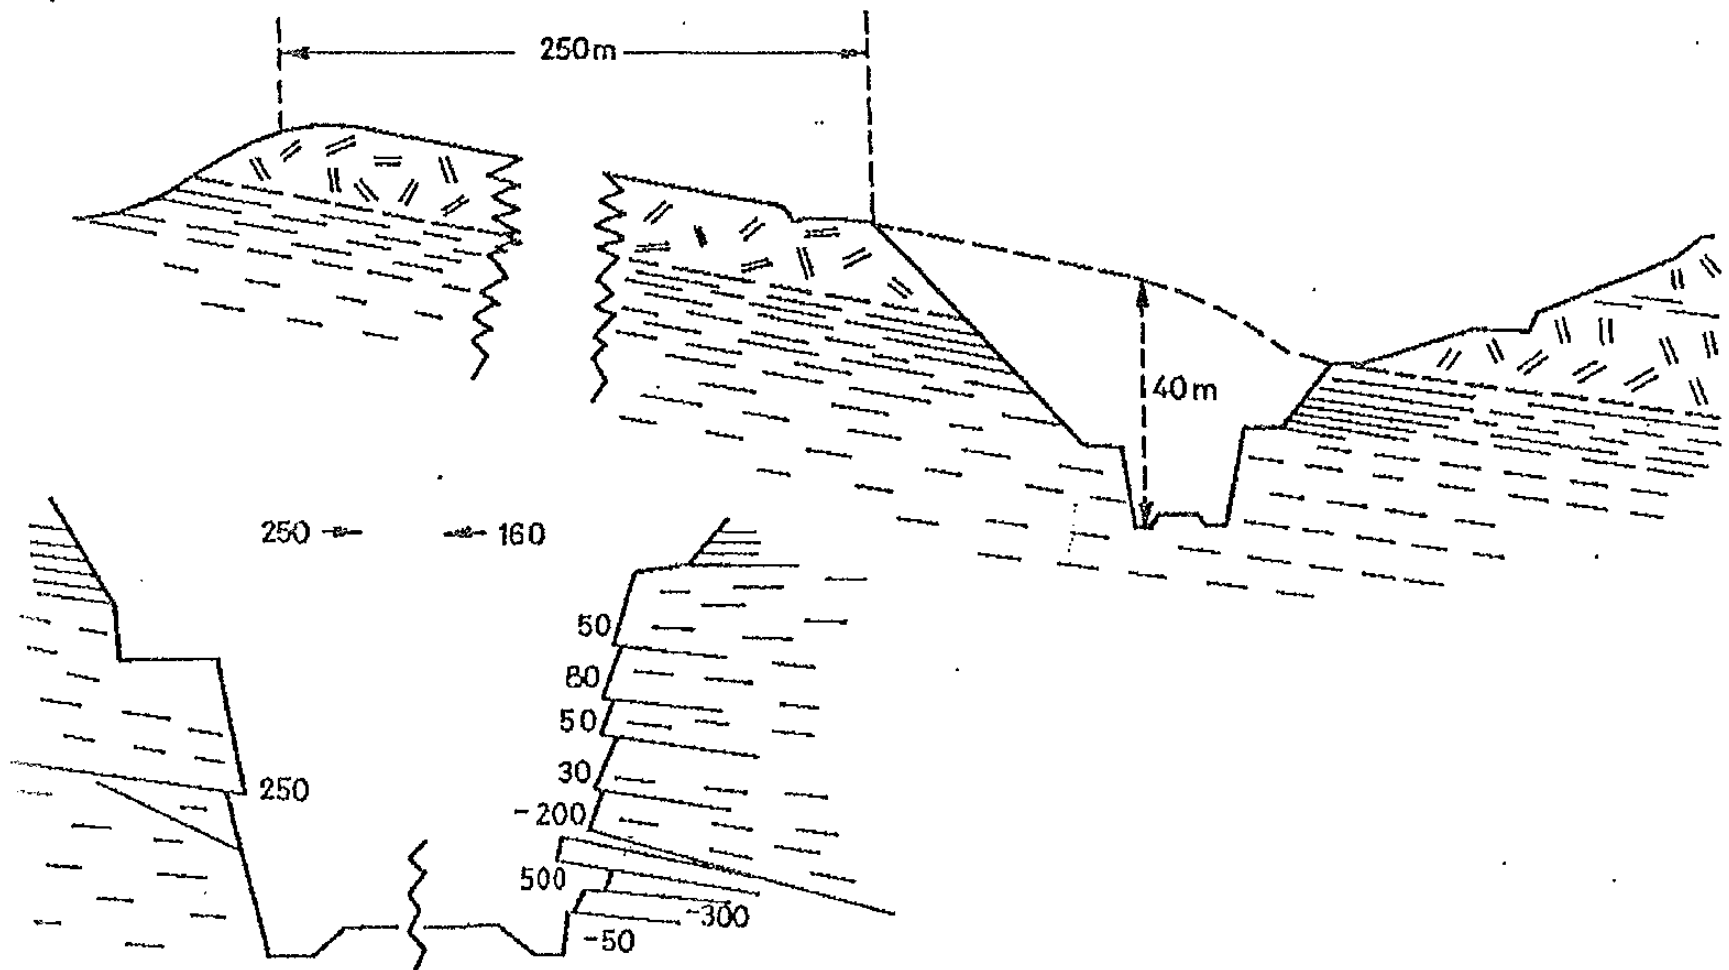
Figure 3.12. Convergence indicated by traces of presplit holes, near base of railway cutting in fresh, strong siltstone.

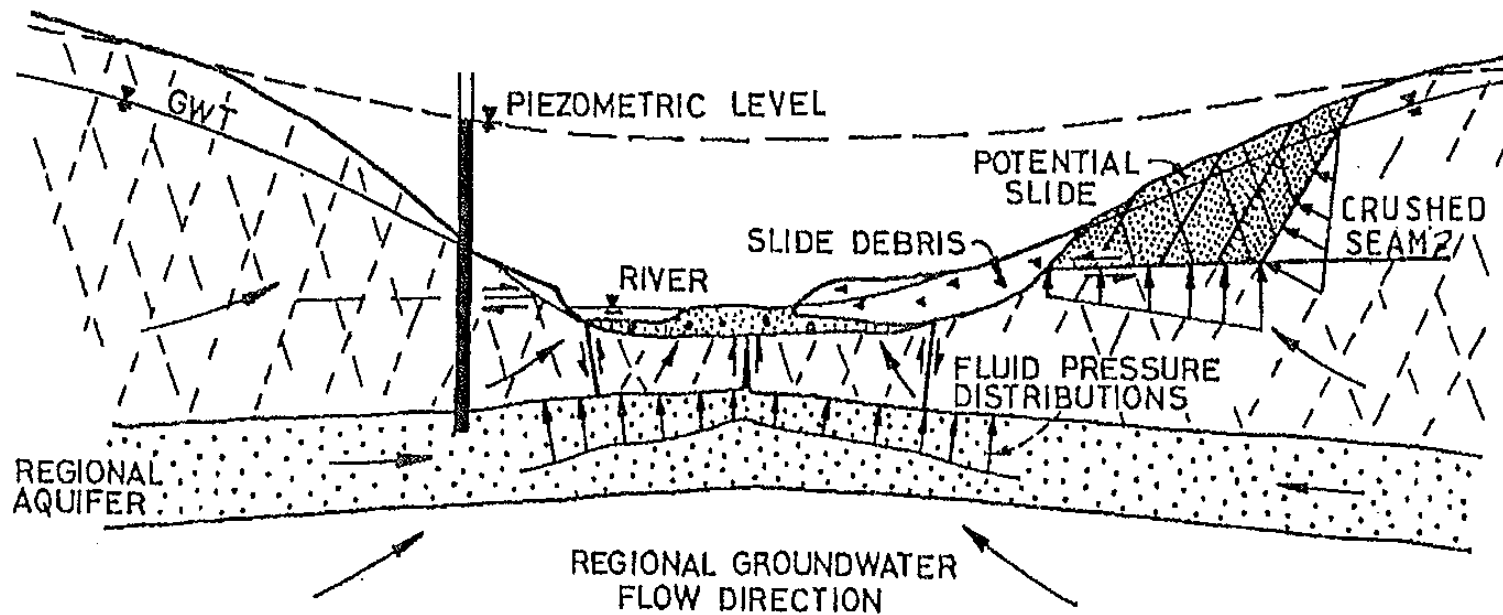
Figure 3.13. Possible effects of high fluid pressures on valleys in groundwater discharge areas (from Patton & Hendron 1972).

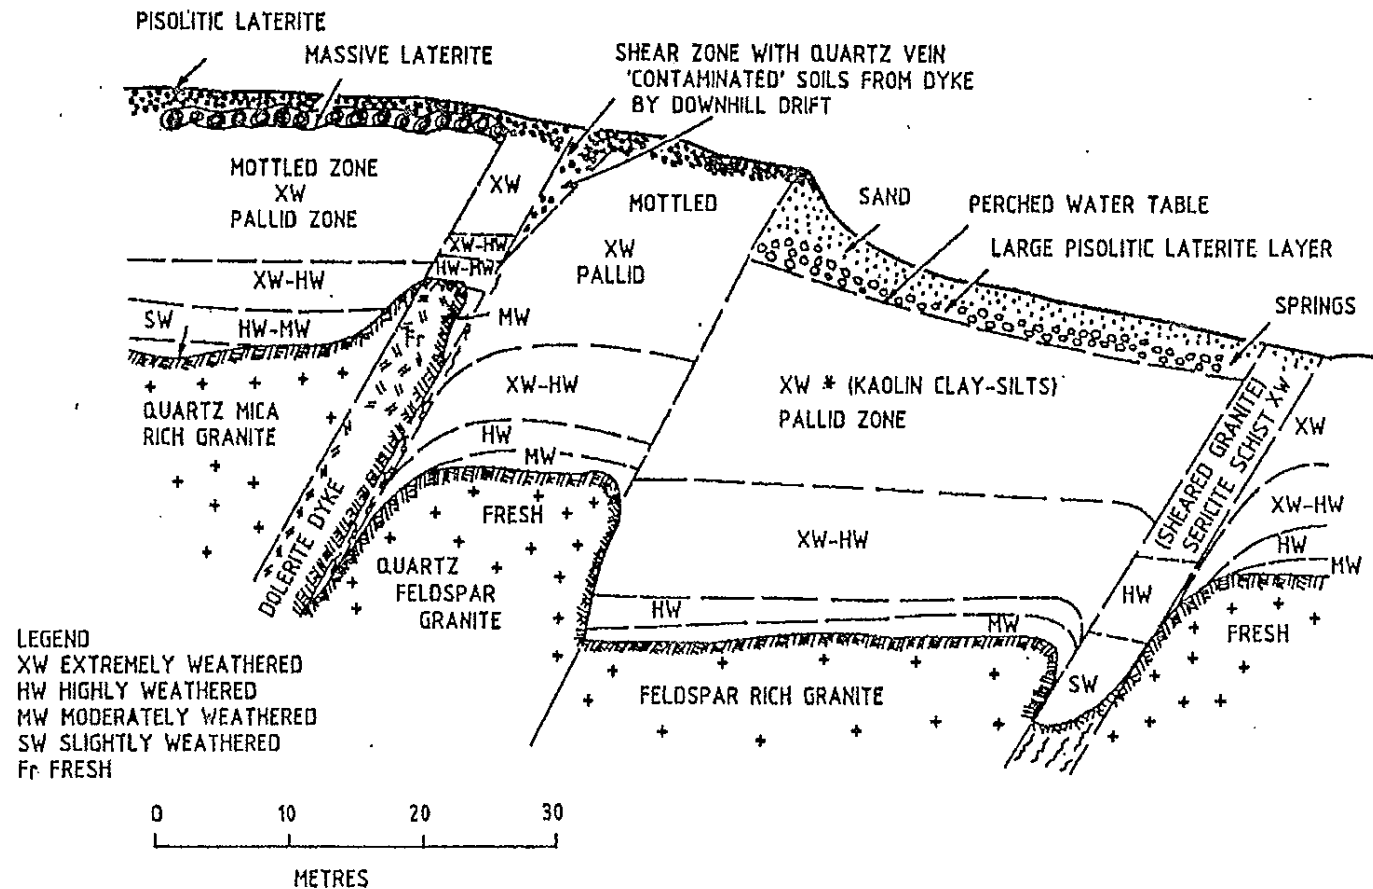
Figure 3.18. Diagrammatic cross section showing weathered profile controlled partly by rock type and partly by sheared zones, Darling Ranges, Western Australia (from Gordon 1984).

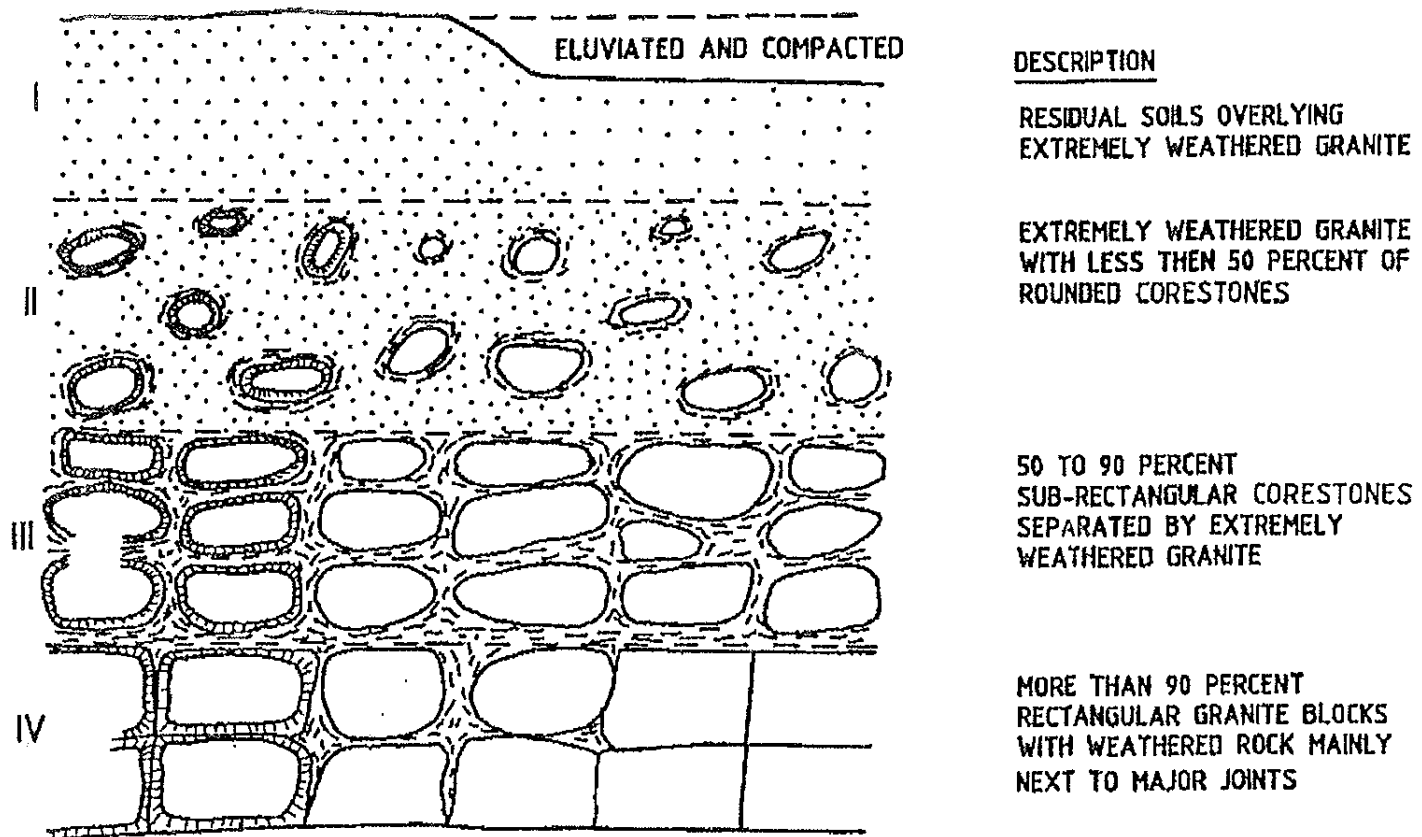
Figure 3.19. Idealised weathered profile in granitic rocks. From Ruxton & Berry (1957).

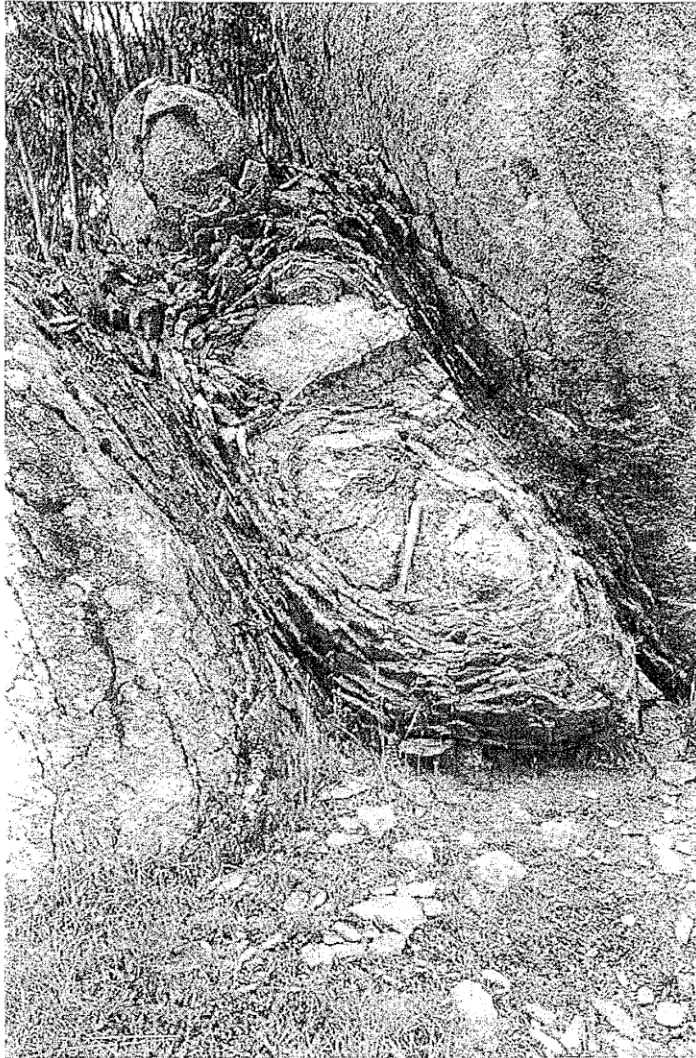
Figure 3.20. Granitic boulders or corestones showing spheroidal weathering effects. Photo courtesy of Dr. R. Twidale.

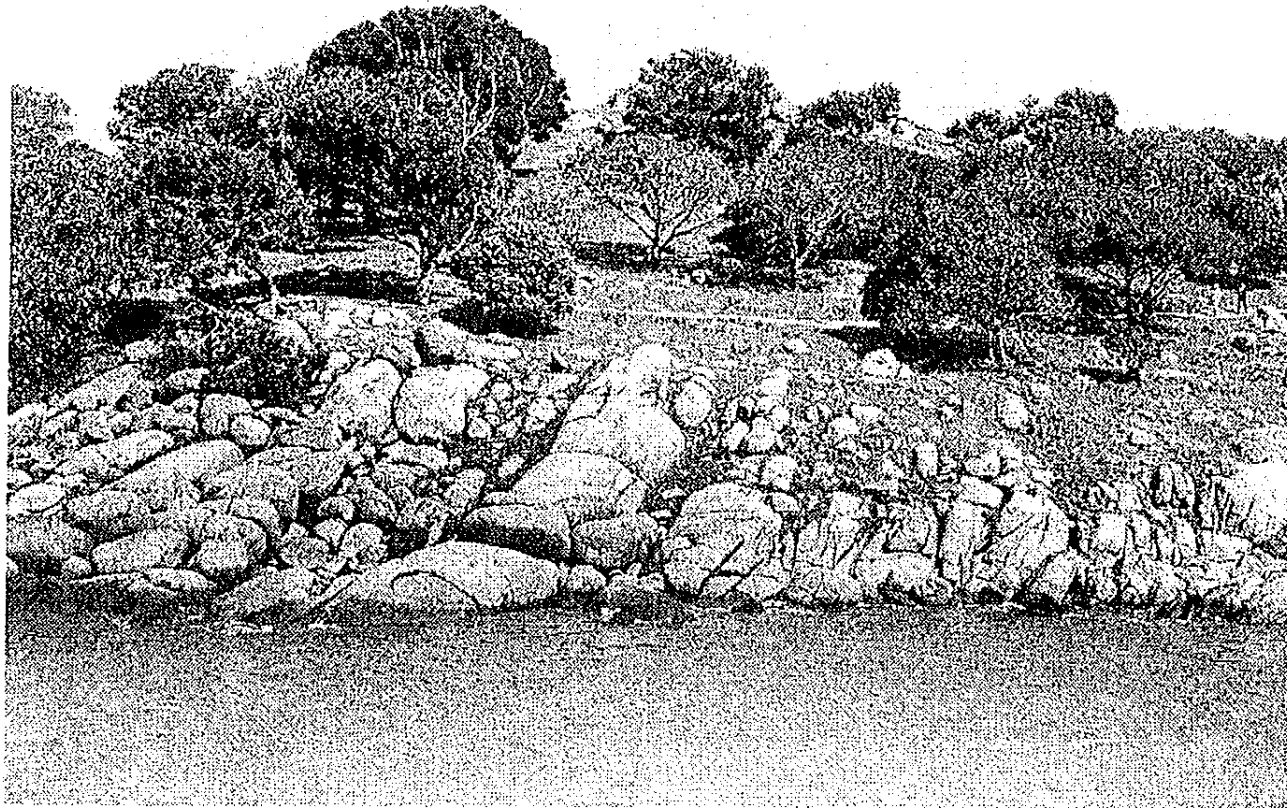
Figure 3.21. Granite corestones and outcrops below granitic soils on Granite Island, Victor Harbor, South Australia

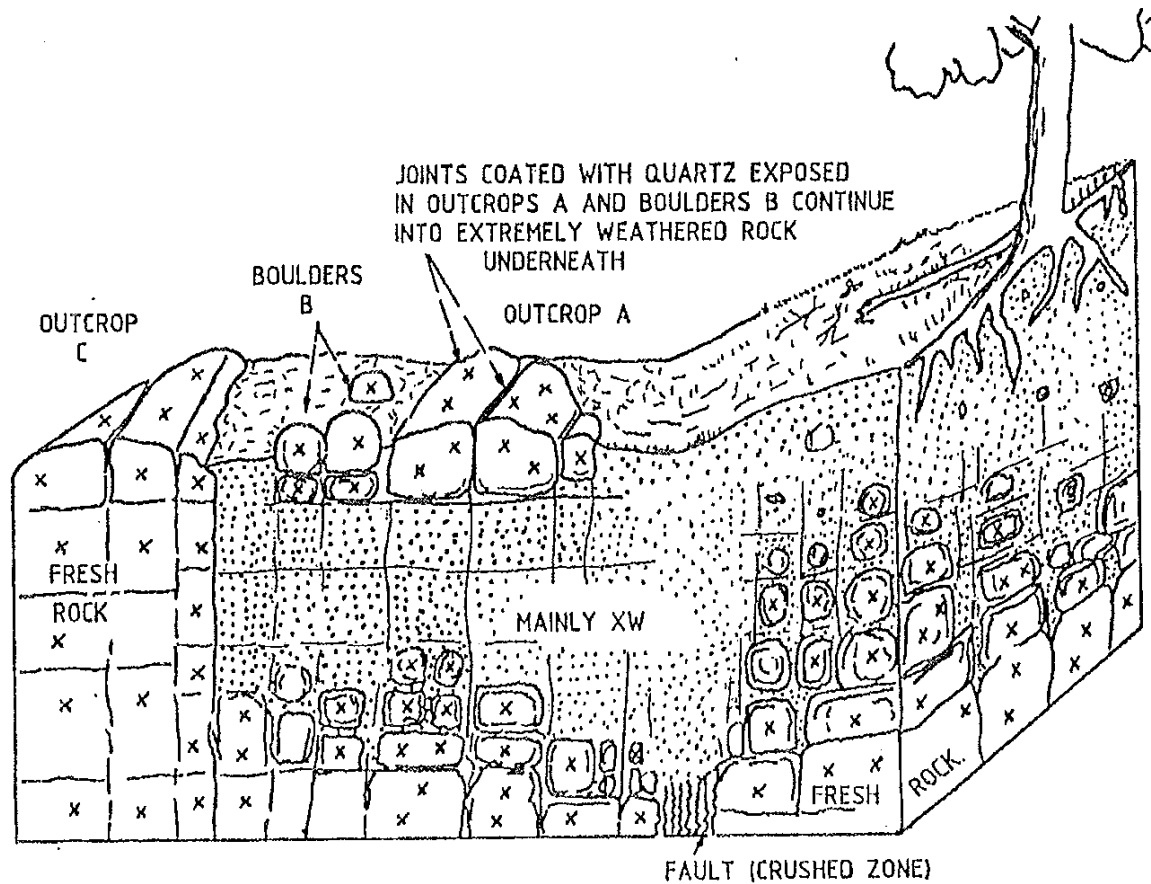
Figure 3.22. Features sometimes seen in weathered masses of granitic and other igneous rocks.

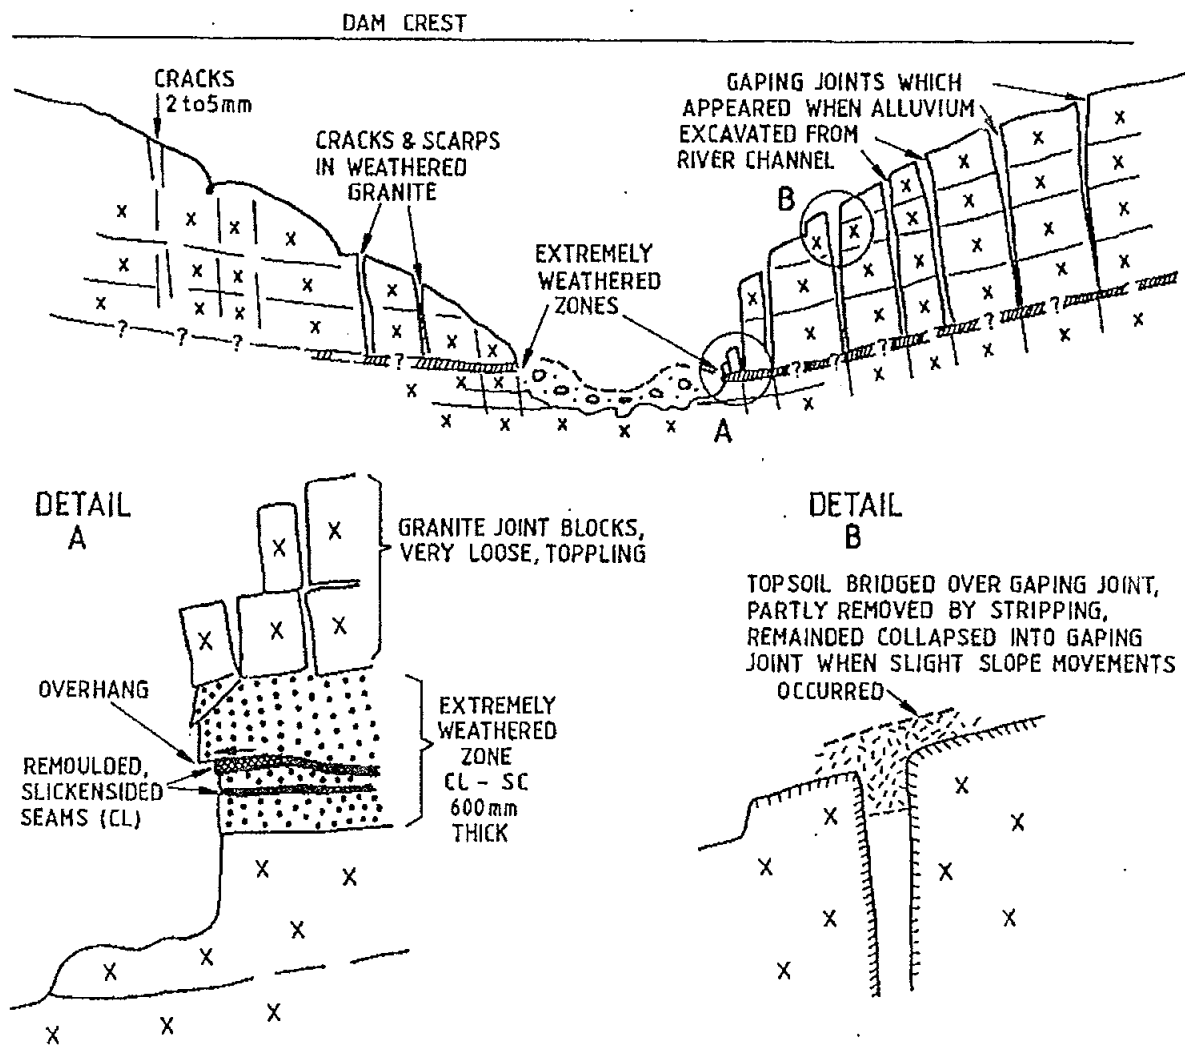
Figure 3.31. Tooma Dam, cross section and sketches through downstream shoulder.

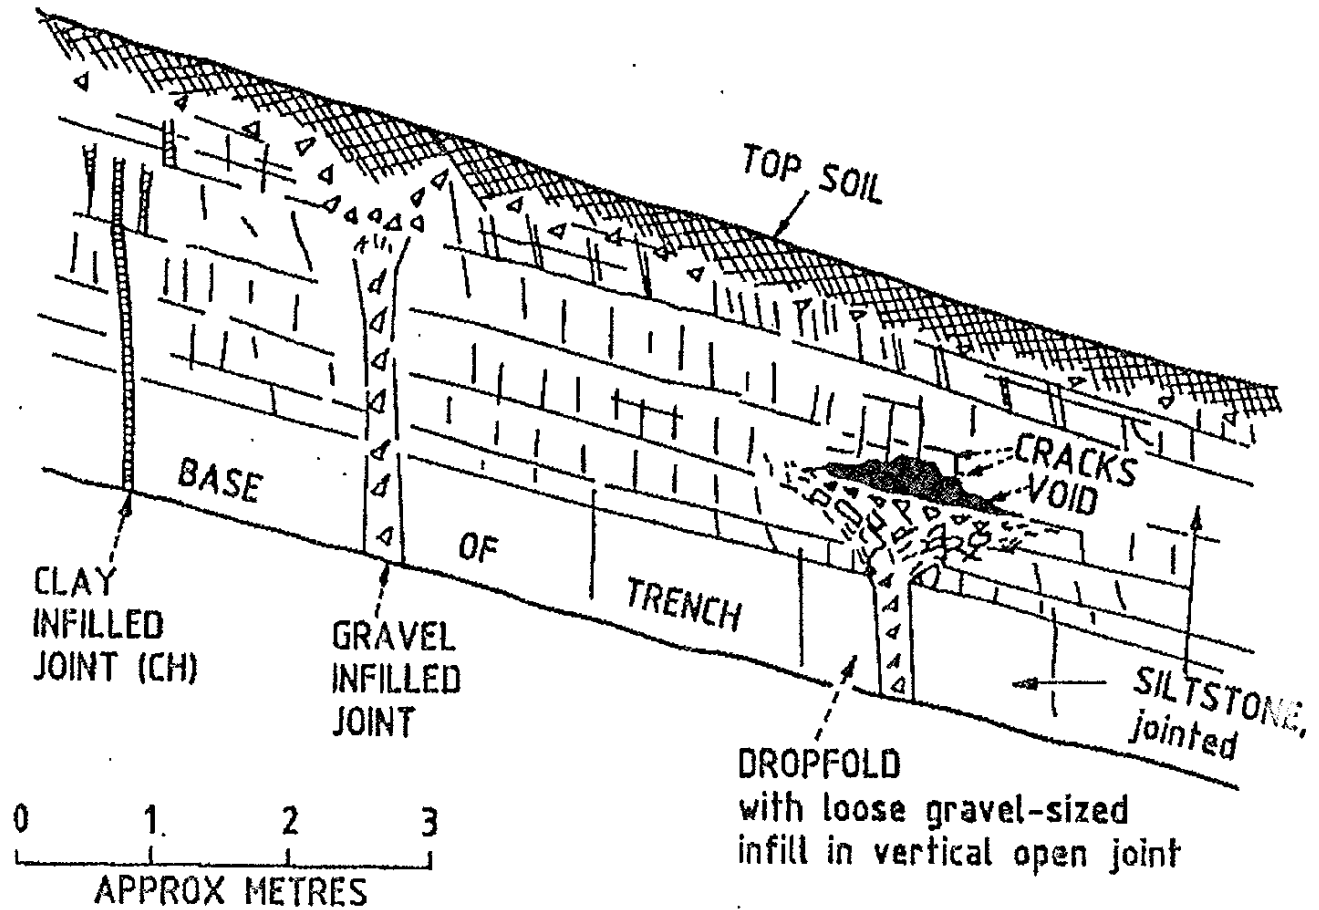
Figure 3.38. Features exposed in trenches on a left bank dipslope at Sugarloaf Dam

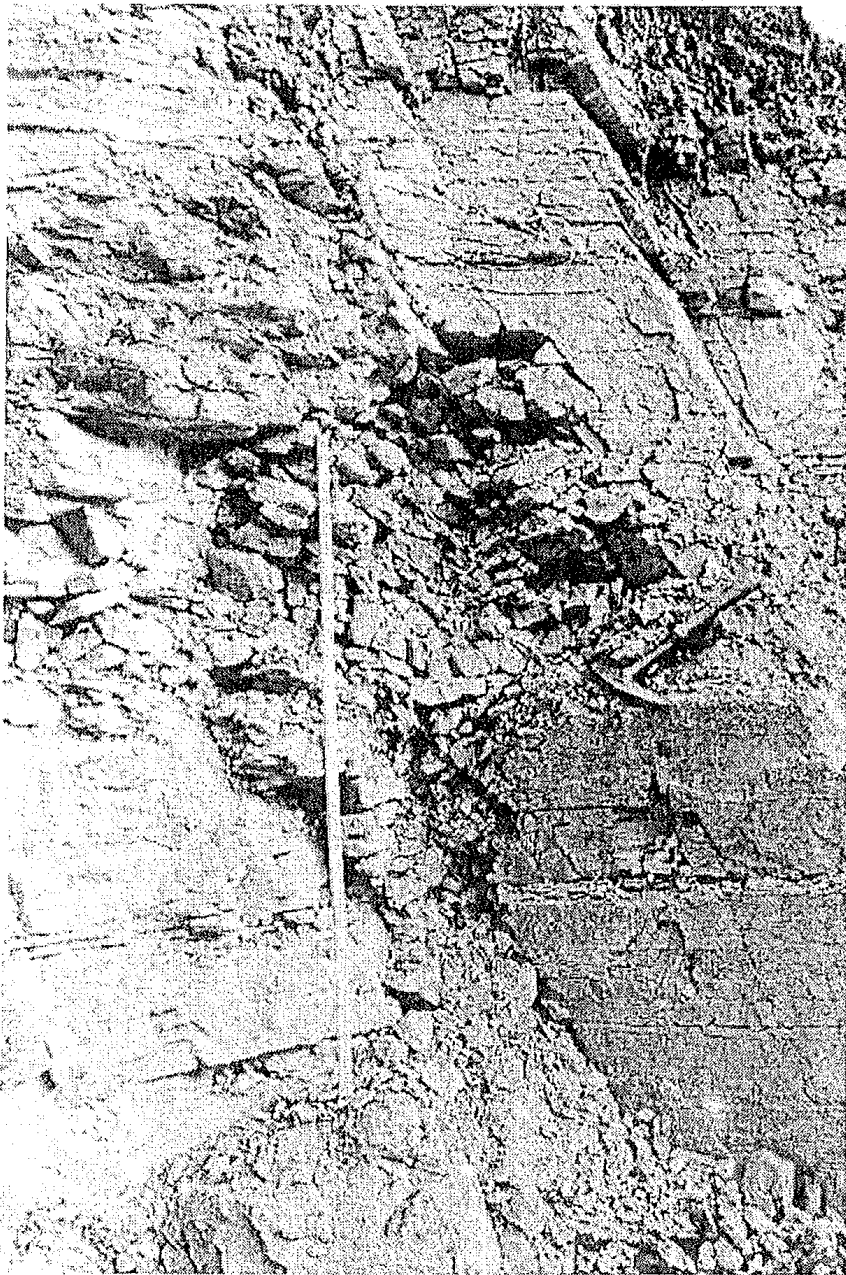
Figure 3.39. Dropfold structure exposed in trench on the left bank of Sugarloaf Dam

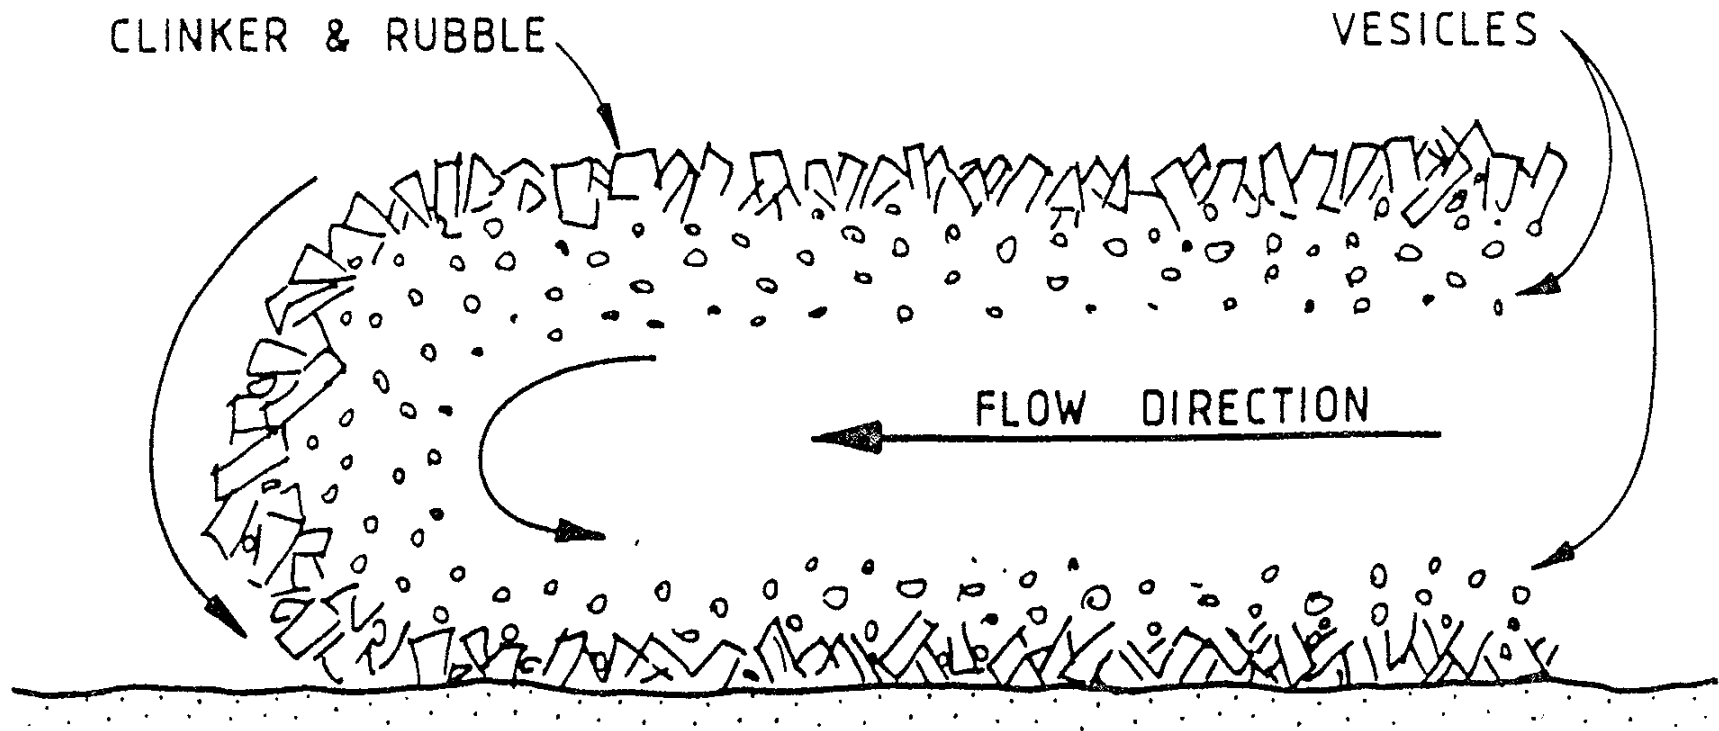
Figure 3.3. Diagrammatic longitudinal section through flowing lava showing the 'caterpillar track' mechanism which results in upper and lower layers of vesicular lava and in some cases clinker or breccia.

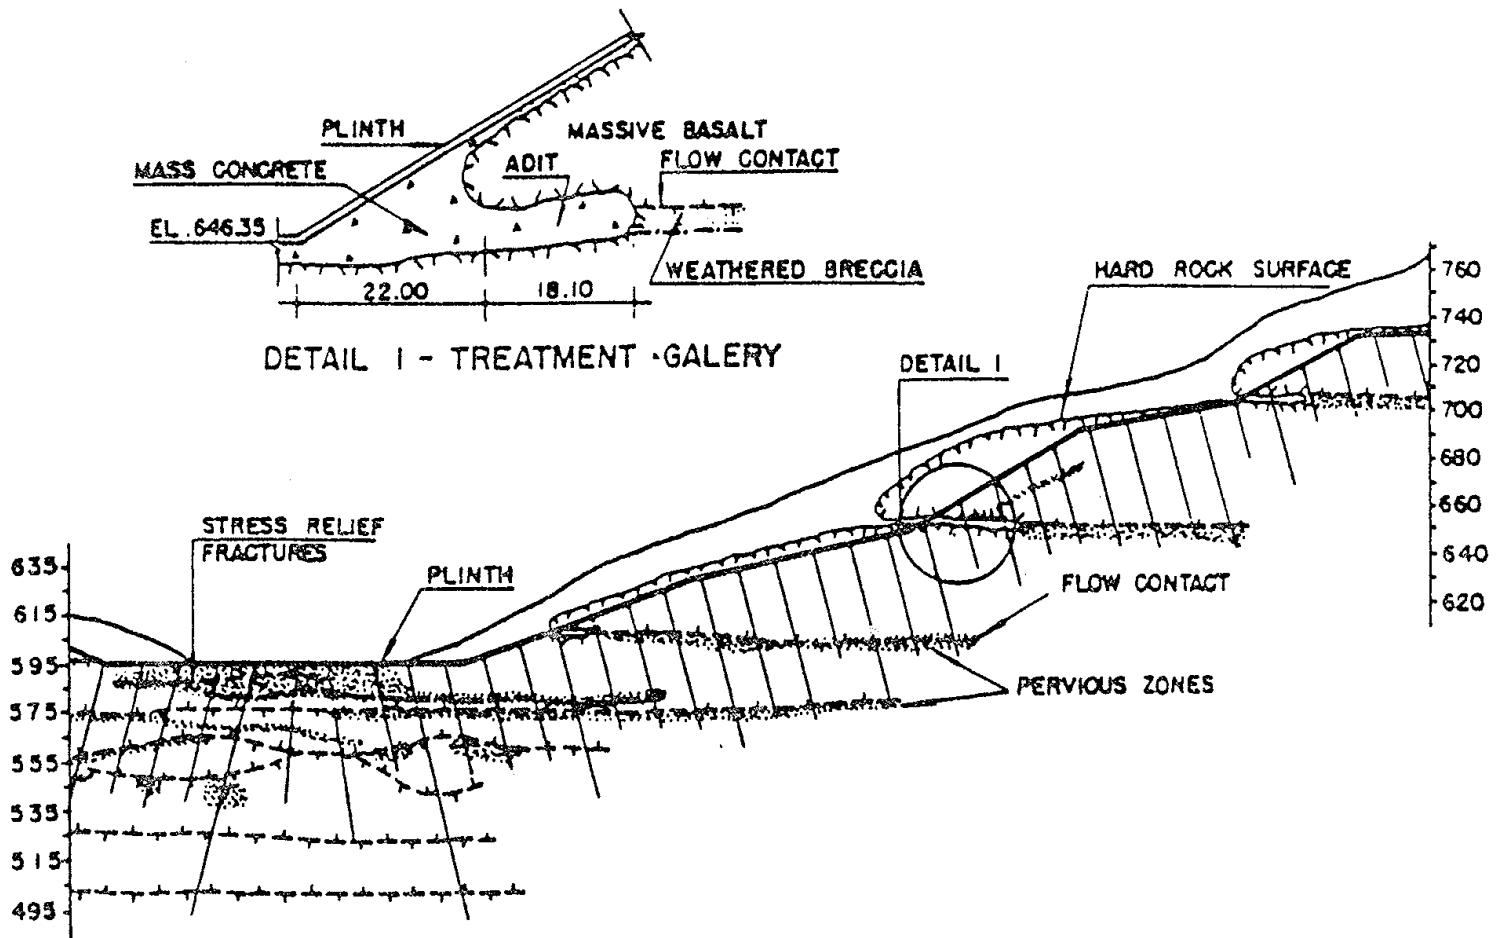
Figure 3.4. Geological section along plinth (right bank) at Foz Do Areia Dam. From Pinto et al. (1985).

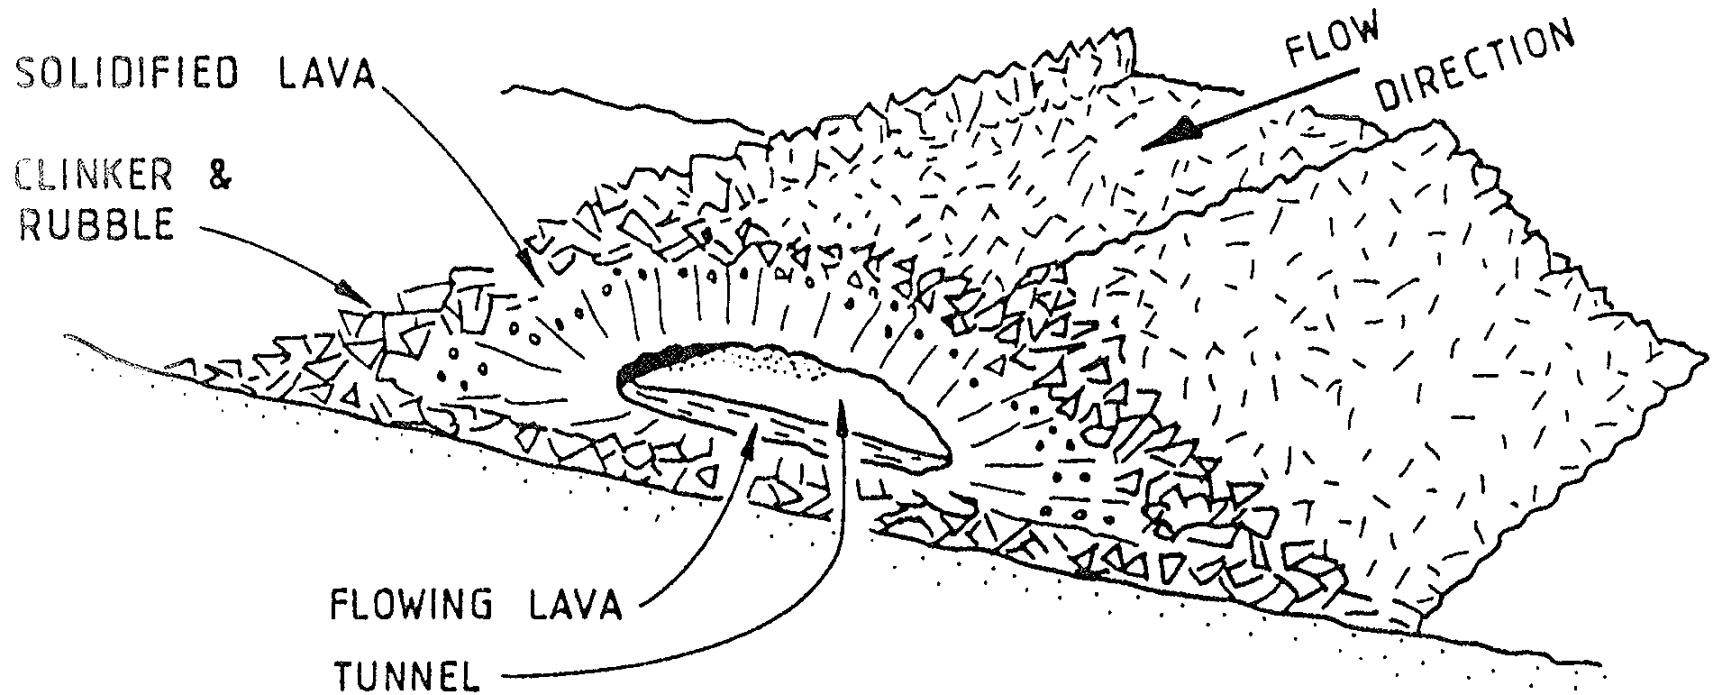
Figure 3.5. Perspective view of, and cross section through a lava flow, showing a lava tunnel developed when the lava flows forward faster than the supply.

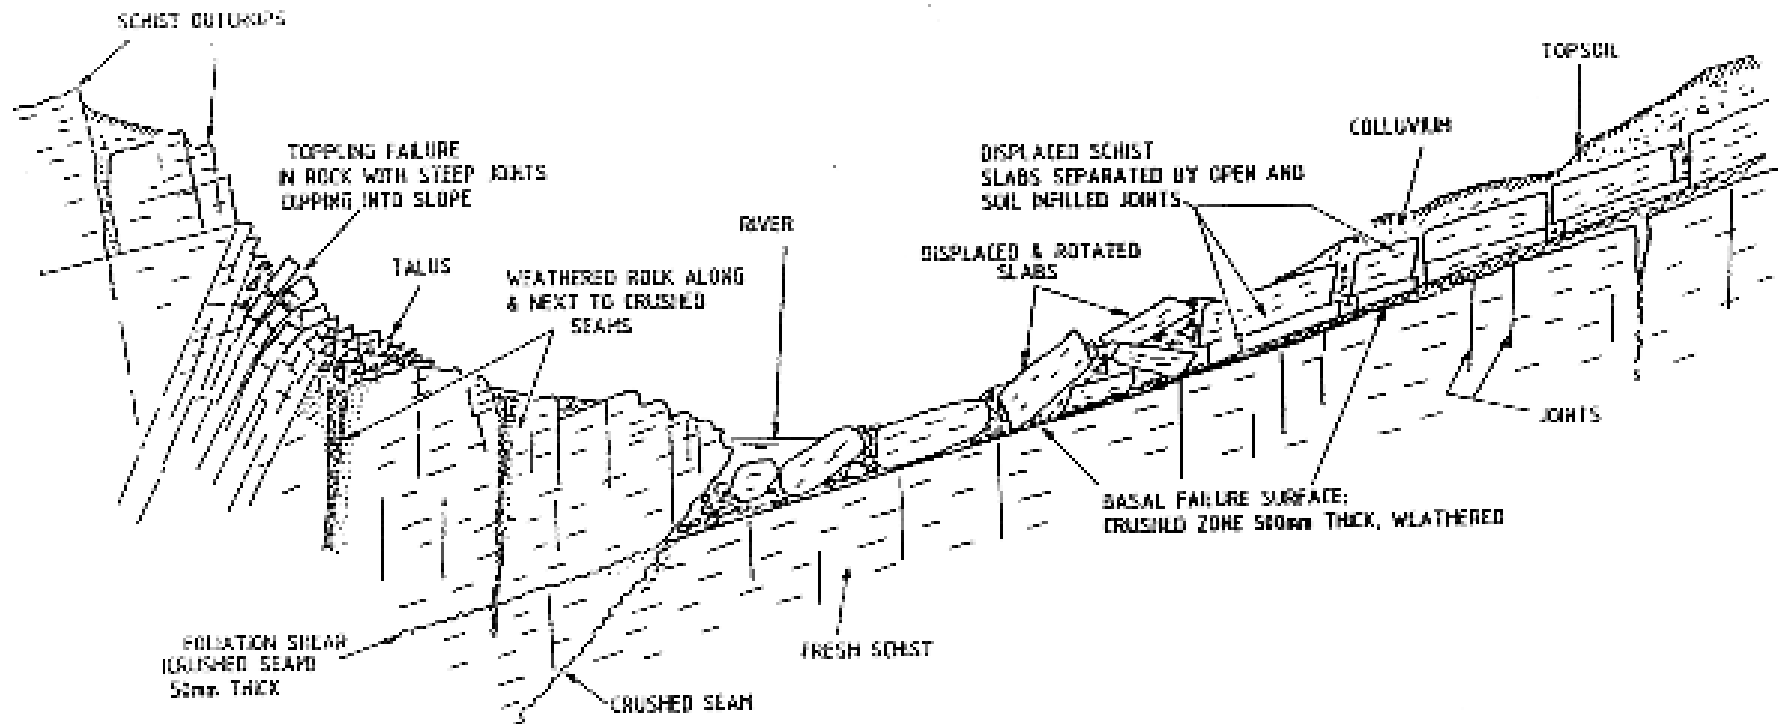
Figure 5.17. Typical valley profile in gently dipping schist affected by past landsliding along a foliation shear.

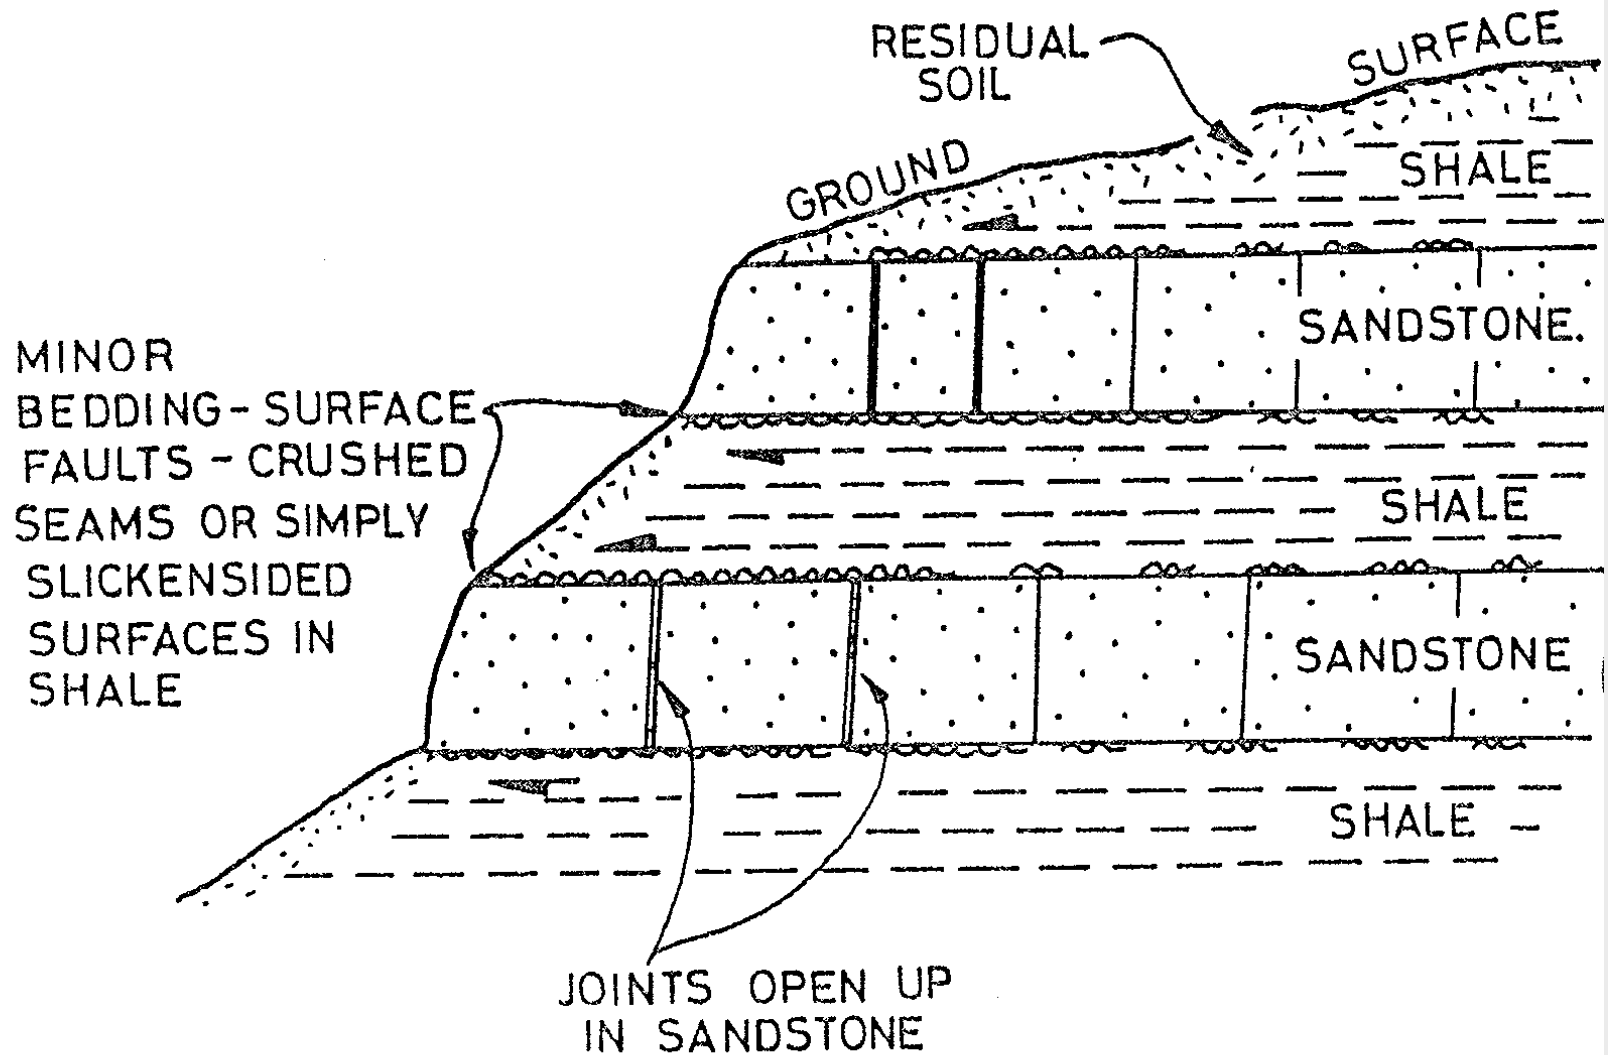
Figure 3.19. Usual ways in which bedding surface faults are formed in mudrocks

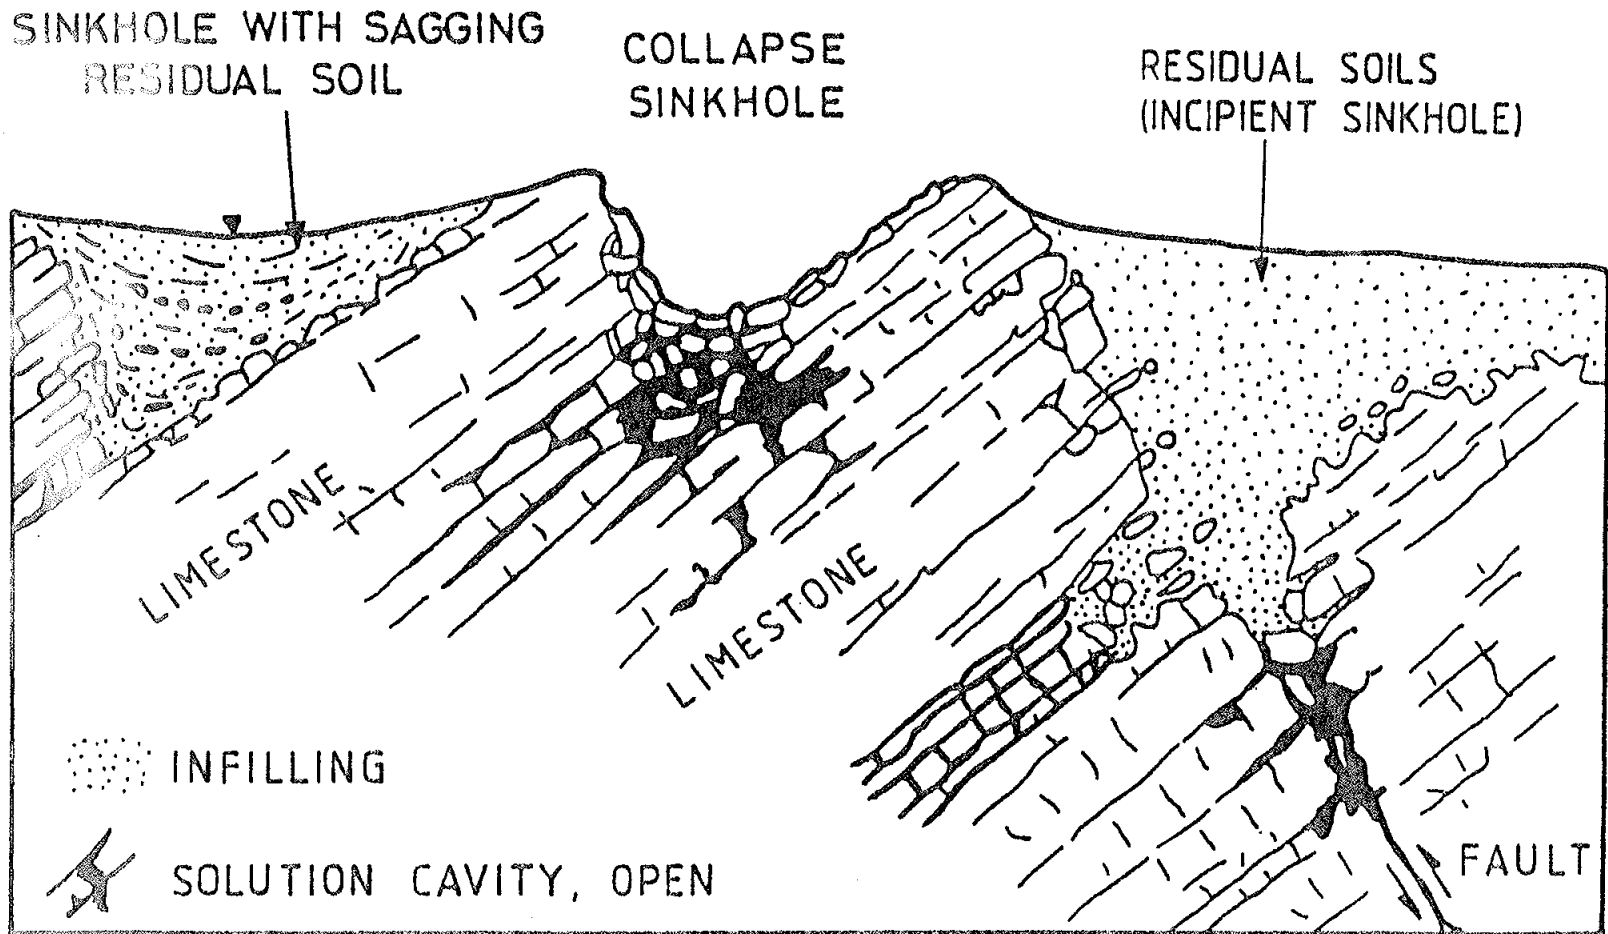
Figure 3.25. A typical weathering profile in dense, relatively pure carbonate rock. (Based on Deere & Patton 1971, Fig. 9)
