Geophysics Case Studies: Slope Investigations

Prof. Bob Whiteley
Senior Principal

- **Deep road cut- New England Hwy.**
- **Slopes adjacent to rivers - Thailand**
- **Buried boulder location – Malaysia**
- **Mapping lithologies & buried hazards with ERI**
- **Seismic Imaging of hazardous slopes LHD**
- **Shear zone mapping for new road tunnel - Malaysia**

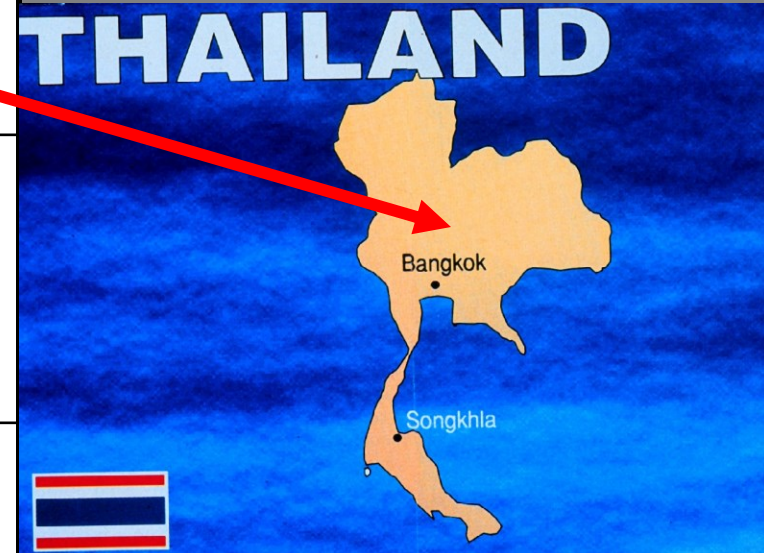
Project	Kwae Noi Dam Site Thailand
Nature of Instability	Slump failure right abutment
Task	Define unstable rock mass
Geophysical Technology	Seismic refraction

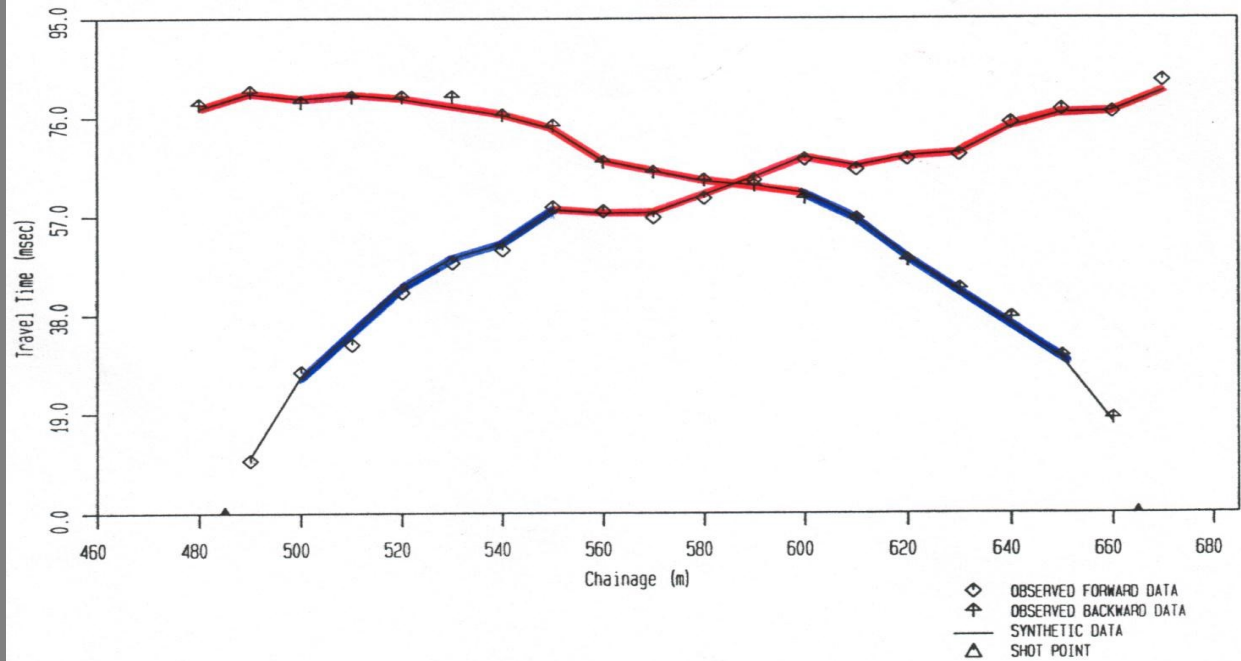
FIRST ARRIVAL SEISMIC TRAVEL TIMES

Visual
Interactive
Ray
Tracing

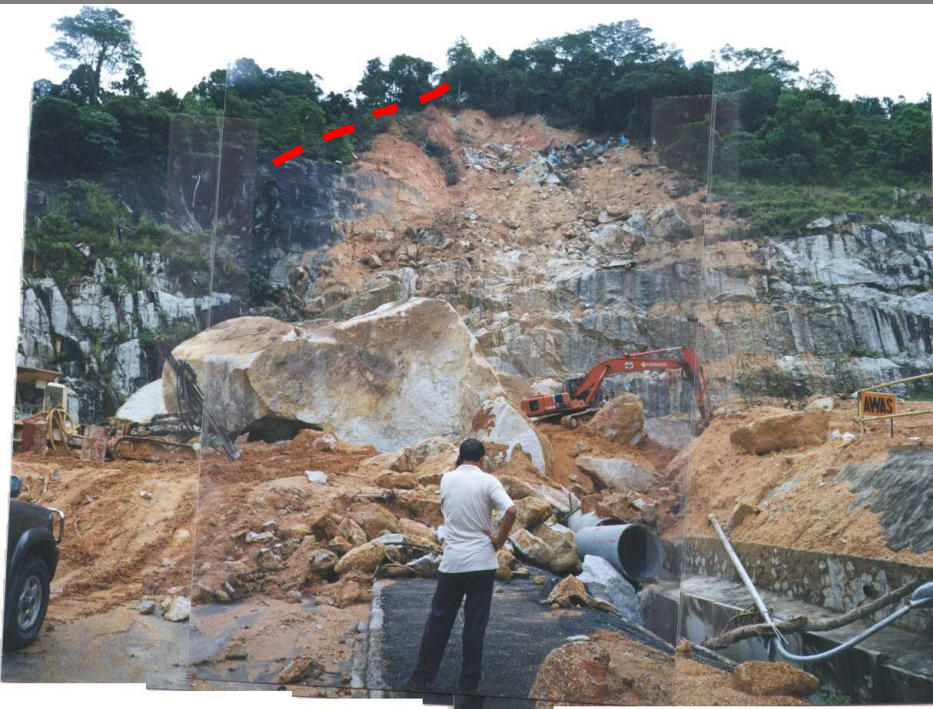
Project	Road cutting Penang
Nature of Instability	Landslip in weathered granite
Task	Locate buried boulders
Geophysical Technology	Electrical resistivity

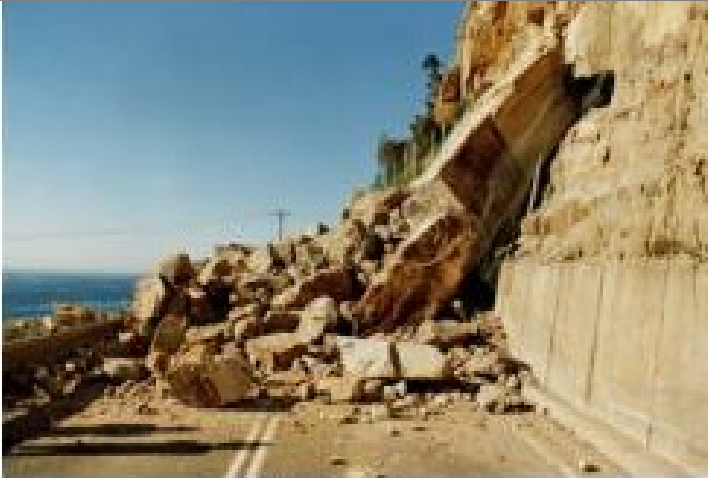
Some Historical - rock falls

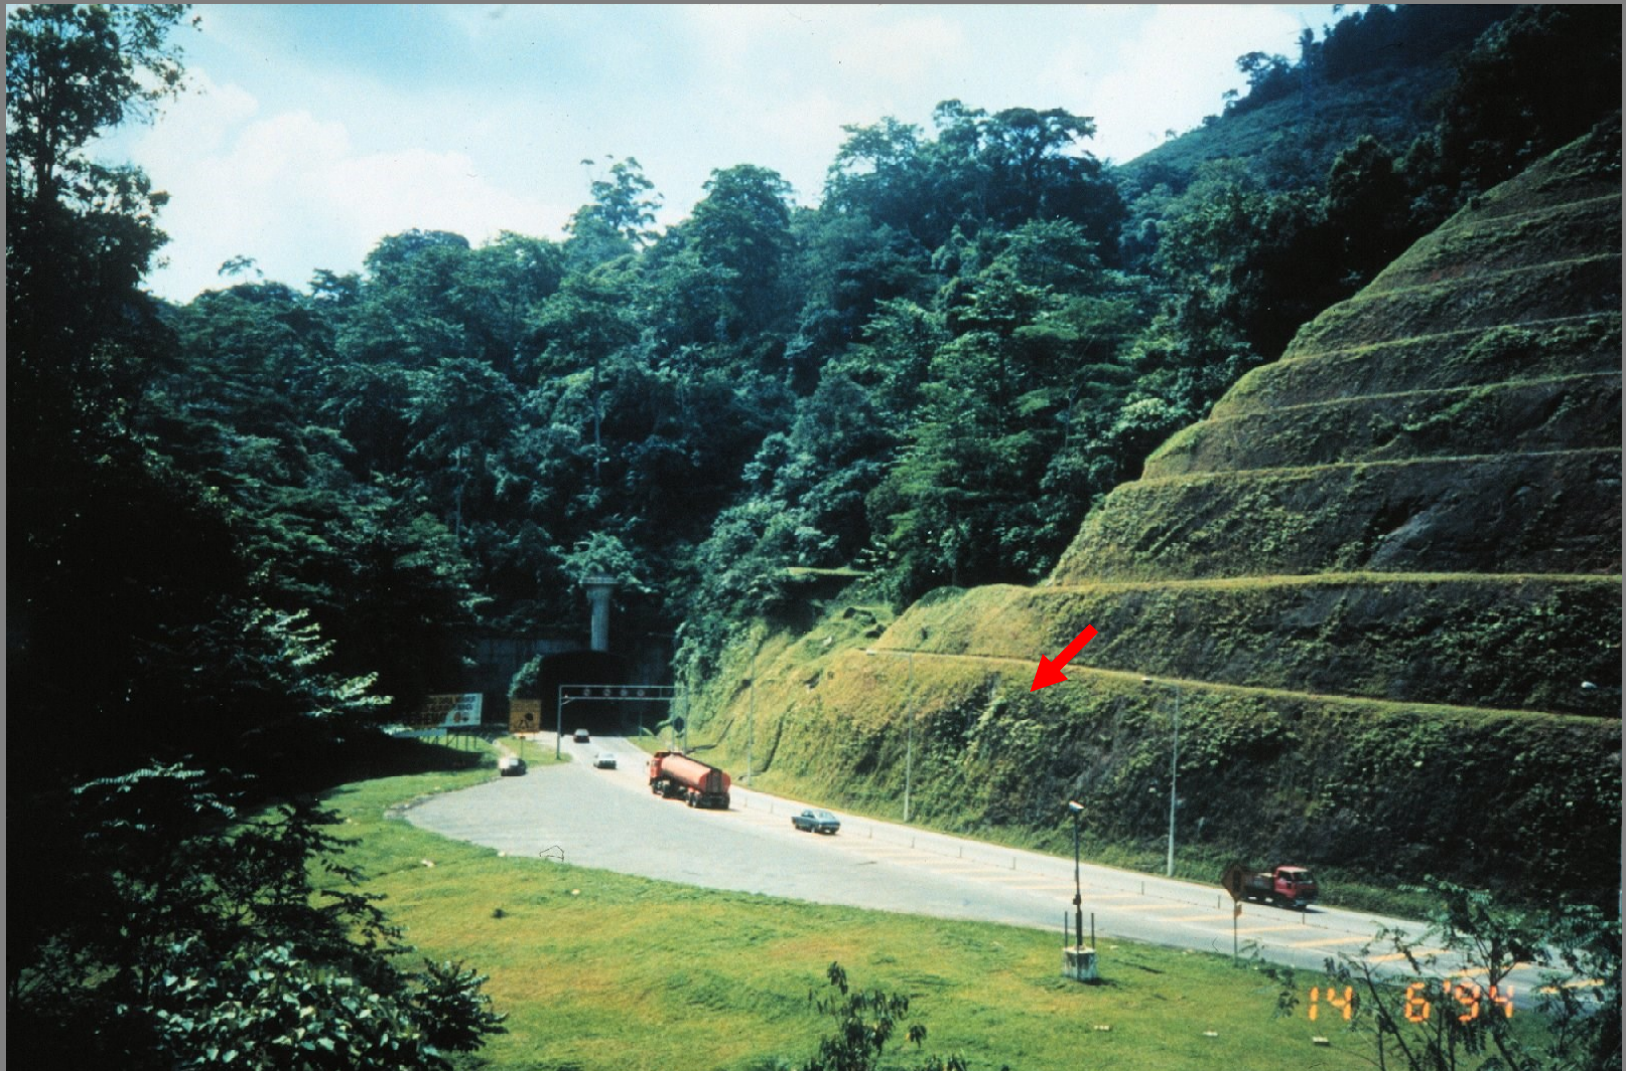
Genting Malaysia: The Old Karak Road Tunnel

New Karak Road Tunnel

- **790 m of 8.4 m high & 11.4 m wide tunnel, 20 shafts in granite at 20 to 70 m depth**
- **Geotechnical and seismic investigations 1994 from limited drilling sites**
- **Construction by roadheaders 1995 - 97**

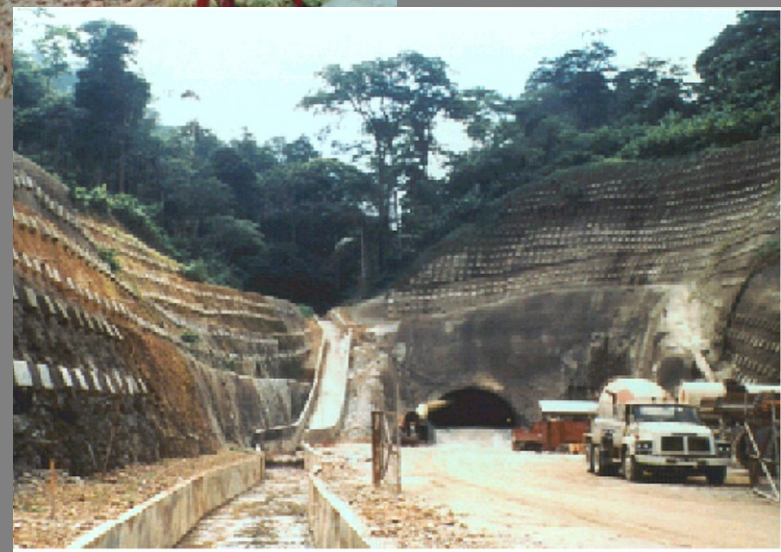
The shear zone exposed
