A consideration of river embankment slip failure caused by seepage-induced foundation ground weakening

ABSTRACT

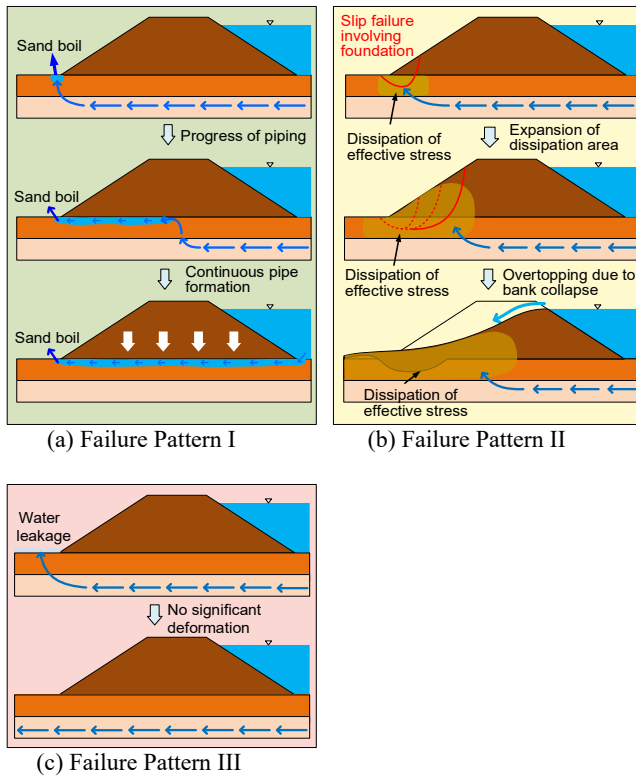
Fig. 1. Three pattern classifications for river embankment seepage failures on multilayered permeable foundation ground.

The results of numerous model tests indicate that river embankment seepage failures occurring on multiple layers of permeable foundation ground can be classified into three patterns, as shown in Fig. 1. Failure Pattern I is the so-called piping failure, which can only be observed in the case of low permeable embankments constructed on top of high permeable foundation ground. In such cases, a water channel, commonly referred to as a “pipe” develops in the permeable sand layer just beneath the low permeable embankment from the land side toe to the river side of an embankment. When the water pipe finally passes through the river embankment, internal collapse within the river embankment can occur.

Failure Pattern II refers to progressive slip failure from the land side toe of a slope that is caused by foundation ground weakening. In such cases, the shear strength as well as the effective stress around the slope toe in the upper foundation, decreases due to the concentration of seepage flow from the lower portion of the highly permeable foundation ground. The foundation weakening is induced by the decreasing shear strength as well as the effective stress.

does not affect the embankment. Thus, any river embankment deformation that occurs will depend solely on the embankment seepage phenomenon. We refer to such failure cases as examples of Failure Pattern III.

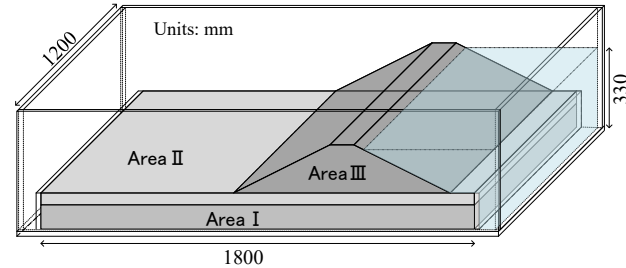
Fig. 3. Schematic view of 3D seepage model test.

Figure 2 shows a schematic view of our 2D seepage model test. Here, it can be seen that the experimental container, which was made of clear acrylic boards, was separated from right to left into three spaces for the water supply, embankment model, and drain. Since the 2D model test focuses on phenomena that can be observed in the embankment cross-section, the depth of the experimental container was just 120 mm and the longitudinal section of the embankment was not considered. In contrast, since our 3D seepage model test was also conducted to observe phenomena occurring in the longitudinal section of embankments during the seepage process, the longitudinal direction depth of the container was 1200 mm, ten times that for the 2D test, as shown in Fig. 3.
