Reflections on Recent Tailings Dam Failures and How the Application of Burland's Soil Mechanics Triangle Concept May Avert Future Failures.

ABSTRACT: In his Nash Lecture in 1989, Burland presented the concept of what he referred to as the Soil Mechanics Triangle. The three apexes of the triangle were identified as Ground Profile, Soil Behaviour and Applied Mechanics, and embedded within the triangle and linked to all three apexes the notion of empiricism and well-winnowed experience. Burland used this concept to emphasise the critical and interlinked nature of the three triangle apexes when teaching Soil Mechanics to undergraduate students. This paper applies the triangle to the current state of practice regarding tailings dam management, highlighting how lack of attention to the concepts embedded in Burland's approach have resulted in sometimes catastrophic consequences. Using the published forensic reports on two recent, major tailings dam failures around the world, the paper illustrates how they may have been avoided if a proper appreciation of the three pillars of good practice suggested by Burland had been adhered to. It also argues for more rigorous training in geotechnical

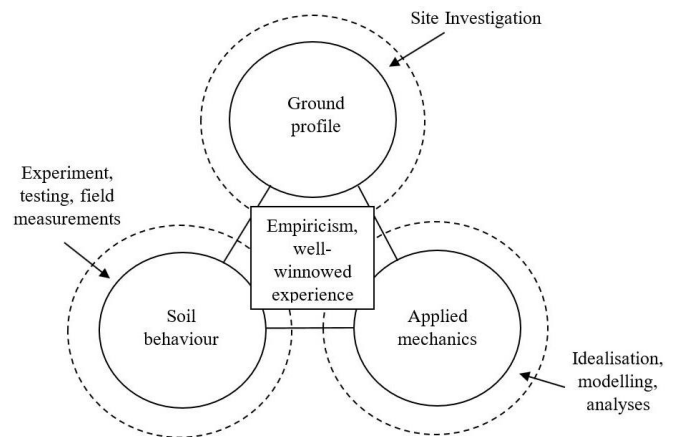
Burland (1989) presented a conceptual approach to undertaking geotechnical projects that integrated a number of separate, but related activities. A schematic is reproduced in Figure 2.

Figure 2 Burland's soil mechanics triangle

A key aspect of the approach summarised in Figure 2 is the need for appropriate input from geologists and particularly engineering geologists when planning and designing a geotechnical structure. Recent times have seen the closing of many University departments of Engineering Geology, presumably because these courses attract relatively small student numbers. However, the value added by engineering geologists and the insights they often provide should be sufficient grounds for ensuring these skills are not lost entirely.
