Biodegradable Prefabricated Vertical Drains: from Laboratory to Field Studies

Thanh Trung Nguyen¹, Buddhima Indraratna², and Pankaj Baral³
^{1,2,3}Faculty of Engineering and Information Sciences,
 University of Wollongong, Wollongong City, NSW 2522, Australia
 Corresponding E-mail: indra@uow.edu.au

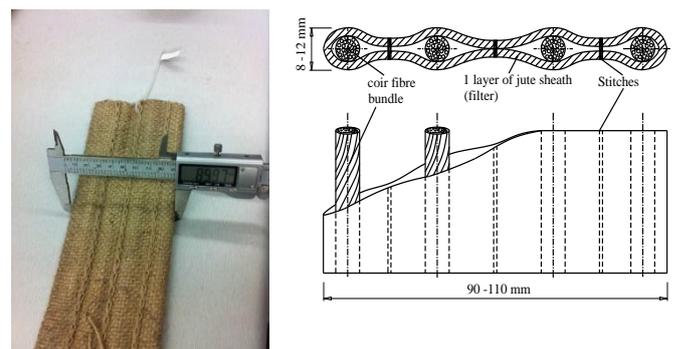
Figure 1 Structural detail of BPVD (jute fibre drains)

less validation in the field. In this current study, the most common form of BPVDs, i.e., band-shaped drains with 4 coconut cores and 1 layer of jute sheath are used (Figure 1). The apparent opening size (AOS) of the filter is 180 μm and the dry mass over a unit length is 193 g/m.

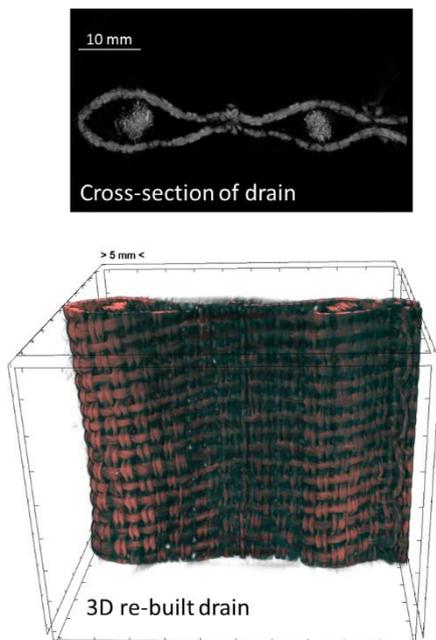
Figure 2 Cross-section and 3D rebuilt drain

The drain was exposed to an X-ray beam to help characterise its geometrical properties on the basis of the differential energy absorption of coir and jute fibres. The difference in the density of jute, coir fibres, and soil in the fibre-soil composites resulted in CT-scanning images with a distinct grey scale, which helped feature their volumetric fraction. Figure 2 shows how the cross-section of the drain is captured in grey scale and how the 3D coloured drain is re-built using the Feldkamp algorithm for reconstruction (Feldkamp et al. 1984; SkyScan NV 2011). In this investigation, X-ray scanning was applied onto the individual fibre bundles that make up the drain, as well as the complete drain, to ensure the accuracy of the fractional data. An investigation into how varying scanning resolutions can affect the accuracy of volumetric measurement is also made to validate the optical observations (Figure 3). For example, with a scanning resolution larger than 15 μm , the quality of the binary images of coir fibres is poor and result in an almost 11% deviation from the optical images.

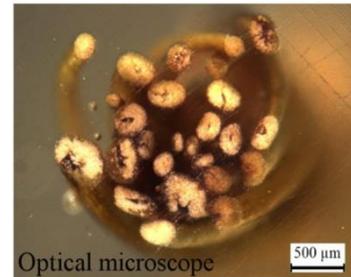
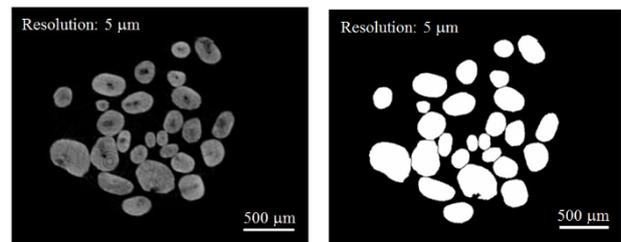
Figure 3 Validation of Micro-CT scanning to optical microscope

a) Coir fibres under optical observation

b) Coir fibres under CT-scanning (left) and its binary form (right)

optical scanning images needed transforming into a binary format in which different components of the sample are distinguished from each other in black and white. A threshold process that includes local and global algorithms was applied to binarized images. To improve the quality of images, a number of techniques such as filtering and de-speckling were used. The watershed process was also applied onto the binary images to separate the contact fibres before carrying out a fractional analysis. Note that the 3D volumetric data of an object is actually generated by combining various consecutive slide images over its longitudinal axis.

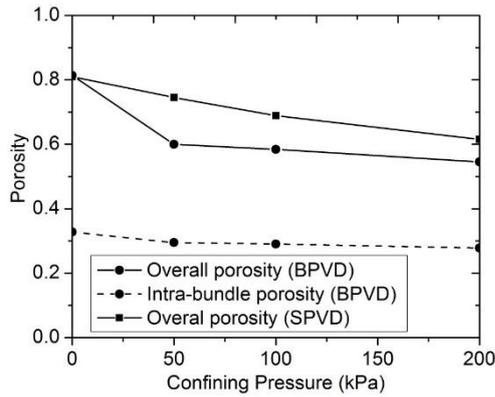
Figure 4 Porosity varies over increasing confining stress (BPVD in comparison with SPVD)

In comparison with conventional SPVDs, BPVDs have almost the same overall porosity, i.e., approximately 0.8 in a fresh condition (Figure 4), but under increasing confining stress, the porosity in BPVDs decreases much faster than SPVDs; for example, it reduces to almost 0.6 when the confining stress increases to 50 kPa. However, this reduction in porosity becomes insignificant as the confining stress continues to increase; this indicates that the fibres cannot rearrange themselves anymore. Since the porous characteristics of these drains affect their discharge capacity, it will be discussed in the following section. Finally, the analysis based on Micro-CT scanning also indicates that BPVDs have a much larger surface area, i.e., approximately 6.32 m^2 per unit length generated by a large number of the individual fibres inside these drains whereas SPVDs consist of plastic cores with only a 0.33 m^2 surface area.

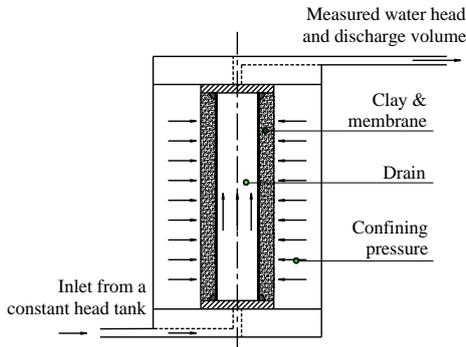
Figure 5 Discharge volume test on drain (with and without soil)

a) Schematic view of discharge volume test

b) Drain being confined after testing

A discharge volume test is often used to measure the discharge volume of PVDs in the laboratory, but the drain-soil interaction where soil clogs a drain due to confinement is usually ignored for simplicity (ASTM D4716 2008; Asha and Mandal 2012; Bo et al. 2016). In this study, however, a discharge volume test that includes soil clogging was designed and established. The sample drain was inserted into slurry made by mixing Ballina clay with water to approximately 98% water content, which was then contained in a circular membrane before seating it into a test cell (Figure 5).

A flow under controlled input water head was then generated at the bottom end of the sample while the output water head and discharge volume were measured over time. The hydraulic gradient (i) of the flow is then estimated with respect to the difference in water head between the inlet the outlet, and the length of the sample. In this

test the confining stress on the drain was governed through cell pressure, in this instance confining stress of 10, 50, 100 and 200 kPa were applied to determine how the confining stress affects the discharge volume. These chosen confining stress reflect the staged construction of an embankment in the field where the surcharge gradually increases (Chu et al. 2009; Rujikiatkamjorn and Indraratna 2009). The confining stress only increases when the soil is fully consolidated, i.e., there is no more discharge water at the outlet of the sample. Discharge volume tests without soil confinement were also carried out in this study.

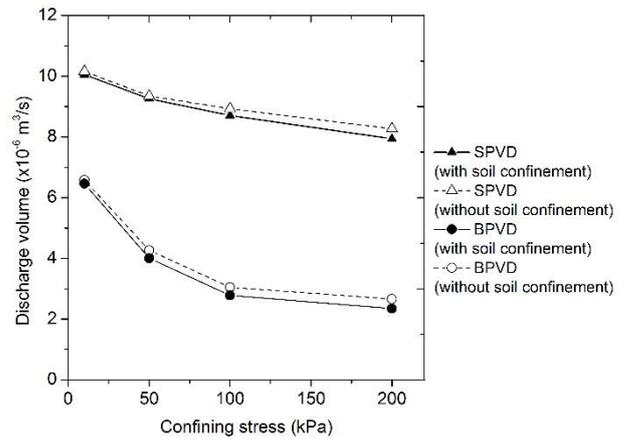
Figure 6 Discharge volume over increasing confining stress

Figure 6 shows the discharge volume of BPVDs with and without soil confinement; here flow decreased from 6.8 to $4.3 \times 10^{-6} \text{ m}^3/\text{s}$ when the confining stress increases to 50 kPa, which matches well the reduction in porosity discussed earlier in the paper. A further increase in confinement does not change the discharge volume significantly. Unlike SPVDs, BPVDs have a much smaller discharge volume at the same confining stress despite having the same porosity. This is because fibre drains have a much larger surface area which is actually the fluid-fibre contact area whenever fluid flows through the drains. A previous study (Nguyen and Indraratna 2017b) indicate that the larger the fluid-fibre contact area, the larger the flow friction and the smaller the hydraulic conductivity of the medium.

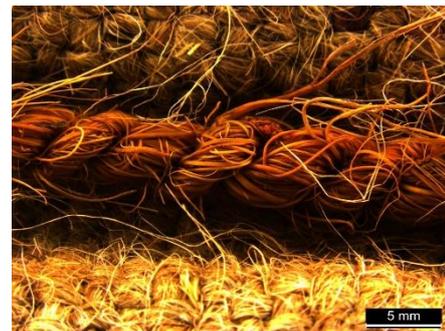
Figure 7 Internal observation under optical-microscope on jute filter and coconut cores indicates no soil clogging BPVDs

This study also shows that the Ballina clay soil used in the current experimental investigation has almost no influence on the discharge volume of BPVDs and SPVDs. This is understandable because SPVDs have a very fine AOS, i.e., less than 75 μm, as shown in previous studies (Chai and Miura 1999). BPVDs have larger AOS (i.e., 180 μm), however, micro-scanning of the jute filter indicates that soil could not penetrate very far into the drain, therefore, most of the soil clings to the external surface of the filter (Figure 7), and the internal porous system remains intact.

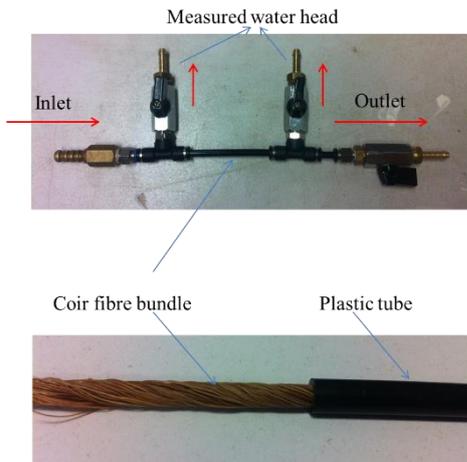
Figure 8 Hydraulic test at bundle (micro) scale

A hydraulic test at bundle scale (Figure 8) was conducted to measure the hydraulic conductivity of the jute and coir bundles that are used to make BPVDs. It is essential to understand how much the void depositing inside the fibre bundles (intra-bundle void) contribute to the overall discharge volume, and how the micro-features of individual fibres can affect the hydraulic properties of these drains. In this investigation, fibre bundles were placed inside a plastic tube with smooth internal walls to mitigate friction, and like the discharge volume test described in previous sections, flow was generated from one end of the tube to the other. After this test was complete, the bundles were subjected to micro-scanning and analysis to capture their micro-features such as porosity, size, and shape. Fibre bundles were 100 mm long and the internal diameter of the tube was 4 mm.

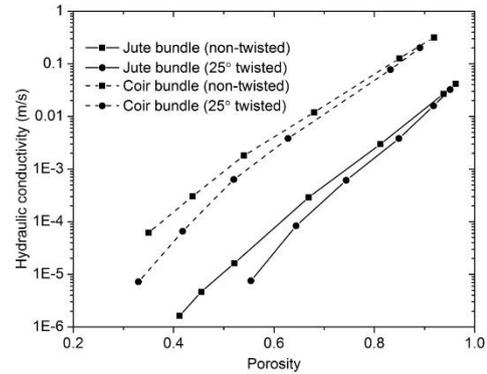
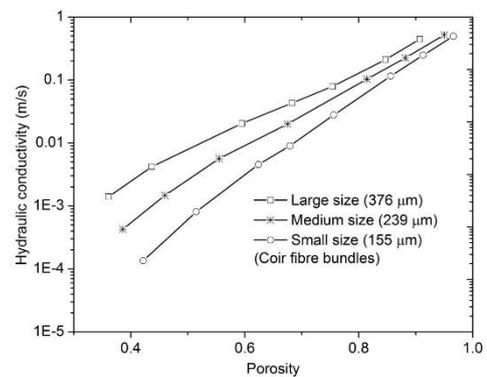
Figure 9 Hydraulic conductivity of jute and coir bundles making BPVDs (after (Nguyen and Indraratna 2017b))

a) Hydraulic conductivity over porosity of fibre bundles

b) Influence that the size of fibre has on hydraulic conductivity

Figure 9 shows the hydraulic conductivity (k) of jute and coir fibres with different porosity (n). Apparently jute fibres have a much lower hydraulic conductivity than coir fibres but with the same porosity. However, the k of jute and coir decreases from 2×10^{-3} and 7×10^{-2} m/s, respectively at $n = 0.8$ to 1×10^{-5} and 9×10^{-4} at $n = 0.5$; which indicates that despite the coir fibres having a smaller volumetric fraction, they can make a large contribution to the drain discharge capacity. At medium to dense packing, i.e., $n < 0.5$, k reduces more steeply. Moreover, as the fibres are twisted more and more, the hydraulic conductivity decreases as the fluid flow becomes more tortuous; for example, twisting coir fibres by 25° reduces their hydraulic conductivity by a factor of 1.8 at $n = 0.6$.

The size of fibres has a big influence on hydraulic conductivity, as shown in Figure 9b; essentially, the larger the fibres, the higher the hydraulic conductivity. For example, the k of coir bundles decreases from 2×10^{-2} m/s to 3×10^{-3} m/s at $n = 0.6$ as the mean diameter decreases from 376 to 155 μm . The influence of size is more apparent when the fibre bundles become denser, especially where $n < 0.7$. This finding clarifies why jute, with the much smaller diameter shown above, has a much lower hydraulic conductivity than coir. The micro-features of fibres must be considered when designing and manufacturing fibre drains.

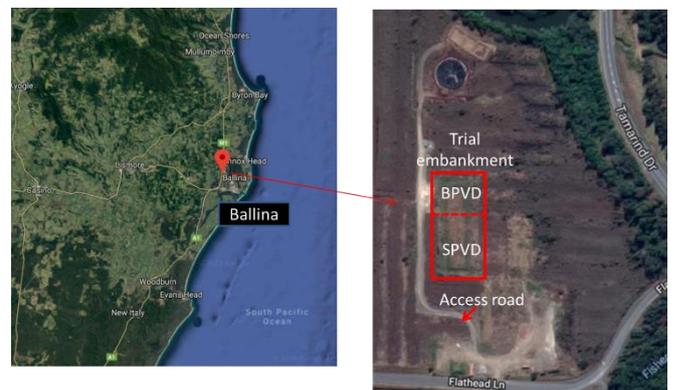
Figure 10 Location and plan views of trial embankment in Ballina

Ballina (Figure 10) is an important region because it connects two of the largest states of Australia, i.e., New South Wales (NSW) and Queensland (QLD), which is why infrastructure development projects such as the Woolgoolga to Ballina Pacific Highway with 4.5 billion AUDs funded by Australian government in 2015 have taken place in this region.

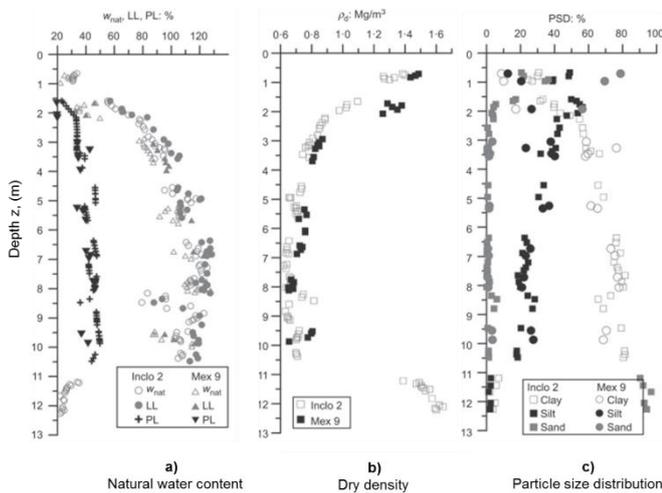
Figure 11 Soil parameters vary over depth (after Kelly et al. 2017)

The soft soils at Ballina were characterised in previous investigations (Pineda et al. 2016; Kelly et al. 2017). Generally, there was an approximately 0.2 m thick layer of organic material at the surface followed by 1.0 to 1.3 m thick layer of sandy to clayed silt alluvium soil. The Holocene estuarine soft clay accounts for most of the approximately 9 m thick layer in the Ballina soil profile (Figure 12). This soil has high natural water content, ranging from 80 to 120% about 10 to 15% below less than the liquid limit (LL). Moreover, the plastic limit (PL) is high to very high plasticity, resulting in a PI that ranging from 40 to 70. The dry density is less than 800 kg/m³. Sand was the major component above 2.0 m depth, however, clay particles were dominant at deeper layers, with the soil containing up to about 80% clay-size particles. An approximately 4 m thick layer of sand mixed with clay was found below the Holocene clay making for a transition zone from Holocene clay to the underlying fine sand layer to a depth of 19 m. The properties of these soils are shown in Figure 11.

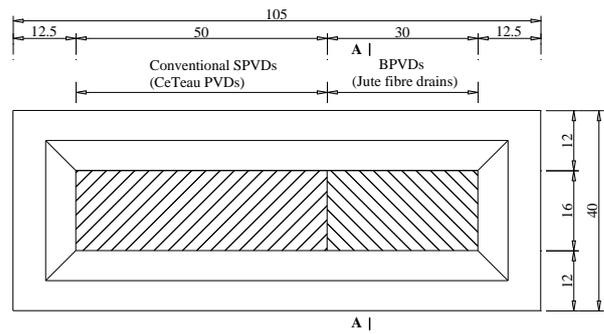
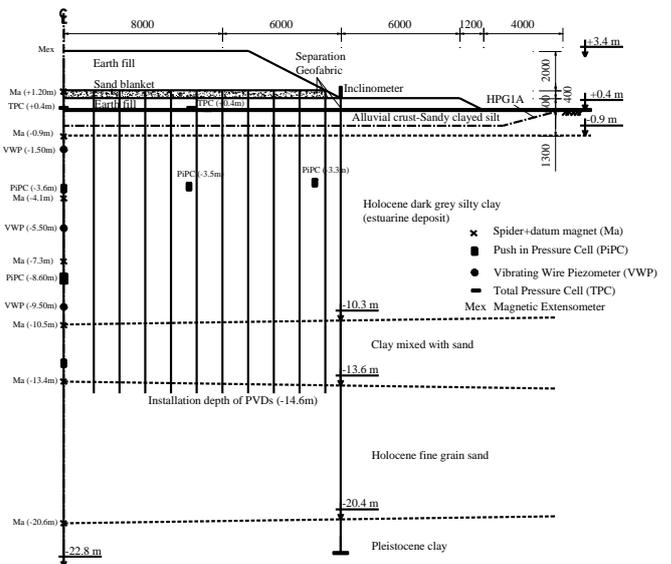
Figure 12 Plan view and cross-section of embankment

a) Embankment plan of BPVDs (jute drains) and SPVDs

b) Cross-section A-A in jute fibre drain zone

A full-scale trial embankment constructed at Ballina was used to discover how BPVDs work in comparison to conventional SPVDs. In this project, the jute fibre drains described previously and SPVDs (i.e., CeTeau polymer PVDs) were used. The schematic details of this embankment with a typical cross-section at the BPVD treatment zone are shown in Figure 12. An embankment (22 m wide) had a slope of approximately 1.5H:1V, and was almost 80 m long. There were two basic treatment zones, a 50 m long zone for SPVDs and a 30 m long zone for BPVDs. A working platform (about 120 by 50 m) was established initially for site activities. Before installing the drains, a 0.4 m thick sand blanket was placed on the working platform over the footprint (about 105 by 40 m) of the embankment.

The vertical drains were installed in 1.2 m square spacing pattern to a depth of approximately 14 m (i.e., into the sandy clay but above the sand layer, see Figure 12b) from the ground surface. The installation took place after instrumentation and additional fills (step c and d). A cut-off of 0.3 m from the sand blanket took place after installation reached the target depth. The construction stage associated with surcharge loading over time is shown in Figure 13. Note that it took more than 60 days from beginning of work to construct the platform to completing all the steps. For instance, it took

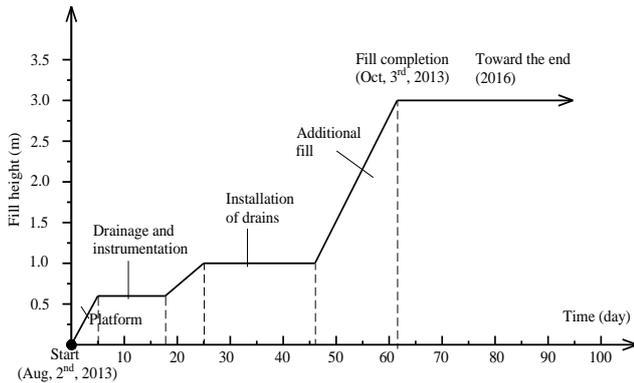
Figure 13 Construction stage with surcharge loading over time

- Thereafter, a 0.4 m thick layer of sand was placed on the platform with a layer of geofabric to separate the layers.
- Installation of SPVD and BPVD drains; although the BPVDs were thicker and heavier than the SPVDs, the conventional installation method using a 120 × 60 mm mandrel was found to be applicable for BPVDs.
- Horizontal drainage connecting vertical drains was carried out. In this project, sand blanket and horizontal PVDs were both used in the SPVDs treatment zone.
- The embankment consisted of additional 2 m fill (to a 3m total height over the original ground surface) placed over a second layer of geofabric which covered the sand blanket. The construction post-process included shaping and reinforcement to avoid erosion.
- The embankment was constantly monitored for about 3 years from 2013 to 2016 (Figure 13).

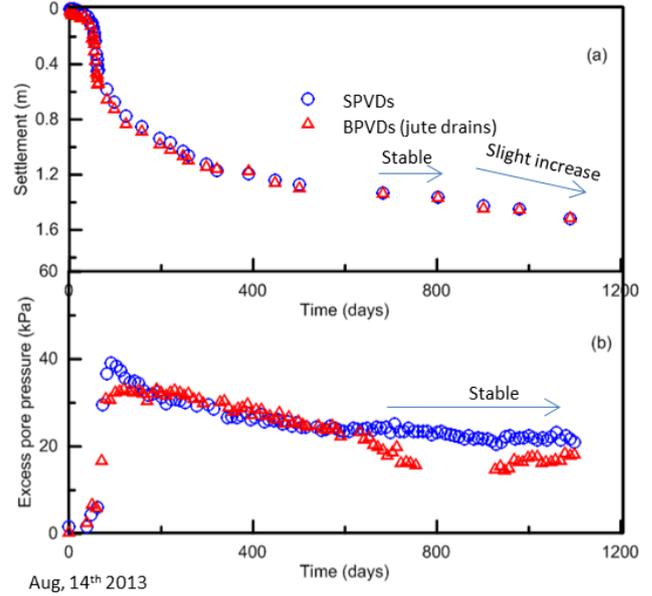
Figure 14 Settlement and corresponding excess pore pressure by BPVDs compared to SPVDs

Figure 14 shows the settlement and associated excess pore pressure at the centre lines of the SPVDs and BPVDs zones over time; obviously, there are no significant differences between these two types of drains. Settlement rapidly increases before the embankment (i.e., 3 m high fill) is complete because the build-up excess pore pressure which has been generated since the beginning of construction is released by the installation of PVDs. For instance, there is a steep increase in settlement 30 days after the PVDs were installed (Figure 13). In fact, the settlement reached almost 85% of its primary settlement after approximately 300 days. The settlement curve gradually stabilises over time, although it increases slightly between 500 and 800 days, and then continues to increase faster after 800 days; this might indicate a secondary consolidation of the soil. This concept can be supported by considering the dissipation of excess pore pressure, because after 700 days the change in excess water pressure is insignificant, which means the increase in settlement after 800 days shown in Figure 14a is mainly due to secondary compression. There is a slightly higher excess pore pressure induced by SPVDs at the beginning, i.e., 40 kPa at 60 days, but both curves quickly become identical afterwards. The excess pore pressure from the BPVDs becomes smaller than SPVDs after about 700 days while

the settlement induced by these two drains is still the same, although there are data missing from 780 to 900 days due to an accidental disconnection of cables in the BPVD site. These deviations are not easy to understand, given the volume of monitoring data, but they could be induced by the degradation of piezometers and drains (i.e., kinking and bending due to large settlement), leading inaccuracy of data, as sometimes reported in the field (Indraratna et al. 2017).

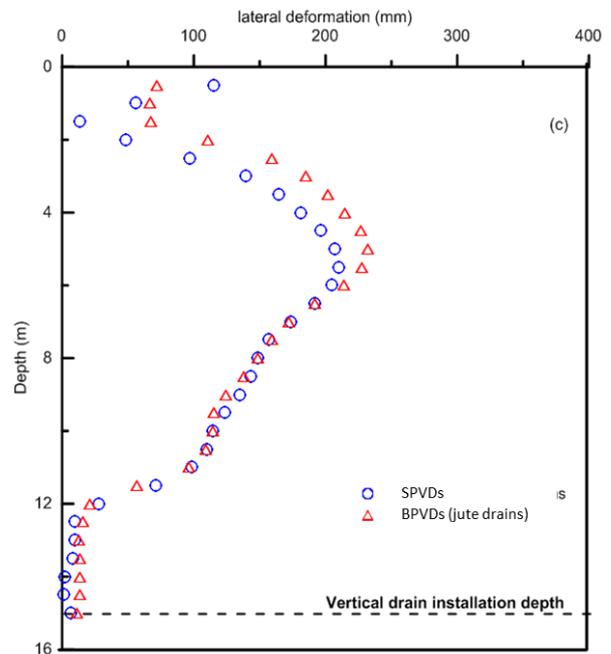
Figure 15 Lateral deformation of soil induced by BPVDs and SPVDs

The lateral deformation (inclinometer data) of soil under the embankment after 1088 days of monitoring is shown in Figure 15. Similarly to the settlement described in previous figures, the difference in lateral deformation induced by SPVDs and BPVDs is insignificant, especially at layers deeper than 6 m.

However, there is a certain gap between the two curves at shallower depths, particularly from 2 to 6 m where the lateral displacement induced by BPVDs is about 210 mm at the depth of 4 m, whereas the SPVDs result in a smaller displacement of 180 mm at the same depth. This discrepancy is probably because BPVDs made from jute fibres are not as stiff as plastic PVDs, in which results in a larger lateral displacement under the same confining stress. Previous laboratory investigations (Jang et al. 2001) indicate that natural fibre drains are more sensitive to deformation (i.e., bending and kinking), and this could result in a much larger lateral deformation of soil reinforced with PVDs. However this deviation could also occur naturally at these two stations without the effect from the difference in stiffness of the two drains. This means that lateral deformation needs further investigation and evaluation. Most of the previous field investigations (Lee et al. 1994; Lee et al. 2003; Kim and Cho 2008) concentrate mainly on settlement and excess pore pressure and ignore lateral deformation.
