## Increasing geotechnical challenges in the design and construction planning of the Third Phase Bangkok MRT Underground

**ABSTRACT:** The 3<sup>rd</sup> phase MRT underground project of Bangkok that is being implemented has faced increased difficulties in design and construction owing to the congested corridor along the alignment and the phenomenon of groundwater rebound in Bangkok subsoils in the aftermath of the end of land subsidence era from deep well pumping. The rebound is more than 10 meters from the situation during the initial phase construction and thus it necessitates careful soil investigation and design approach to prevent instability of groundwater ingress and uplift in bore tunnelling and excavation of station boxes. The tight space along the MRT underground alignment resulted in the twin bored tunnels being placed at very small clearance in a few locations. It creates high risk in the shield driving, particularly in the saturated sand layer. The works also involve tunnel driving at close proximity or under a number of existing buildings or road viaducts. In such cases, various schemes of underpinning are employed, and one of them is strengthening of founding soil

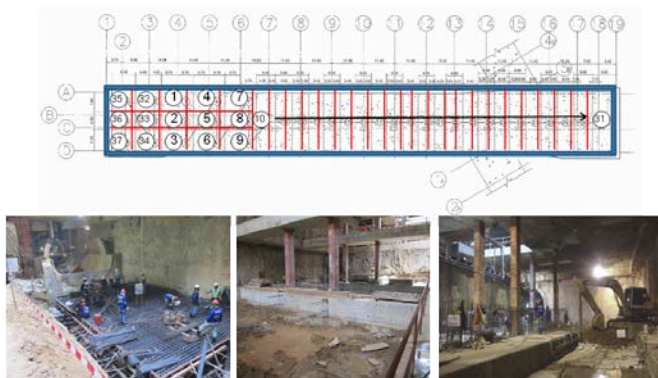
Fig. 10 Sequence of staged base excavation of BS13

stages of a small sized excavation zone bounded by high soil surcharge + cast concrete slab around the perimeter of the excavation, the stability of the excavated base against the hydraulic uplift will be significantly assisted by the side shear resistance of the soil along the perimeter as compared with that of large excavation area. The Outline Design Specification stipulated at that in case shear strength of base soil was considered, a minimum factor of safety was required at 1.20. This requirement could be satisfied for the soil and groundwater condition below the excavation base of the station. The accurate determination of the density of the soil layers and the spatial variation of the thickness of the stiff clay layer were a must in the adaptation of this method. The staged excavation sequence adopted for BS13 excavation is shown in Figure 10. The work was successfully completed as planned.
