ASSESSMENT OF ROCK JOINT ROUGHNESS USING IMAGE ANALYSIS OF DAMAGED AREA IN DIRECT SHEAR TESTS

ABSTRACT

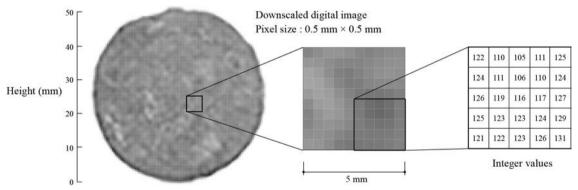
Figure 1. Greyscale digital image of a joint surface and integer values

In this study, greyscale images of sandstone and argillite core samples are used to obtain brightness values along the centre lines by which the roughness profiles are manually measured. The integer values obtained from the pixels of the images are then extracted using the image processor, MATLAB code. The results are then analysed using correlations with the asperity angles calculated from the measured profiles.

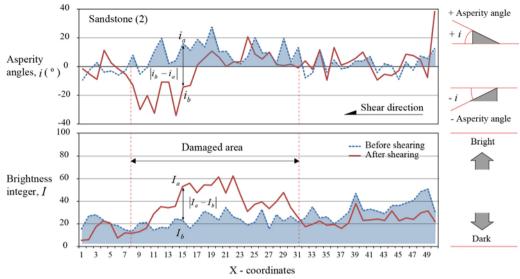
Figure 5. Brightness integers of greyscale images and asperity angles, sandstone (2)

The range of brightness integers varied from 0 to 255. The values were extracted from the images of joint surfaces on the areas of the measured roughness profiles using MATLAB code. The values were compared to asperity angles calculated from measured profiles. Figure 5 demonstrates the brightness integers and the asperity angles at the same positions along the profiles before and after shearing stages for the sample of sandstone (2). It was observed from the results that the variances of brightness integers (I) obtained from greyscale images can correlate with the variances of asperity angles (I) of roughness profiles after shearing stages. Large variations of I values occurred at the same areas where large variations of I were observed. It was also observed that shearing can reduce asperity angles and the areas damaged from shearing were able to be identified using the variance of brightness integers. In damaged areas from the direct shear tests, brightness integers increased more than the barely or non-damaged areas nearby as shown in Figure 5.
