# Pile Design and Group Behaviour; A Case Study of Large Tank Foundations in Soft Soil Conditions

W.F. Van Impe<sup>1,2</sup>, P.O. Van Impe<sup>1</sup> and A. Manzotti<sup>3</sup>

**ABSTRACT:** The paper presents the case study on the construction of three 48m diameter oil tanks in Ostend (Belgium), each founded on a group of 422 displacement cast in-situ screw piles. The three tanks are close enough to each other to induce interaction. Monitoring of the tanks' movements has been performed during the hydro-testing of the steel tanks and during the subsequent working stage of the tanks. The bearing layer of the pile group is a 5m thick stiff sand layer at a depth of about 20m, overlain by a very heterogeneous soft clayey/silty fill containing sand pockets, and underlain by a very thick slightly over-consolidated clay. Some short and long term settlement prediction of the tanks have been done, assuming soil parameters derived from the CPT data on site, and compared to the measured settlements. The initially derived soil parameters are then re-evaluated in order to predict the long term settlement for the full life span of the construction.

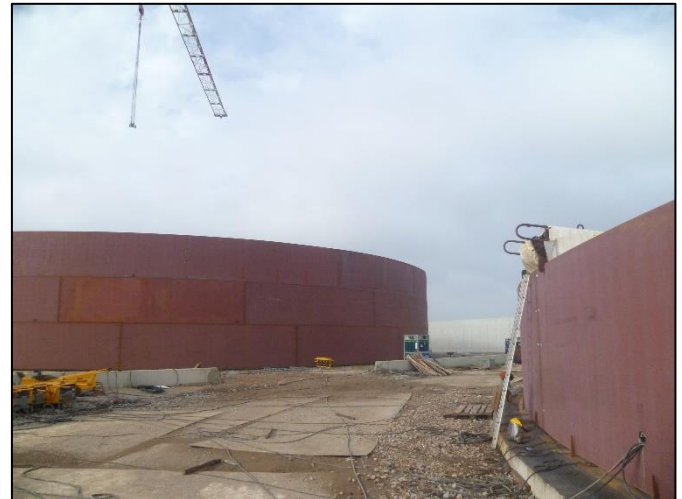
Figure 2 Fuel tanks under construction at Ostend (Belgium) – fall of 2012.

The case study which will be presented here in this paper refer to three oil tanks located in Ostend (Belgium), steel structures of 48 m in diameter and 19 m height, each containing 33000 m<sup>3</sup> and positioned in a triangular shape at a center-to-center interdistance of about 65 m (Figure 1 and Figure 2). They are founded on a 48.8m diameter, 60 cm thick reinforced slab, supported by 422 displacement screw piles.

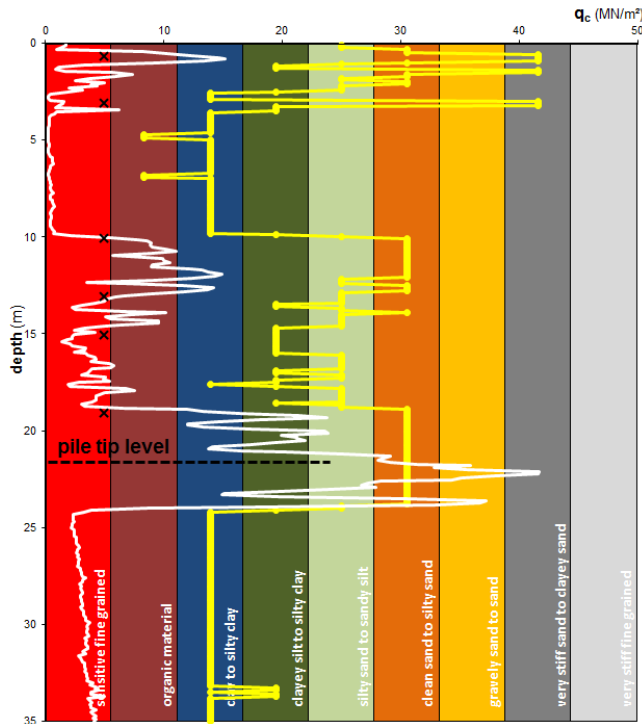
Figure 9 CPT based soil type classification ( $q_c$  profile: white line; SBTn : yellow line, Robertson 2010) at the location of the test pile axis. The black crosses represent the locations of the 6 extensometer.

The ground conditions at the (21.56 m long) test pile axis location is given in Figure 9; at the site the ground water table can be assumed at about 0.5 m below natural ground level. The pile base is anchored in the tertiary dense sand layer, overlying the tertiary slightly O.C. 100 m thick clay formation, starting from about 2.5 m ( $>5\phi_{\text{pile}}$ ) below the pile tip. The 6 extensometers are located at the depths shown in Figure 9.

The stiffness values estimated for the various soil layers identified (cfr Figure 9) along the pile shaft and underneath the pile tip at the test pile location, are summarized in Table 1.

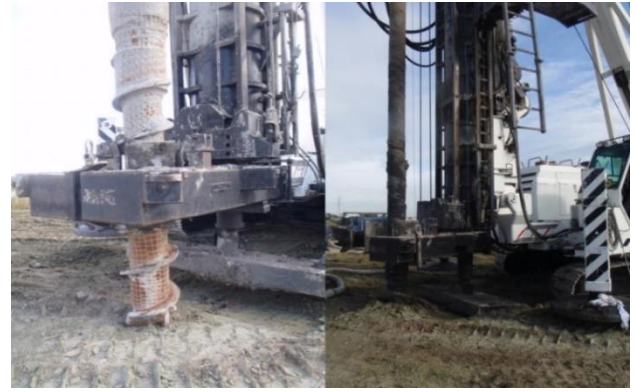
Figure 10 Omega pile installation, test pile instrumented on the reinforcement cage at 6 depth locations.

In order to optimize the design method, a fully (extensometer) instrumented test pile was installed (Figure 10 to 12) to be test loaded up to a pile base settlement of 10% of the pile base diameter; which in accordance to the Belgian practice is corresponding to the required deformation at “failure load” of a soil displacement pile.

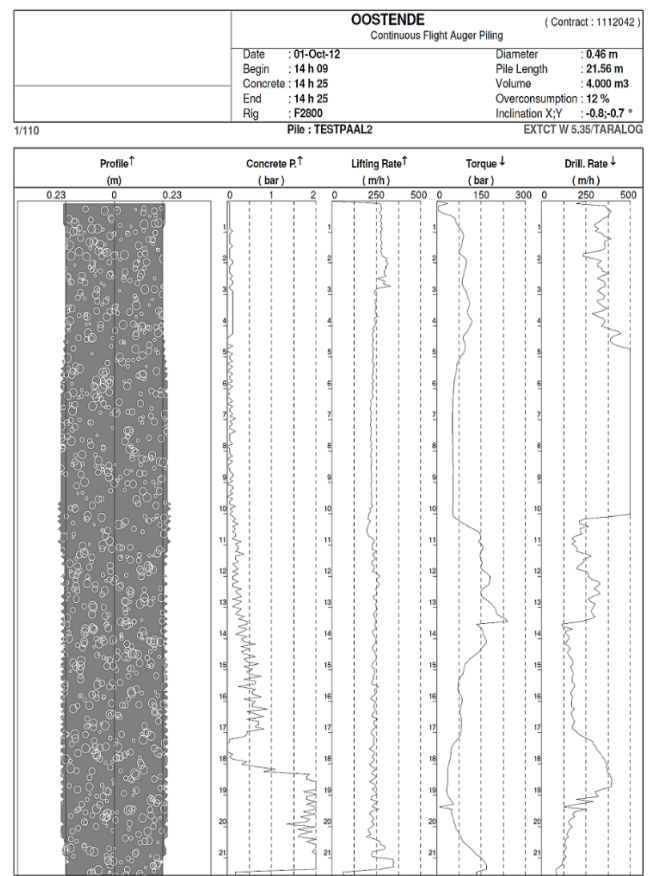
Figure 12 Test pile installation parameters of the Omega test pile.

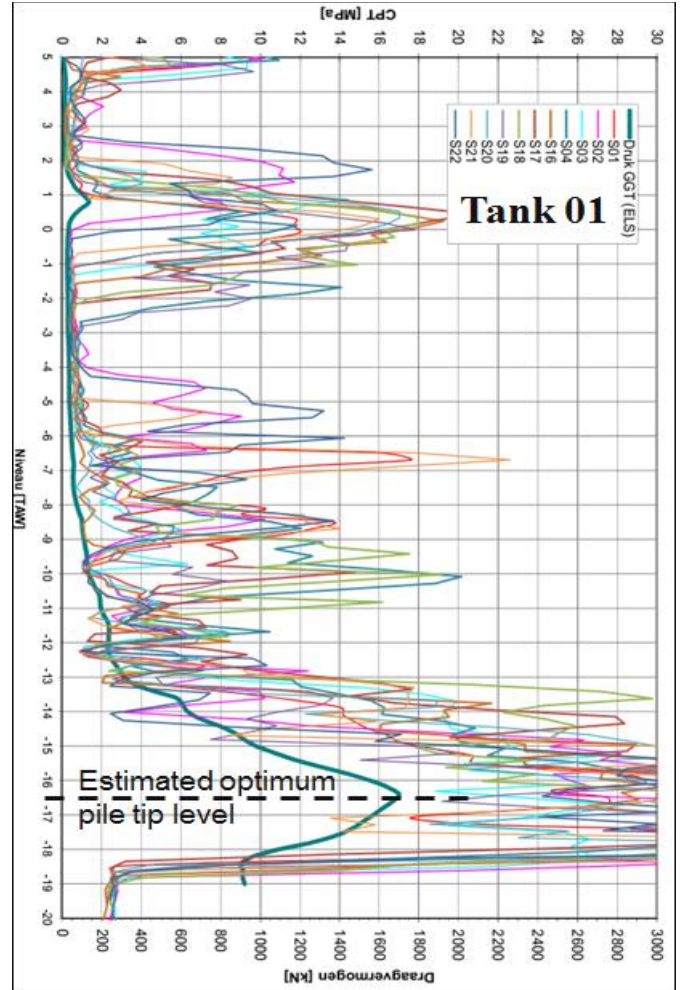
Figure 14 Examples of typical CPT-results in the area of Tank 1 and its derived total ultimate pile tip capacity at corresponding levels of possible pile tip depths (cfr Belgian practice).

The unit ultimate pile base (460 mm diameter) capacity (method Van Impe-De Beer- 1986) times the pile base area, (cfr Figure 13-14), increased by the ultimate pile shaft capacity on the lower part of the pile shaft mainly, has been applied in order to predict the total ultimate pile capacity of the test pile. The result of this ultimate total pile capacity ( $Q_{ult}$ ) prediction, linked to the CPT result at the location of the test pile is shown in Figure 15.

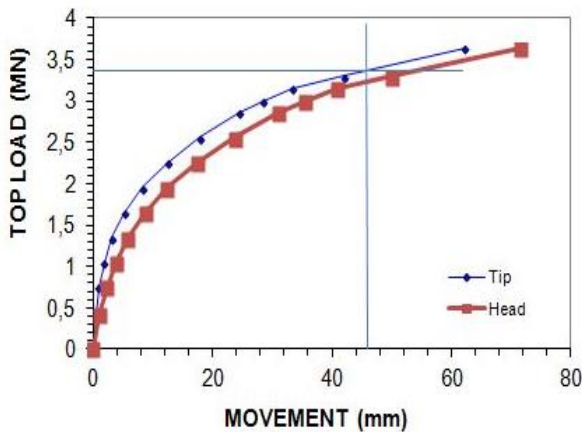
Figure 16 Estimated total ultimate pile capacity from the predicted pile load-settlement curve (Van Impe W.F. 1986–1994).

The predicted pile load-settlement curve (Van Impe W.F. -1986, 1994), using the above mentioned stiffness estimates and the failure criterion of  $Q_{ult}$  at 10% pile tip settlement, would bring us to a value of about 3350 kN (Figure 16).

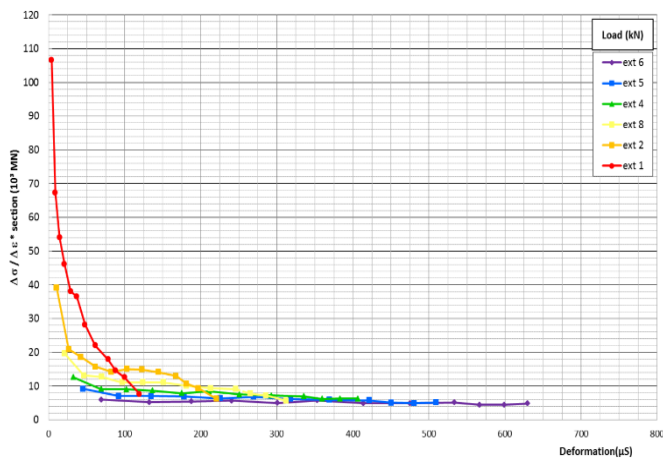
Figure 17 Stiffness evaluation of the test pile with best fit for all extensometers (adapted from Fellenius 2001 method).

The actual test pile stiffness evaluation was performed on the basis of the proposal of Fellenius (2001) of plotting  $\Delta\sigma/\Delta\varepsilon$  at the locations of each of the extensometers in the pile shaft, versus the local strain  $\varepsilon$  at that respective locations. Figure 17 is showing these results. All curves measured during the pile load test seem to more or less converge at values of  $\Delta\sigma/\Delta\varepsilon$  of 6, corresponding to a pile stiffness of about 30 GPa; which is not so far from the first estimate we made at the start of the pile installation (32 GPa).

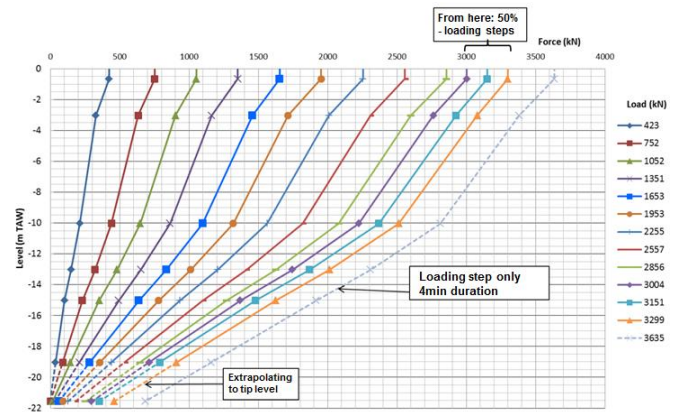
Figure 18 Axial load distribution in the test pile at the extensometer levels, and extrapolated to the pile base level.

Starting from the pile stiffness evaluated now from the pile test, we can draw the load distribution in the pile at the extensometer locations for the increasing pile head levels during the load testing of the pile. Figure 18 and 19 are showing the measured data interpreted in this way. From the measured data one could read that the large deformations ( $>46$  mm = 10% of the pile tip diameter) of the pile tip, with subsequent ongoing pile tip displacements do appear at pile head load levels in between 3300 kN and 3600 kN. This is fairly well corresponding to the CPT- predicted “failure” load of about 3.5 MN, and to the from predicted load-settlement curve ultimate load of 3.35 MN, all mentioned above.

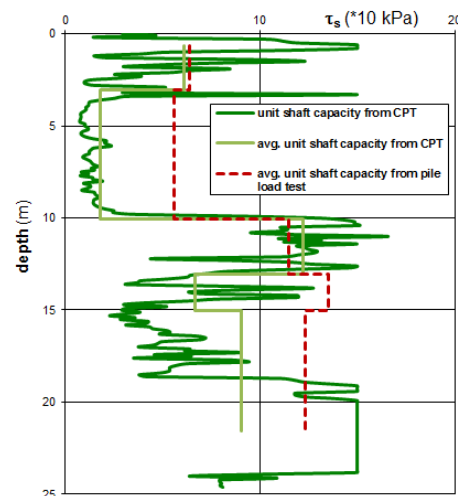
Figure 20 Comparison of the mobilized unit shaft friction along the test pile shaft; CPT based predicted mobilized friction versus the measured values during the load test.

Even with the ultimate test pile load corresponding quite well to the predicted values, the distribution of the ultimate pile tip load versus the ultimate pile shaft load as measured appears to be quite different from the predicted distribution, discussed above under 2.2. The expected shaft capacity to be developed starting from the CPT results at the test pile location, as compared to the measured values during the test loading of the pile is indicated in Figure 20.

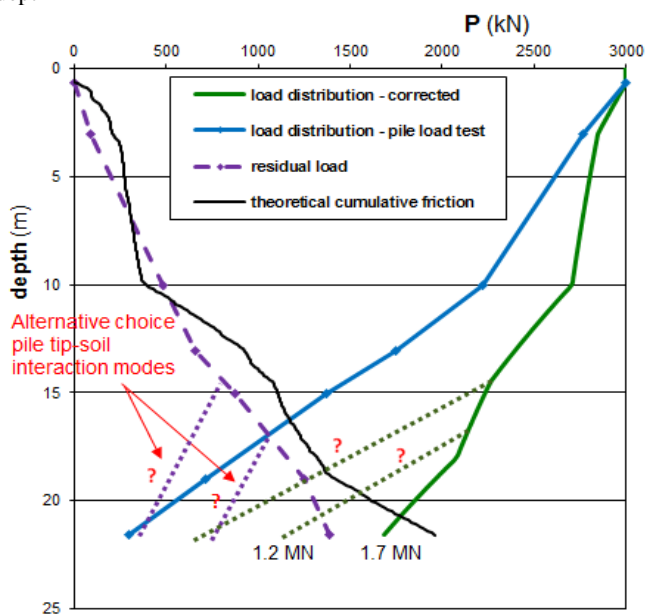
Figure 21 Corrected test pile load distribution implementing the residual stress induced loading

The Figure. 21 indicates with the full blue line, the test pile load distribution during the test loading at a level of 3005 kN pile head load (of the assumed not pre-stressed pile). The violet dashed line indicates the negative skin friction developed along the pile shaft due to reconsolidation of the soil layer in between 1 m and 17 m depth

This is, consequently, the new zero-reference line for the extensometer readings. The actual, corrected pile load distribution curve therefore would be the full green line in Figure 21, reflecting indeed the much higher pile tip load contribution and the expected ratio pile shaft to pile tip load as one would derive from the CPT-based or the rational load-settlement curve based predictions, and leading to a pile base load of about 1.7 MN at a pile head load of 3 MN (so with a shaft load contribution of 1.3 MN).

The dashed violet line is calculated starting from the assumption of a perfect soil-pile tip interaction, which is not necessarily the case for this instrumented test pile, as argued before. So, the dotted lines in Figure 21 do suggest other possible shape developments of the dashed violet curve, including some influence of a less perfect soil-

pile tip interaction. The most reliable correction of this type in our opinion is the correction shown by the dotted line from level -17 m on. This would lead to a tip load of about 1.2 MN at a pile head load of 3 MN; so with a shaft load contribution of 1.8 MN.

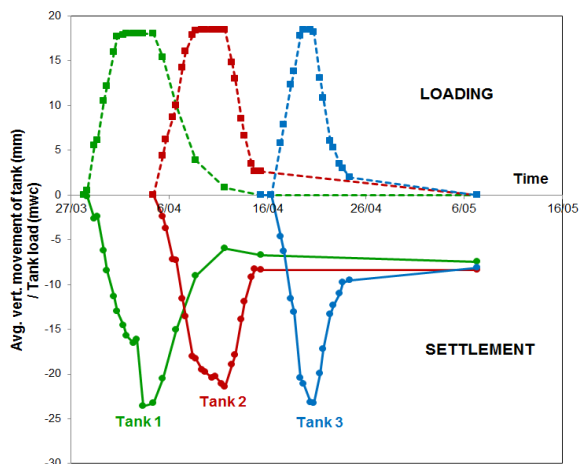
Figure 22 Average settlement of the tank during the hydro test.

Figure 22 shows the history of the loading pattern as well as the measured average settlements at the level of the tank bottom during the hydro test. The data gathered data during the hydro-testing of the 3 tanks are summarized in the Tables 2, 3 and 4.

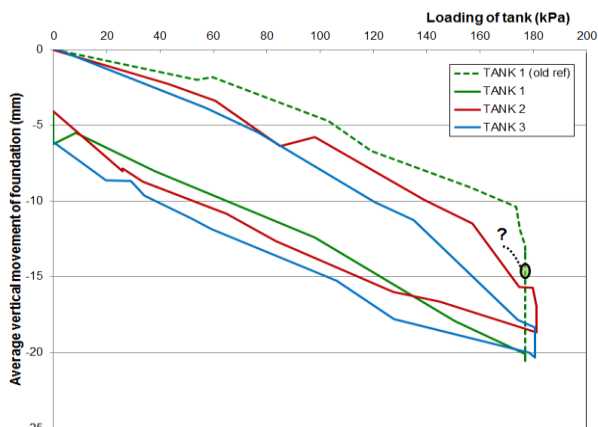
Figure 23 The full load-settlement curves for each of the oil tanks at hydro testing with unloading.

In Figure 23 the full load-settlement curves at the loading/unloading during the hydro testing of each of the tanks has been reproduced; as from the data of the Tables 2, 3 and 4.

The reference mark for the settlements of tank 01 very unfortunately moved unnoticed, vertically over about 5 mm during the load testing. It means that the green curve on the Figure 23 at its full load should probably be situated around a settlement range of 15 mm (black dashed line on the Figure 23).

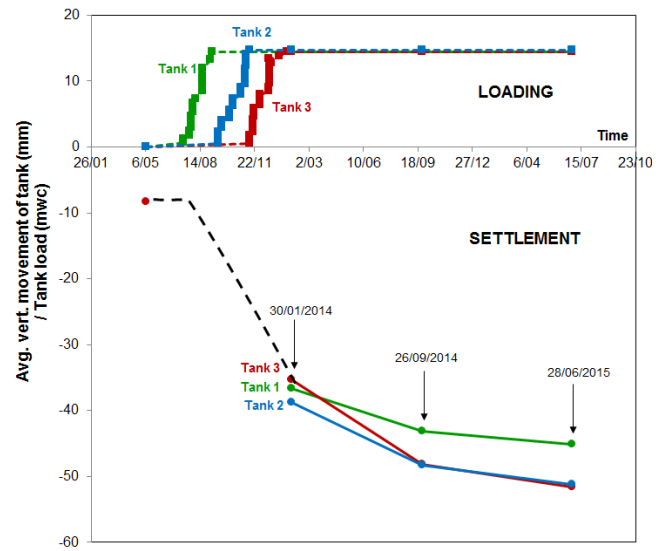
Figure 24 Average settlement (mm) of the tanks during operation.

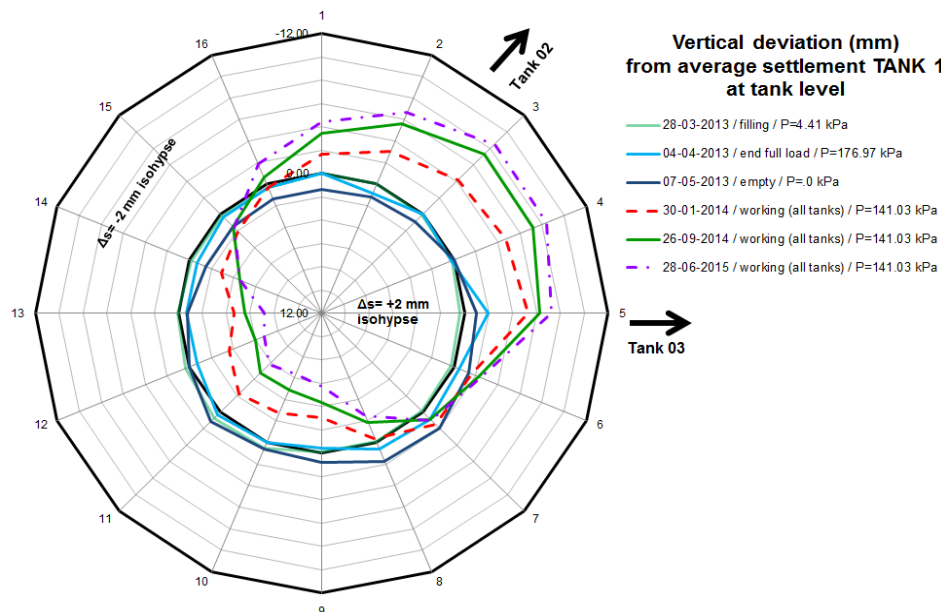
Figure 25 Vertical deviation from average settlement (mm) of Tank 1 - during hydro test and during operation, at tank level.

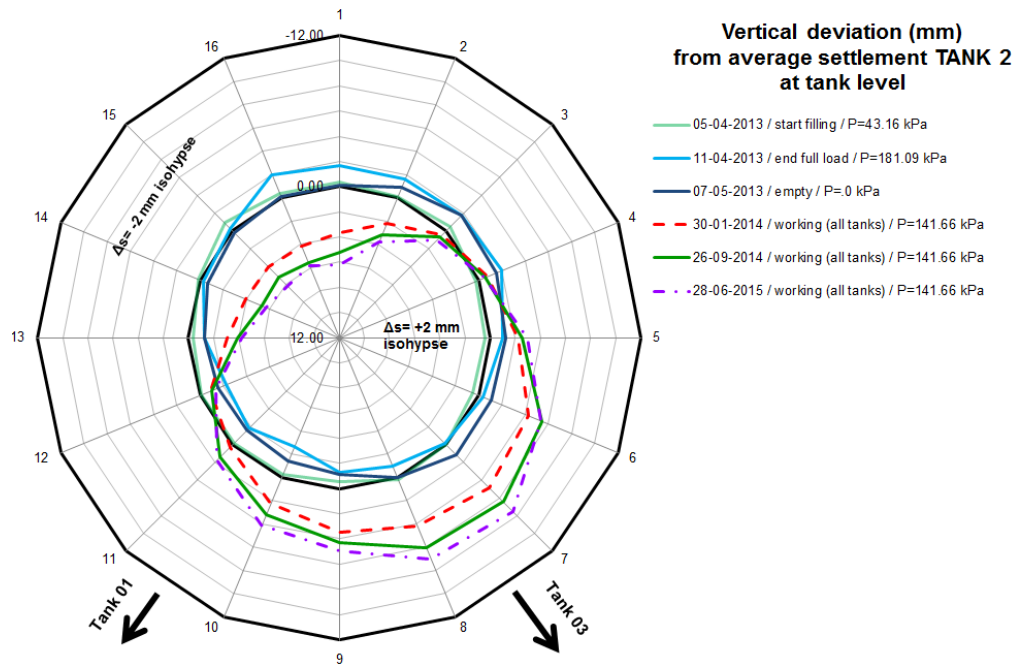
Figure 26 Vertical deviation from average settlement (mm) of Tank 2 - during hydro test and during operation, at tank level.

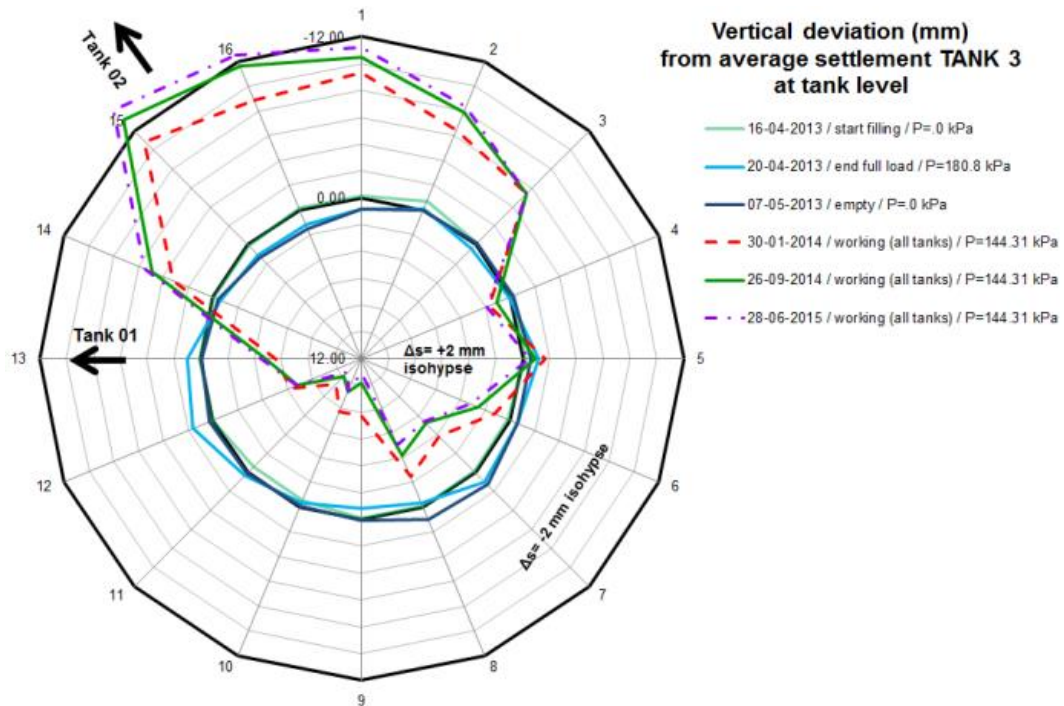
Figure 27 Vertical deviation from average settlement (mm) of Tank 3 - during hydro test and during operation, at tank level.

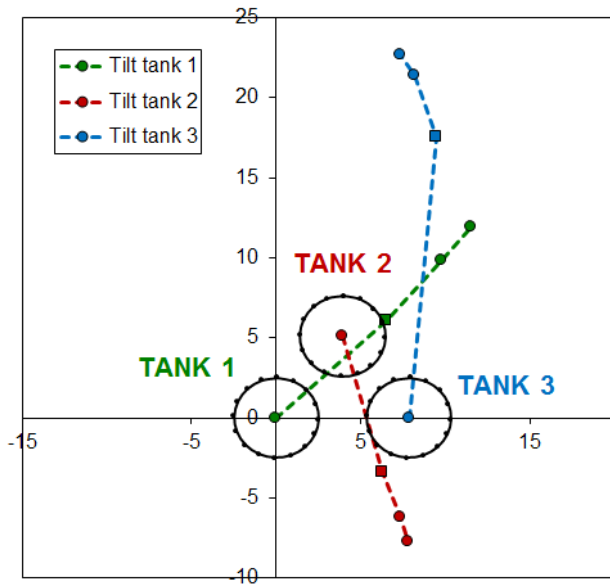
Figure 28 Direction and size (mm) of tilt of the tanks during operation.

An increased value of the tilt compared to the situation of the hydro-test is also to be expected due to the interaction of the different loads. Although the average settlement for all tanks is very similar, there is a significant difference in the size and direction of the tilt. Both tank 1 and 2 exhibit about 15mm of nearly perfectly planar tilt ( $0.00031 \text{ m/m}$ ) towards the central area in-between the tanks (i.e. the centre of the stress field), while tank 3 tilts clearly slightly distorted and almost directly north for about 22 mm ( $0.00046 \text{ m/m}$ ). The local subsoil heterogeneities below tank 3 are probably the reason for such uneven tilt of tank 3.

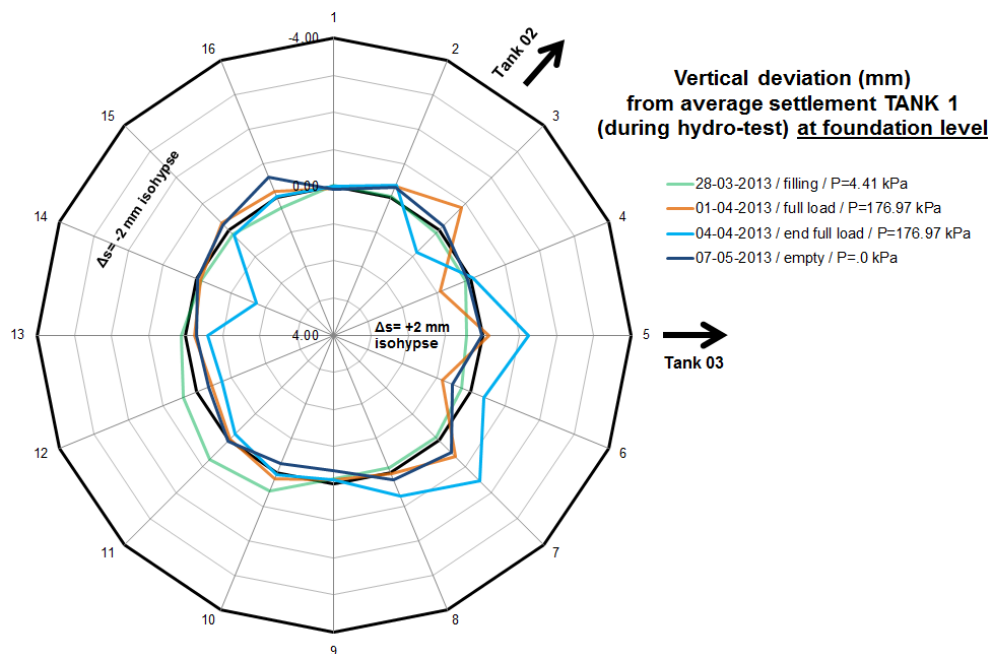
Figure 29 Vertical deviation from average settlement (mm) of Tank 1 - during hydro test (Tanks 02 and 03 still empty), at foundation level.

The rotation or tilting of the foundation slab as measured during the hydro loading tests has been summarized – from the Tables 2, 3 and 4 (measured points at foundation level) – for the major loading conditions, in the Figure 29 to 31.

The first conclusion can be that after all, all tank foundation slab tilting values do remain very low; as such not more than 3 to 4 mm over a tank diameter of 48 m; so a rotation as low as  $<1/12000$ , higher than the  $1/16000$  above, at tank level, due to the interaction of the tank and foundation through the interlayer of asphalt and due to different interaction of the outside temperature (sun shine) on the perimeter in the Eastern – Southern part of the tanks.

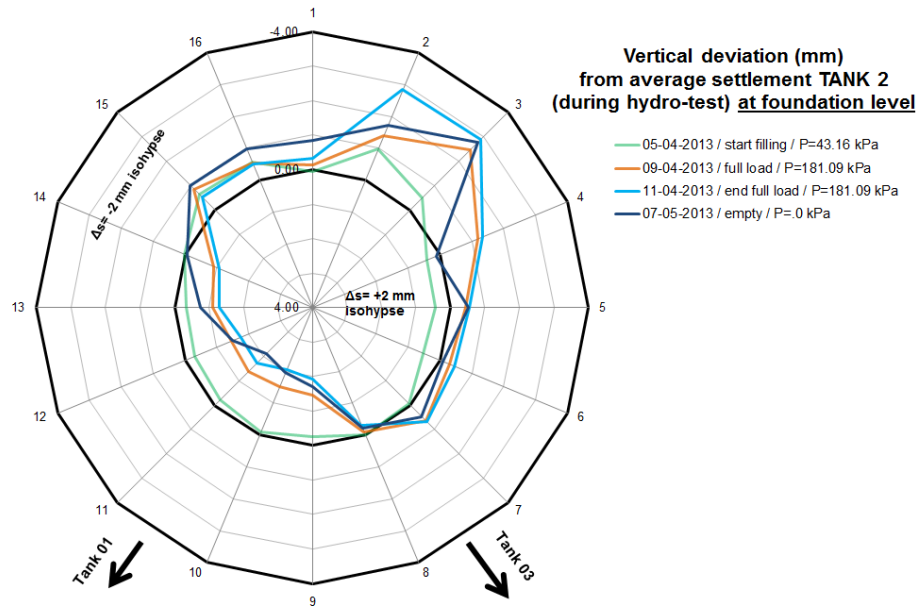
Figure 30 Vertical deviation from average settlement (mm) of Tank 2 - during hydro test, at foundation level.

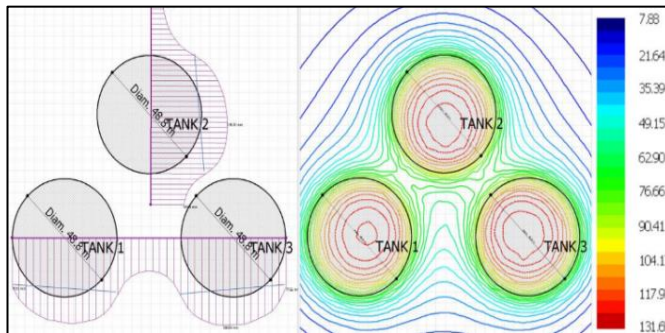
Figure 32 Simplified settlement analysis of the tanks under operational load.

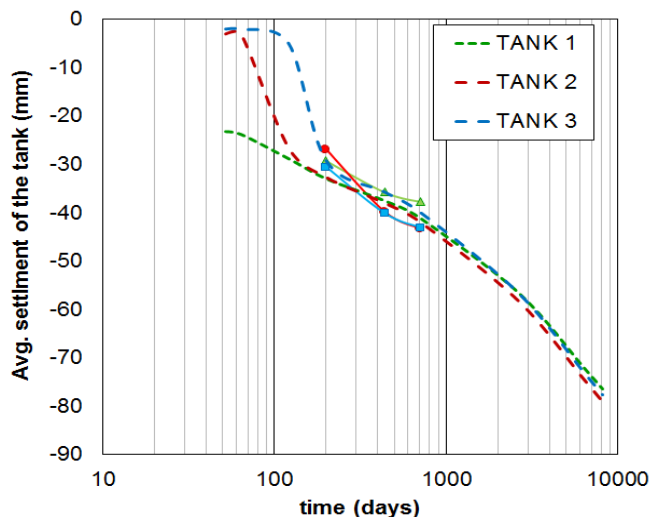
Figure 33 Predicted (lines) versus measured (dots) average settlement of the tanks under operational load.

The results of the fitting are presented in Figures 33 and 34, which show the predicted versus measured values for respectively the average settlement and tilting of the tanks. The time range which is presented is approximately 20 years.

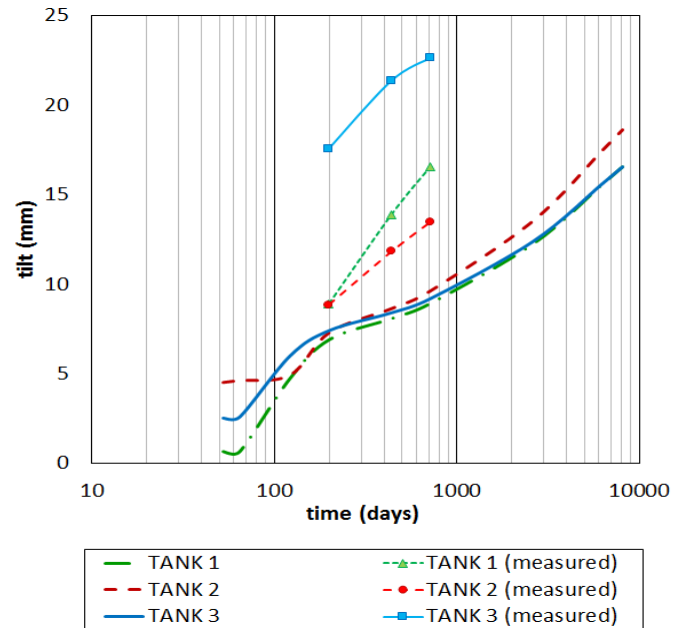
Figure 34 Predicted (lines) versus measured (dots) tilt of the tanks under operational load.

The prediction at this point underestimates the amount of tilt which is occurring, especially for tank 3. This could be due to the existence of some stiffness heterogeneity in the region of this tank, which could also be responsible for the distortion (non-planar tilt).
